**079-4186**

**2006-01 Ford Escape; Mazda Tribute; 2006-05  
Mercury Mariner**

## **O-Ring and Gasket Issues May Be Causing a Misfire**

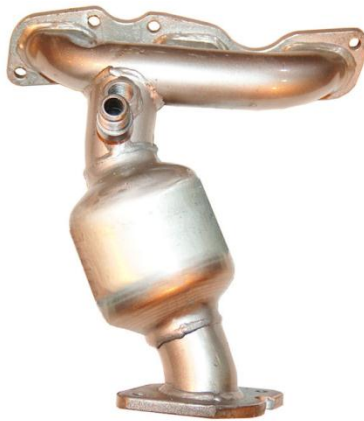
O-Ring failure in the area of the intake manifold and EGR valve on certain Escape, Tribute, and Mariner applications may be causing a vacuum leak and eventual misfire condition, which could be the root cause of the original converter failure.

Prior to converter replacement, it is recommended that the gasket and O-Ring between the EGR valve and intake manifold be replaced with the manufacturer's updated version. Failure to replace / update the gasket and O-Ring can leave the vehicle susceptible to repeated converter failure from the original problem.

In addition to the above, confirmation of a fully operational coil-on-plug system is recommended prior to catalytic converter replacement.
