# **bosal**

**079-4185**

**2006-01 Ford Escape; Mazda Tribute; 2006-05 Mercury  
Mariner**

## **O-Ring & Gasket Issues May Be Causing Misfire**

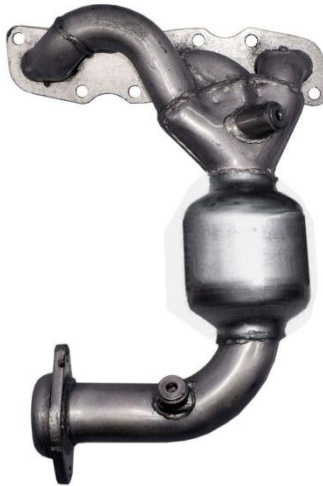
O-Ring failure in the area of the intake manifold and EGR valve on certain Escape, Tribute, and Mariner applications may be causing a vacuum leak and eventual misfire condition, which could be the root cause of the original converter failure.

Prior to converter replacement, it is recommended that the gasket and O-Ring between the EGR valve and intake manifold be replaced with the manufacturer's updated version. Failure to replace / update the gasket and O-Ring can leave the vehicle susceptible to repeated converter failure from the original problem.

In addition to the above, confirmation of a fully operational coil-on-plug system is recommended prior to catalytic converter replacement.
