Transfer Case Motor Typical Failures and Prevention

Transfer Case Motor Connector Missing Pins

48-113: Faulty Ground Affects Transfer Case Motor Operation

ProTech Bulletin Summary: Motors

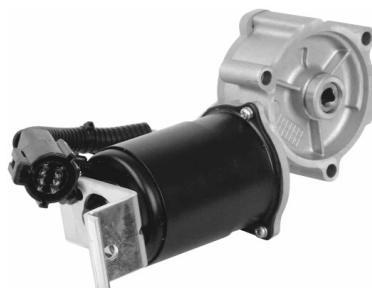
Typical Ford Motor

Most units fail because of water or mud intrusion. Carefully inspect motor boot or protective coverings. Be sure connector seals can keep water and debris out. Check wiring harness and connector. Replace or repair wiring as necessary. After installation, periodically select 4-wheel drive mode to ensure operation when needed.

Ford applications require transfer of wire connector pins. Be sure to record pin location before removing the original unit.

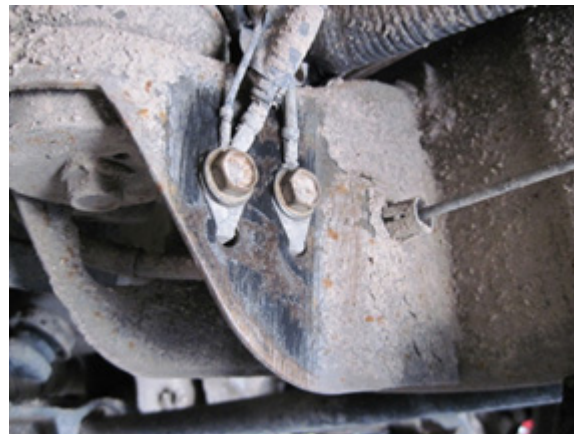
The ground wire for the Transfer Case Motor control module is mounted to the frame rail just in back of the driver's side front wheel well. Especially in salt and corrosive areas of the country, this ground wire becomes corroded resulting in a faulty ground causing intermittent operation. For many applications the PCM ground is also connected to this common ground. Verifying the integrity of this ground point may solve PCM related problems too.

We recommend inspection of the ground distribution wires and bolts securing them. Clean the ground surface, bolts and wires as needed. Repairing this ground will ensure reliable operation of the Transfer Case Motor.
