# CARDONE™ ProTech®

## Water Intrusion Causes Many Wiper Motor Problems

## Grounding Wiper Motor Corrects Parking and Other Problems

## Operating Wiper Motor Before Installation Causes Problems

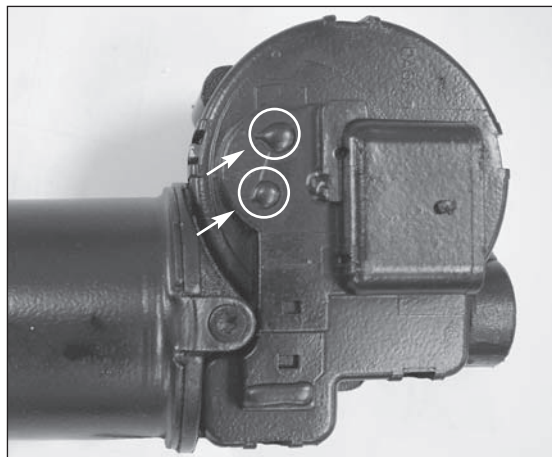
**Problem** Wiper motors with and without integrated electronic pulse board not working properly or at all.

**Cause** Wiper motor and/or electronic components may have failed due to water intrusion.

**Solution** To protect the replacement wiper motor and pulse board, be sure water does not drain on wiper motor assembly. Remove any debris that might block or restrict the flow of drain water to the left or right fender well areas. Be sure to also check for proper operation of control switch and associated wiring.

To prevent water intrusion, our replacement units are re-engineered to overcome original design flaws. Vent holes that allow water entry are blocked, therefore protecting the motor & its electronic components.

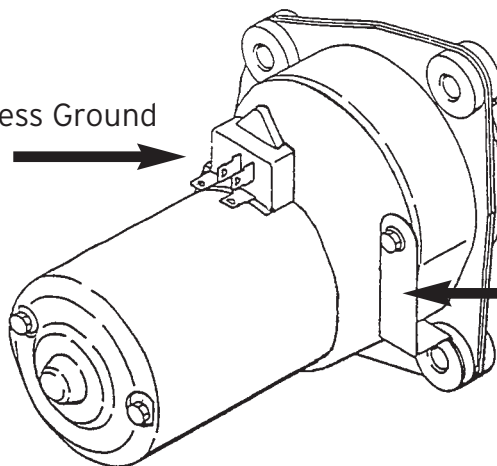
**Problem** Motor will not park, will not shut off, parks in middle of windshield, or motor will not run.

**Cause** Resistance in ground path to motor.

Check Harness Ground

Check Ground Strap

**Solution** Connect a ground strap from engine block to the motor case. If necessary scrape some paint off motor to insure a good connection.

If motor operates, check wiring harness ground, terminal ground lug or ground strap if equipped for good connection. Also check for paint on motor bosses where the mounting bracket is fastened.

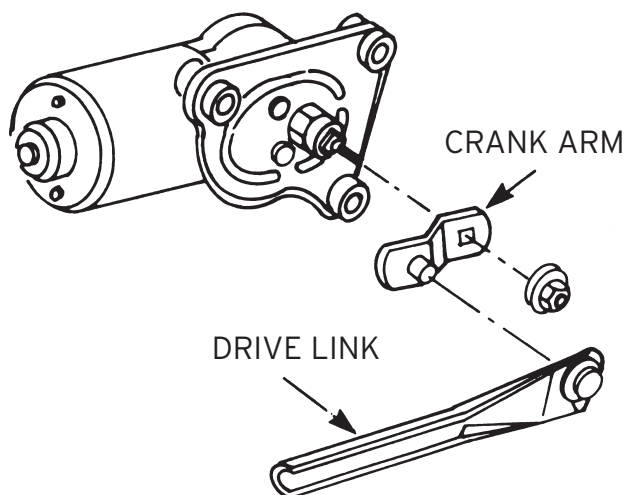
**Problem** Replacement wiper motor parks in wrong position.

**Cause** Power was applied to the unit before installation moving it off park position.

**Solution** Remove linkage from installed unit, operate motor on high speed for 5 seconds, then switch to park position. Reinstall linkage so wiper arms are in park position. Operate unit and test for proper operation. If not correct, test motor ground (see ProTech® PT 40-0001), also refer to vehicle service manual for specific installation procedures.
