CARDONE ProTech

Ford 7.3L Powerstroke "Cackle" (Noisy) Injector

Ford Diesel 7.3L Injector Replacement Tips

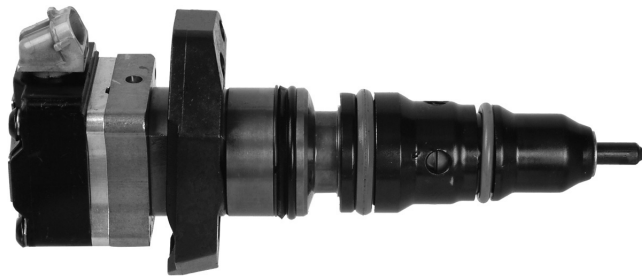
Some vehicles may experience a misfire or "cackle".

The injectors in the 7.3L diesel run off of the high pressure engine oil pump. The number 8 injector is the farthest away from the oil pump, causing a filling problem, which may result in a misfire. Ford replaced the number 8 injector in some vehicles as needed with a different injector to solve the problem.

Most vehicles use eight AB or AD type injectors, but your 7.3L Powerstroke vehicle may use seven AB or AD and one AE type. CARDONE has made the AB, AD and AE types available. Identify the type installed in your vehicle by checking the 2 digit alpha code on top of the solenoid. Note that the AE type may also be labeled LL, which stands for "Long Lead". The part number for the AB type is 2J-204, the AD type number is 2J-205, and the AE type is 2J-209.
