ALL MANIFOLD CONVERTERS

Sequential Torque & Tightening of Manifold Converter Bolts

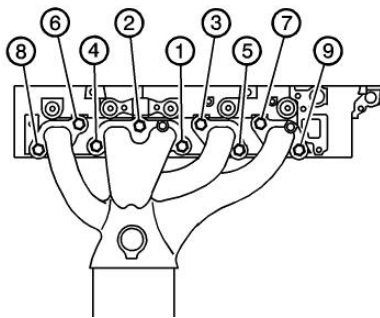
- Subject:** Sequential Torque & Tightening of Manifold Converter Bolts
- Model(s):** All engines with Manifold Catalytic Converters
- Year:** 1997 to present.
- Condition:** Unmetered air leaks or exhaust manifold gasket not sealing.
- Cause(s):** Improper tightening of the Manifold Converter Bolts
- Solution:** ALL Manifold bolts must be sequentially tightened and torqued to manufacturer's specs. These bolts should be tightened in four (4) stages in a spiraling pattern starting with the inner bolts working sequentially outward per the illustration below.

The first tightening should be to snug the bolts only and to check for proper new gasket alignment. The second tightening should be to 25% of the manufacturer specs. The third tightening should be to 75% and the last should be to 100%. All bolts should be checked and re-torqued after the first heat and cool down cycle.
