ALL MANIFOLD CONVERTERS

Sequential Torque & Tightening of Manifold Converter Bolts

2004-10 GM 2.2L & 2.4L Manifold Converters

Proper Identification of the Vehicle Emissions System

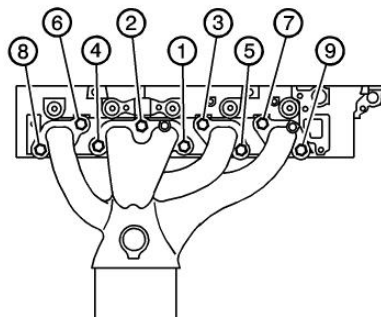
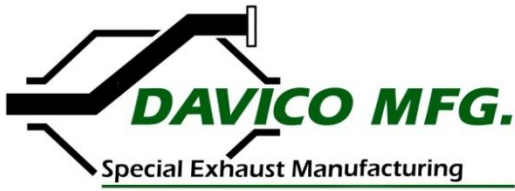
- Subject:** Sequential Torque & Tightening of Manifold Converter Bolts
- Model(s):** All engines with Manifold Catalytic Converters
- Year:** 1997 to present.
- Condition:** Unmetered air leaks or exhaust manifold gasket not sealing.
- Cause(s):** Improper tightening of the Manifold Converter Bolts
- Solution:** ALL Manifold bolts must be sequentially tightened and torqued to manufacturer's specs. These bolts should be tightened in four (4) stages in a spiraling pattern starting with the inner bolts working sequentially outward per the illustration below.

The first tightening should be to snug the bolts only and to check for proper new gasket alignment. The second tightening should be to 25% of the manufacturer specs. The third tightening should be to 75% and the last should be to 100%. All bolts should be checked and re-torqued after the first heat and cool down cycle.

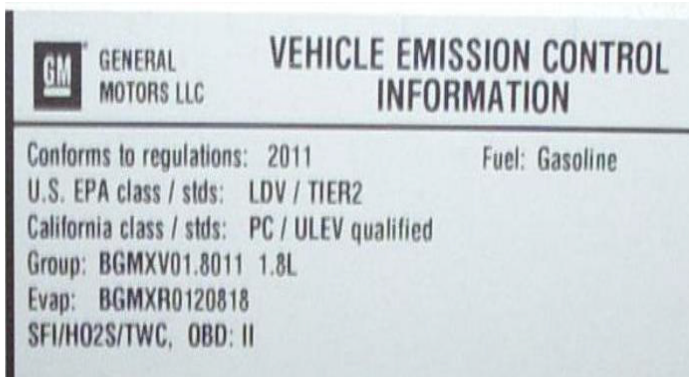
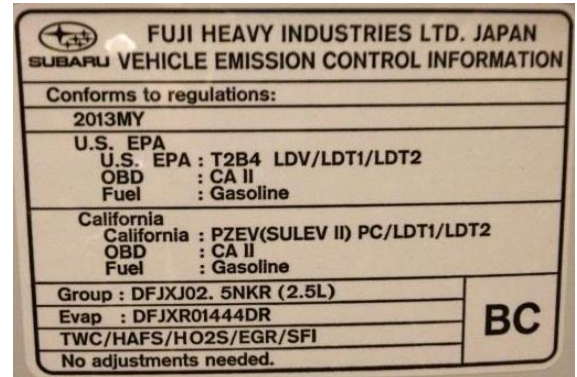
- Subject:** PZEV & Non PZEV Applications
- Model(s):** Chevy Malibu, Pontiac G6 & Saturn Aura
- Year:** 2004-10 Using our part numbers 19212 or 19292
- Advisory:** Installers must properly identify the vehicle's emission system to determine the correct part number for the application. The vehicles emissions ID tag is located under the hood of the vehicle in one of the following places: Under and on the hood structure, on the radiator support structure or on the strut tower.
