Tech Help

Applications: All Subaru vehicles

GSP Part Numbers: NCV66002, NCV66005, NCV66011, NCV66013, NCV66037,
NCV66053, NCV66059, NCV66501, NCV66505, NCV66901,
NCV66903, NCV66904, NCV66916, NCV66920

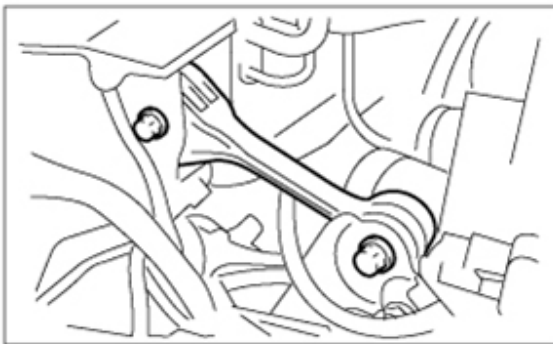
Figure 1

It is very important to check **motor mounts** on any vehicle prior to replacing a [CV Axle](#). If a motor mount is worn or broken it may cause excessive engine movement that could result in the axle exceeding its plunge distance and pulling out of the transmission. Subaru axles are designed to operate at a greater angle of declination than most vehicles. In addition to a possible separation with the transmission these axles may create a vibration or noise if they continue to operate at the maximum plunge distance. Worn or broken motor mounts may cause this action. In addition Subaru have a third mount referred to as the Transmission mount (see Fig. 2). If the rubber in the cradle is worn or cracked it may also contribute to excessive engine pitch. The engine pitching stopper (see Fig. 1) also has two rubber isolators that need to be checked for wear, stiffness or cracking. On some models of Subaru a heat shield and exhaust pipes may interfere with checking these components.
