Applications: All 2001 and newer Volvo 60, 70, and 80 Series

GSP Part Numbers: NCV73500, NCV73503, NCV73504, NCV73511,
NCV73512, NCV73514, NCV73515, NCV73518,
NCV73519, NCV73522, NCV73523, NCV73528,
NCV73530, NCV73531, NCV73532, NCV73533,
NCV73541, NCV73542, NCV73543

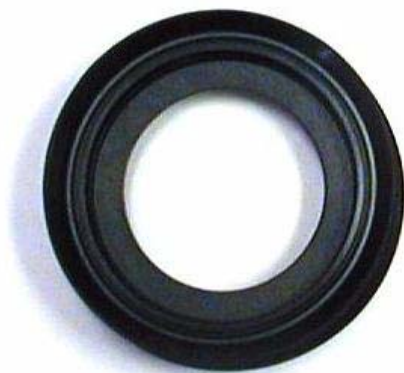
Front View - Faces Hub

When shifting from Drive into Reverse or from Reverse into Drive, a pinging type noise may be heard. This noise may also be heard when cruising and/or during acceleration or deceleration. This is not a manufacturing defect in the [axle](#). A sealing washer (see picture below), is needed to resolve this issue (refer to Volvo TSB #77-08).
