PROBLEM SOLVER™ BULLETIN

Alignment Adjustability Restrictions

1999-2007
General Motors Trucks

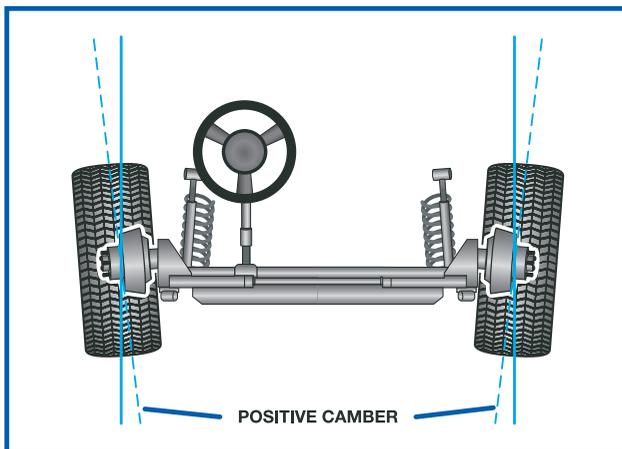
Alignment adjustability restrictions

- OE adjustments may not provide adequate range to obtain a proper alignment on late model Chevrolet and GMC light trucks.
- Excessive positive or negative camber will cause the vehicle to pull left or right and will create wear on the inside or outside edge of the tire.

MOOG® upper control arm offset bushings for camber and caster

- Provides an effective, low-cost means of obtaining more camber (and/or caster).
- Offers an additional 2 degrees of camber change.
- Used with factory cam adjuster, but allows greater range.
- Designed with OE-type material to maintain ride quality and service life.
- Fast and simple installation – made easier with the use of T40259, a bushing adapter specially designed to work with K6669 and K6670.
