PROBLEM SOLVER™ BULLETIN

BULLETIN: 27026

Chrysler Control Arm with Ball Joint Chrysler/Dodge Full Size Sedans

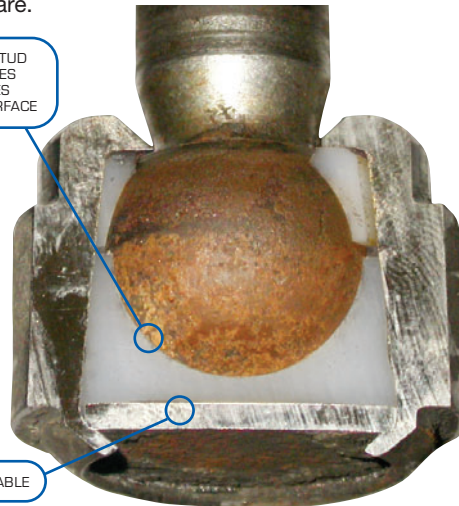
- Ball joints experience premature wear due to intrusion.
- Non-serviceable polymer socket cannot flush contamination, which quickly leads to corrosion and wear, causing excessive deflection in the socket assembly.
- Socket assembly deflection causes changes to alignment angles, resulting in steering and tire wear issues.
- Mounting hardware is not included in competitor's replacement part kits, forcing technicians to reuse old hardware.

CORRODED STUD
CONTAMINATES
AND ABRASES
BEARING SURFACE

NON-SERVICEABLE

A failed OE part measured .025" of play, a result of the corroded stud wearing into the bearing surface.
