BULLETIN: 25963

Front Wheel Drive Lower Ball Joint Wear

1992-1996
General Motors Minivan

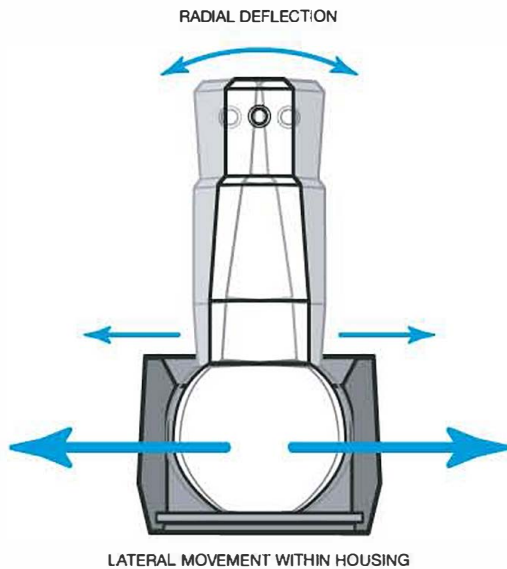
Premature ball joint wear

- Lateral deflection (side to side) loading causes excessive wear in ball joint.
