# PROBLEM Solver™ BULLETIN

BULLETIN: 25871

## Excessive Play; Joint Separation

1997-1999  
Dodge Dakota and Durango

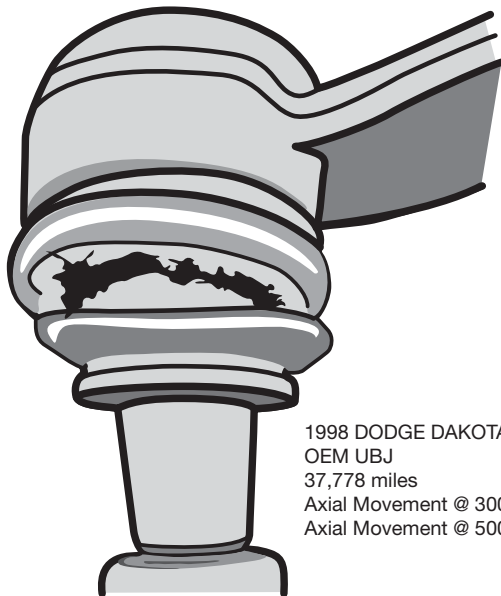
#### OE Ball Joint Fails Prematurely

- OE ball joints experience boot failure, letting contaminants in and allowing vital lubrication loss.
- Non-serviceable polymer socket design is unable to flush contamination; corrosion and wear quickly set in. (Failed OE Ball Joint problem illustration)

1998 DODGE DAKOTA 4WD  
OEM UBJ  
37,778 miles  
Axial Movement @ 300 lbs = .045"  
Axial Movement @ 500 lbs = .048"

#### MOOG® K7242

- Serviceable MOOG socket design features unique sealed boot technology, with a special grease-relief valve, that prevents contamination.
- Greaseable design.
- Belleville washer pre-load provides lower torque and stud articulation with minimal axial clearance.
- Hardened, powdered-metal bearings are not prone to excessive wear often experienced by plastic bearings under adverse conditions. (Solution illustration)
