BULLETIN: 25888

4WD Solid Axle Ball Joints

Various Solid Axle Applications

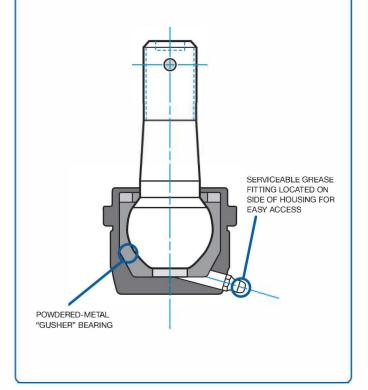
MOOG° Exclusive: Improved design K8194T

Non-Serviceable or Non-Accessible Ball Joint Grease Fitting

- Grease fitting on some serviceable ball joints cannot be accessed for service after installation due to proximity to u-joint yoke assembly.
- Parts with grease fittings located in the bottom of the ball joint can interfere with u-joint resulting in damage when service is attempted.
- Non-serviceable polymer sockets cannot flush contamination, which quickly leads to corrosion and wear.

- · Grease fitting relocated to the side of the ball joint housing.
- · Provides easy access for lubrication service.
- MOOG's hardened, powdered-metal bearing are not prone to the excessive wear plastic bearings experience under adverse conditions.
