NISSENS' TECHNICAL TIPS AC Compressors

PRODUCT SUBJECT CLUTCH PROBLEMS

MANUFACTURER VOLVO

MODEL SERIES 850

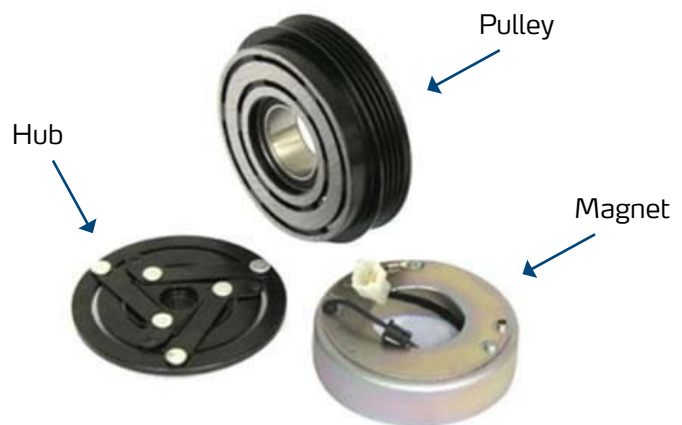
Most Volvo 850 models have problems with the clutch after a certain timeframe. The shims that ensure the distance between the hub and the pulley start to create problems. The distance increases over time, and the magnet will at the end not be able to engage the hub properly.

When the clutch is cold, there will be no problems. But once the pulley gets warm (after 2-5 minutes), the hub will disengage due to the increased distance.
