Bulletin BPI 17-04

TITLE Determining Correct Rotor for Med Duty Trucks
Vehicles Involved: All Medium Duty Trucks

Bulletin BPI 03-02

Subject: Diagnosing and Measuring Rotor Run-out.

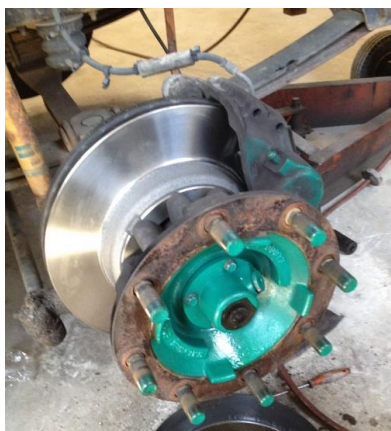
Fig 1

Condition: Wheel studs not used when counting mounting holes

Medium duty truck rotors are cataloged a little different than the typical light truck rotors. Light truck rotors are usually slip on style and go over the wheel studs on the bearing hub. Many medium duty truck rotors do not slip over the studs but are bolted to the back side of the stud flange. When the catalog listing says 6 bolt or 10 bolt, they are not talking about the lug studs, they are talking about the bolts that fasten the rotor to flange. These bolts are not visible but may be determined by counting the casting extensions on flange (see fig 1). The figure below shows a 10 bolt mount with 8 studs.

Another note is catalog listings. Medium duty applications are sometimes better determined by size. Overall diameter, height of rotor lying flat on table, center hole diameter and bolt holes are some of the measurements needed for correct part.

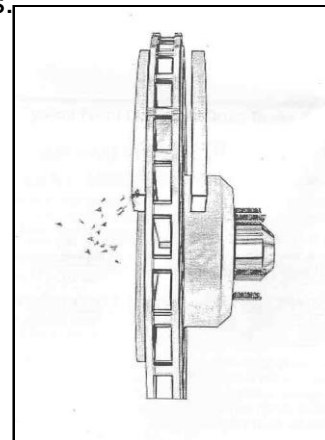
Fig.1

2. What are the effects of excessive lateral rotor run-out? With excessive run-out, the rotor wobbles as it turns (Fig.1). Uneven rotor wear occurs with the brakes not applied causing rotor thickness variation. Thickness variation causes:

- Brake pedal pulsation
- Dissatisfied customers
- Comebacks

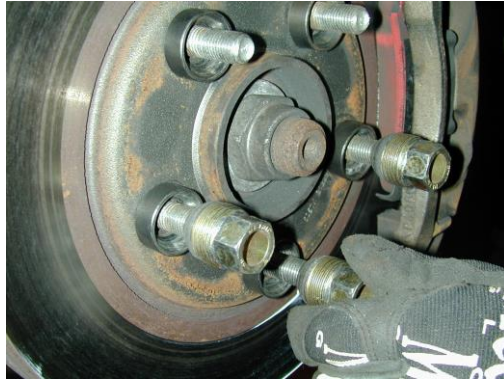
Fig.2

3. How do I check rotor run-out? (Fig.2)

- Inspect unitized hub and bearing for excessive play
- Clean hubs and rotor hat
- Install conical cones/washers
- Torque lug nuts in sequence
- Secure dial indicator

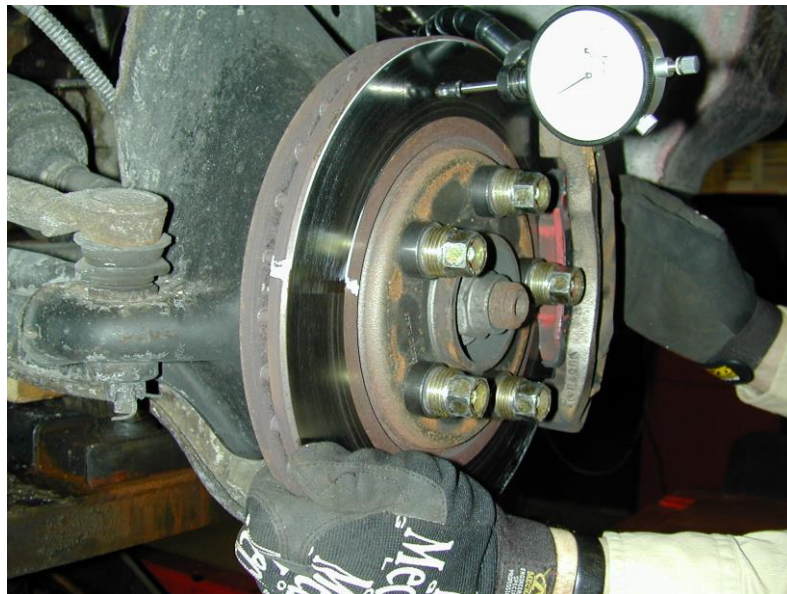
Fig. 3

A new rotor or a good resurfaced rotor placed on a hub that has run-out may cause a comeback. With a little extra care and time, a technician can index the rotor to hub. This process is very easy, and in most cases the run-out specification can be attained.

* Begin the process by cleaning the hub and rotor of rust and burrs. Identify one of the wheel studs with a yellow marker, torque the rotor to the hub and check run-out. If the run-out is out of specification, remove the lug nuts and move the rotor one-wheel stud to the right. Torque the lug nuts and re-check rotor run-out. Repeat this sequence until the least amount of run-out is attained. Fig.3
