# SMITTYBILT TECHNICAL UPDATE

DATE 7-14-16

APPLICATION 2007+ JK

PART NO. 2793

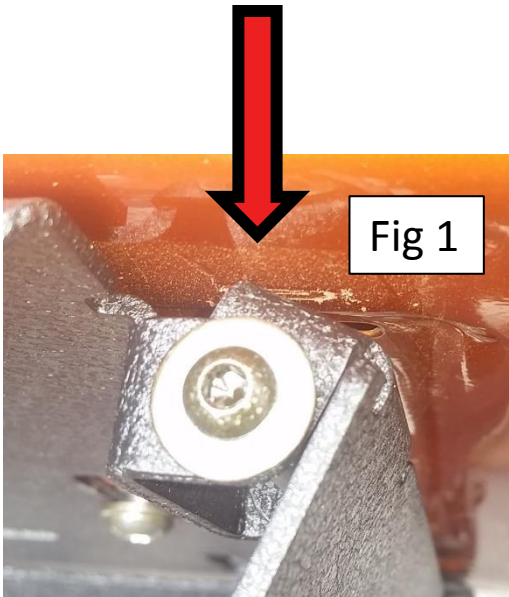
Depending on positioning of table, side brackets may slightly come into contact with tailgate if mounted on the inside of the tailgate.

Depending on mounting location, side brackets may slightly contact tailgate when mounted on the inside of the tailgate.(fig 1) Use flat washer between tailgate and table to allow for clearance. Use one washer for each of the 4 mounting bolts. Fig 2

Short term fix: use M12 or ½" flat washer( qty 4) as spacer between tailgate and table.
