SMITTYBILT TECHNICAL UPDATE

APPLICATION 07-15 JK 2 & 4 Door

PART NO. #76896 #76858, #76614

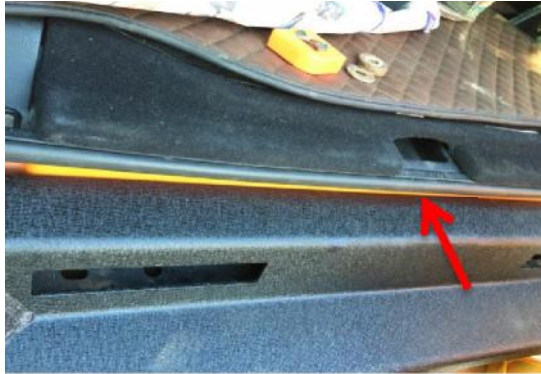
Fig A

1. On some vehicles the center of the Gen 2 bumpers (on top) may come into contact with the body tub. (Fig A) or the corners
2. On some vehicles the corners of the Atlas may be too close to the body tub.
