Just the Facts

Don't Get PO'ed with P0401 Codes

Ford P0401 Issues

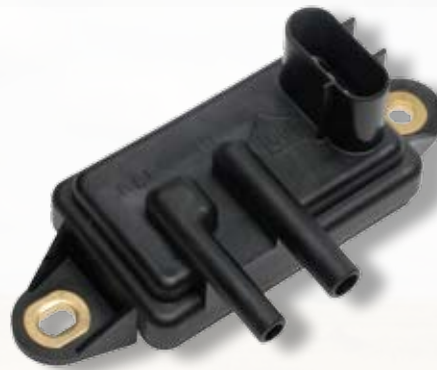
DPFE Sensor
VP8

The most common issue is the failure of the EGR Pressure Feedback sensor commonly known as the DPFE sensor. If the diaphragm in the sensor becomes weak or the sensor is contaminated with moisture it can fail to supply the computer with the correct reference voltage. When this occurs, the computer increases the vacuum supply to the EGR valve causing the vehicle to run poorly. When the low flow signal is unable to be corrected by the computer's adjustment, then the computer sets a P0401 code for EGR flow.

To prevent a reoccurrence of the P0401 code, Standard recommends inspecting and replacing if necessary, the EVR and DPFE hoses when replacing the DPFE sensor. To further guard against a P0401 code, a de-carbonization treatment of the EGR system should be performed.

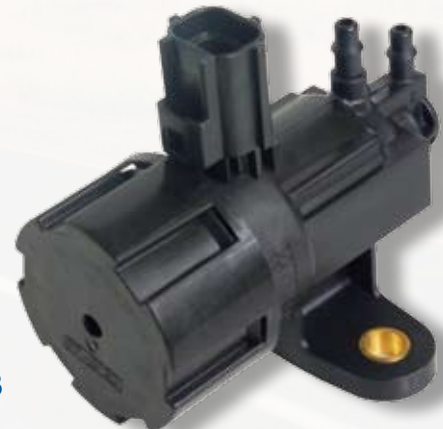
EVR
VS63

The other parts that commonly get overlooked are the EGR Valve Regulator (EVR), which is cataloged as an EGR control solenoid, the DPFE hoses, and carbon build-up inside the EGR system. The EVR is responsible for supplying the proper vacuum to the EGR valve. Any resistance in this control circuit or failure of the EVR can cause a P0401 code. The original DPFE hoses are a special high-temperature hose. These hoses can crack or collapse internally over time due to intense thermal cycling that takes place within the EGR system.
