TERAFLEX

Technical Service Bulletin JK HD Ball Joint Kit 2013+ JK Stub Shaft Modification

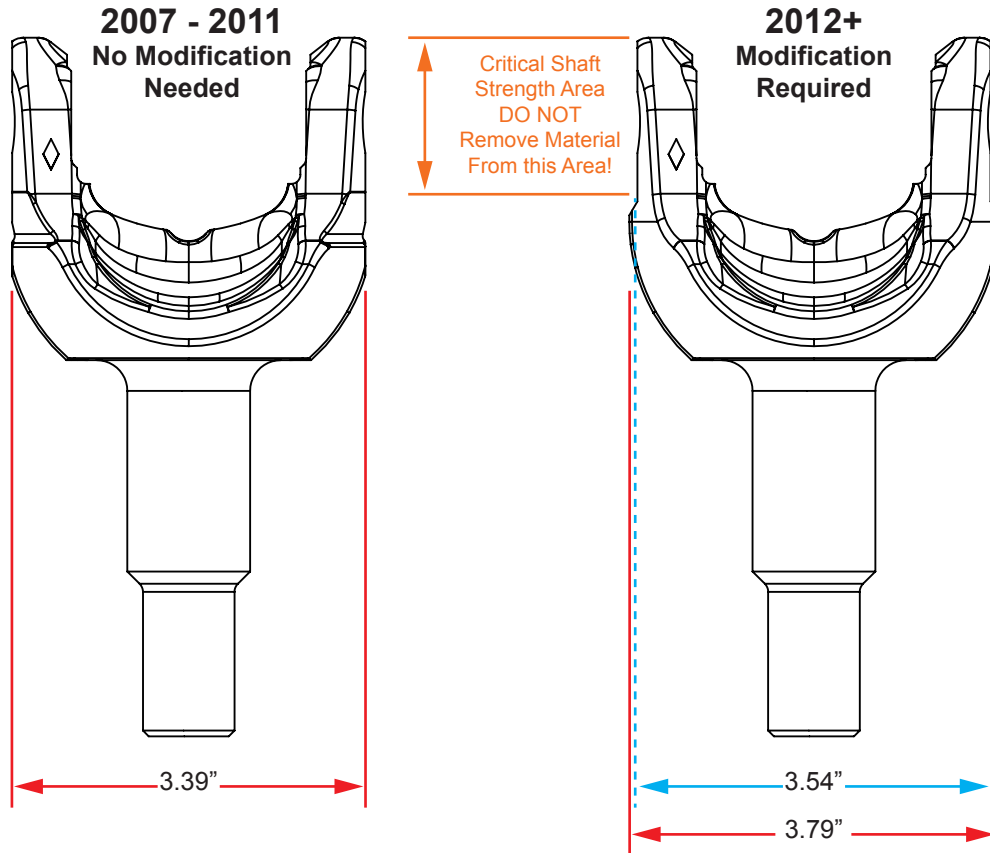
2012 and newer front Dana 30 & Dana 44 equipped JK Wranglers utilize a larger diameter outer stub shaft. This causes interference issues when used with TeraFlex HD Ball Joints (lower ball joint only).

A DIY solution to fix this issue involves minor clearing of a non-critical area of the outer stub shaft to allow proper lower ball joint clearance. As seen in the diagram above, removal of approximately 0.125" from each side of the outside diameter of the outer stub shaft shoulder is required.

Note: By avoiding any modification to the critical strength area, shown above, the outer stub shaft's performance and strength will not be affected by this slight modification.
