Scope

An aftermarket replacement Valve Cover for OE part number 11 12 7 552 281, sold by company noted as OTHER, was reviewed using the tools, measurement equipment and quality verification processes in use at APA Industries. This report itemizes non-conformances found with the OTHER Valve Cover when compared to cover 11 12 7 552 281 from the original equipment manufacturer (OEM).

The OTHER brand Valve Cover 11 12 7 552 281 does not pass APA Quality Inspection.

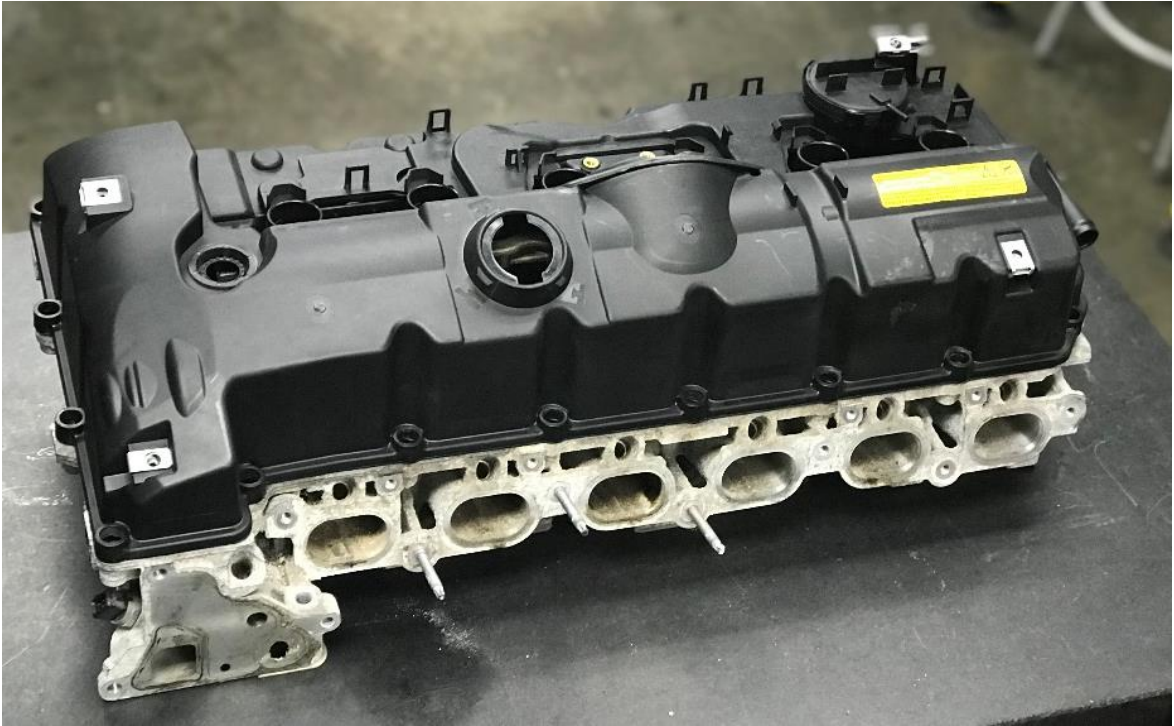
Figure 1a: OTHER valve cover seated on OE Engine Head without fasteners

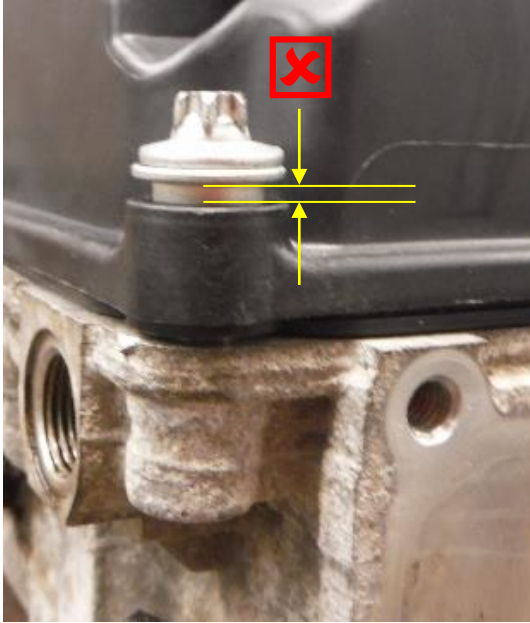
Figure 2a: Electric impact tool achieved specified torque, yet gasket was not compressed due to sleeve stand off.

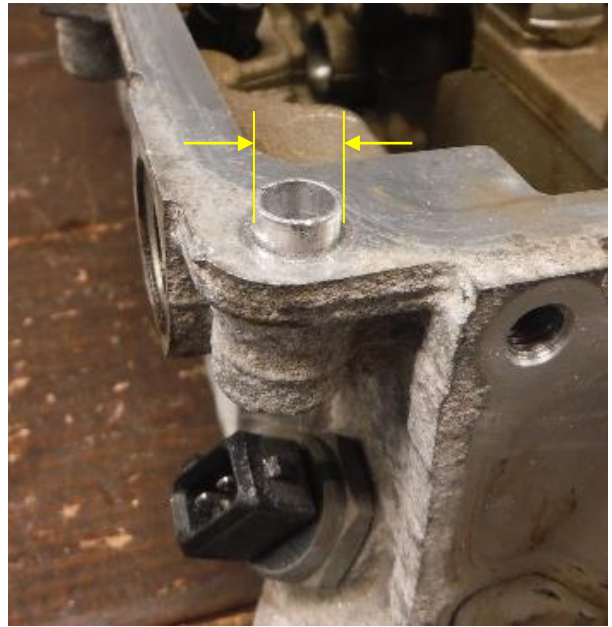
Figure 2b: Locating feature on engine head has larger OD than fastener sleeve ID.

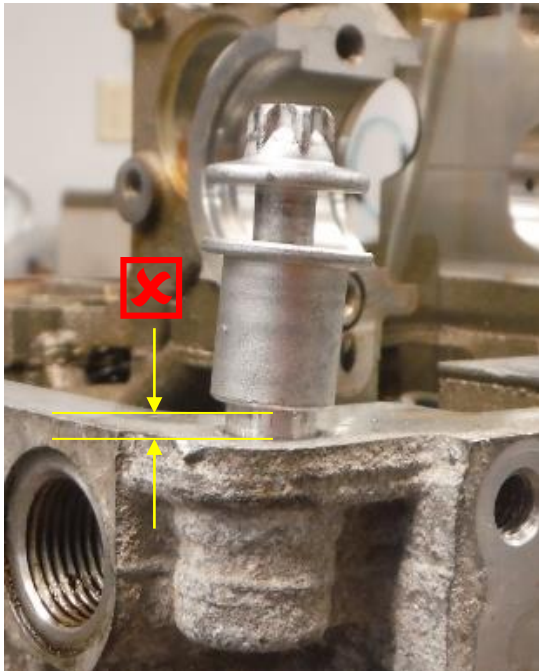
Figure 2c: Female fastener sleeve could not accommodate male locating feature.

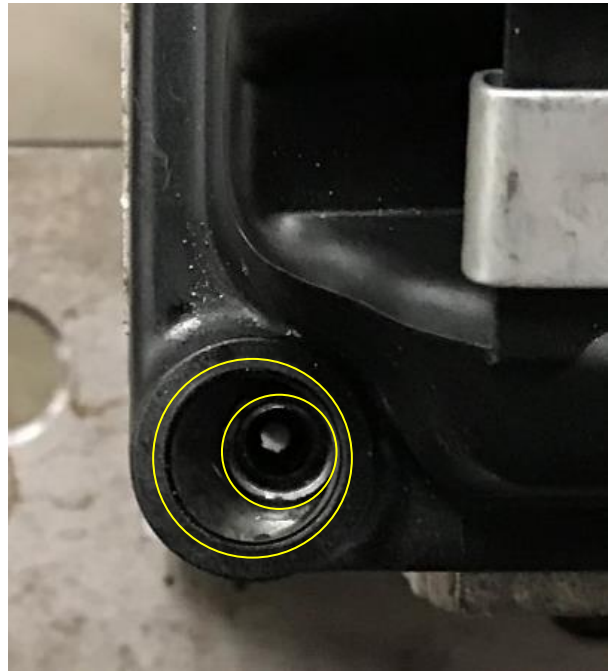
Figure 2d: Valve cover without bolt or sleeve. Housing must be forcibly deformed by installer to align fastener holes.

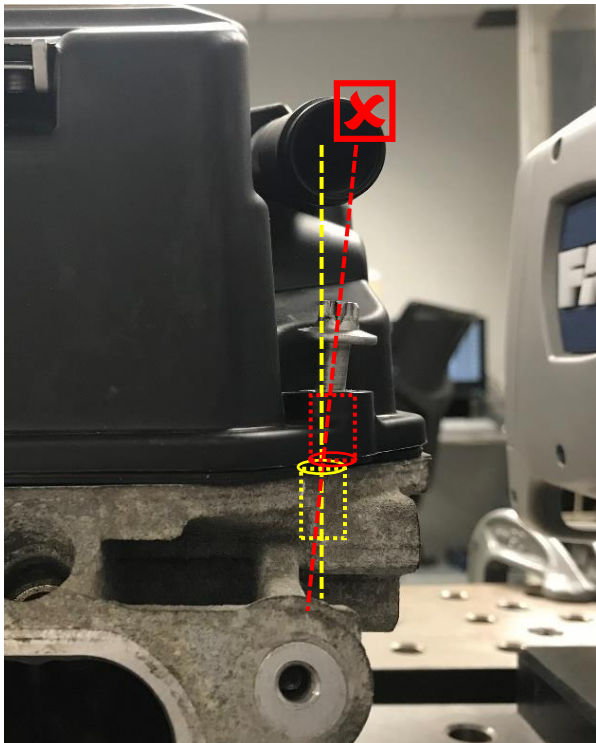
Figure 3a: NG Part Fit Detail: bolt did not achieve specified torque due to part dimensions.

Valve Cover hole location creates a NG bolt angle (in red), which did not allow the fastener to be installed to proper torque.

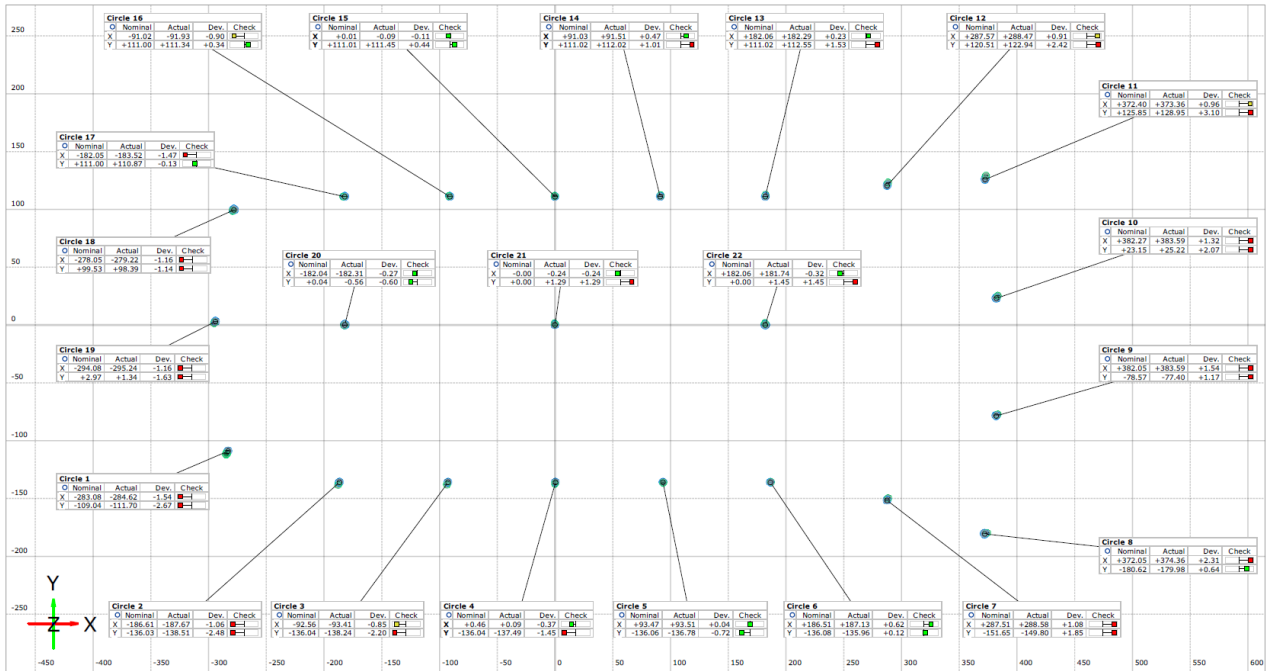
Figure 4: CMM DATA: FARO ARM

Applying a positional tolerance on each point of $\pm 1.0\text{mm}$, the OTHER valve cover has 17 out of 22 holes with a NG hole position in either the x-direction, y-direction, or both.

Additionally, the holes on the left side of the image, holes 18, 19 and 1, are off location in the X negative direction. The holes on the right side of the image, holes 11, 10, 9 and 8, are off position in the X positive direction. This is an additive situation. If you install a bolt into one end of the valve cover, all of the error is pushed to the other end of the part, causing the NG install experienced during the part fit activity.

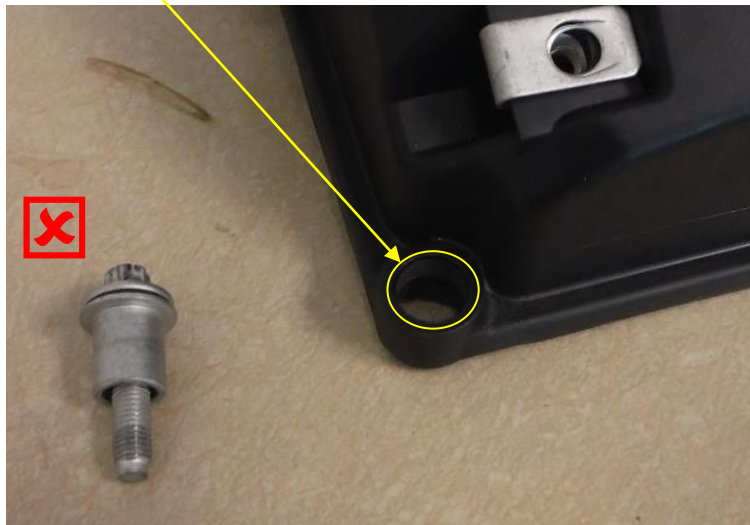
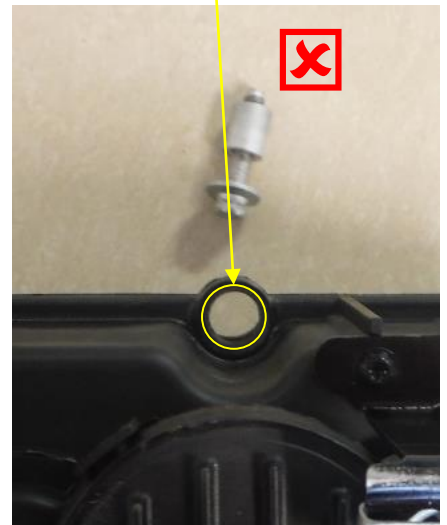
Figure 5: Fasteners Falling Out

Upon unboxing, the fasteners shown in Figure 5 fell out of the valve cover assembly with little or no outside influence. This is not acceptable for customers. The cover molding must have a proper press-fit/interference fit between the valve cover main body and the fasteners.

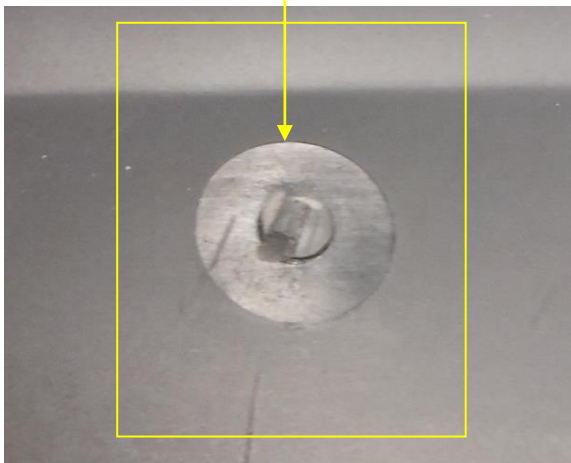
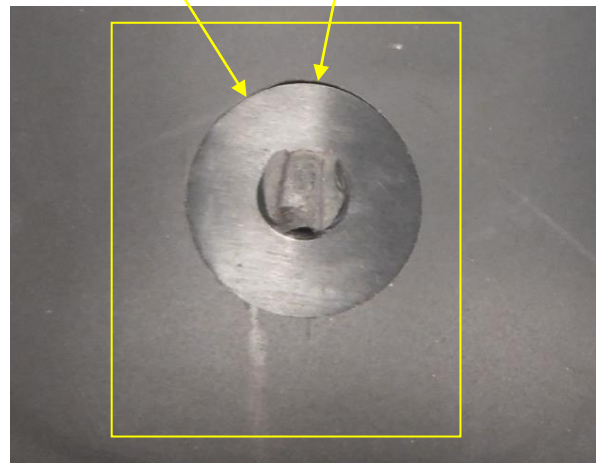
Figure 6: NG Appearance - Tooling Marks

The main molding of the valve cover has rough tooling marks from the injection molding process. These marks are located on the top of the part, where they are visible in the engine bay of the automobile. This is an NG appearance for the customer.

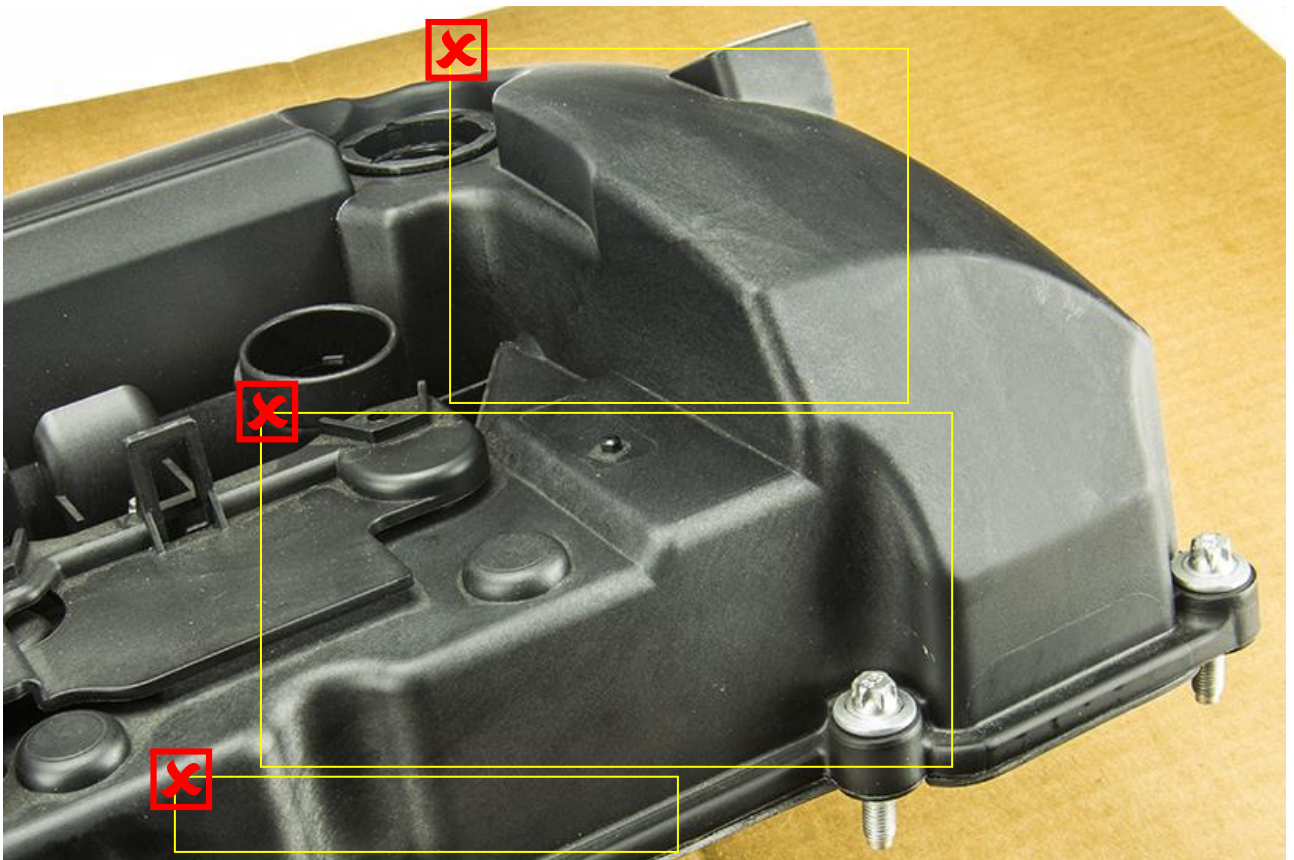
Figure 7: NG Appearance – Surface Finish

The surface of the OTHER Valve Cover has a mottled, matte grey appearance in areas, which suggests a high percentage of regrind (recycled) plastic. The OEM Valve Cover is an even black color, which is consistent with the use of virgin plastic. (A recycled plastic can never achieve the full mechanical properties of its virgin form.)
