Weasler®

**80° CONSTANT VELOCITY JOINT
OVER ANGLE NON-OPERATING**

**LACK OF GREASE
CROSS & BEARING KIT**

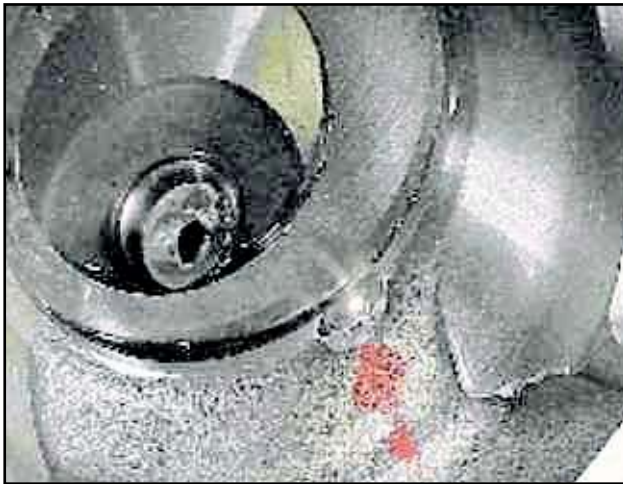
SIDE 1

These pictures show damage resulting from turning an 80° CV beyond the 80° design limit while the driveline is not operating. Both sides of the same center housing are shown. Side 1 shows a sheared pin and indentation where the pin contacted the center housing. Side 2 shows an indentation where the pin contacted the center housing, note the pin did not shear on Side 2. The ball and socket yoke shows an indentation caused when the pin contacted the center housing.

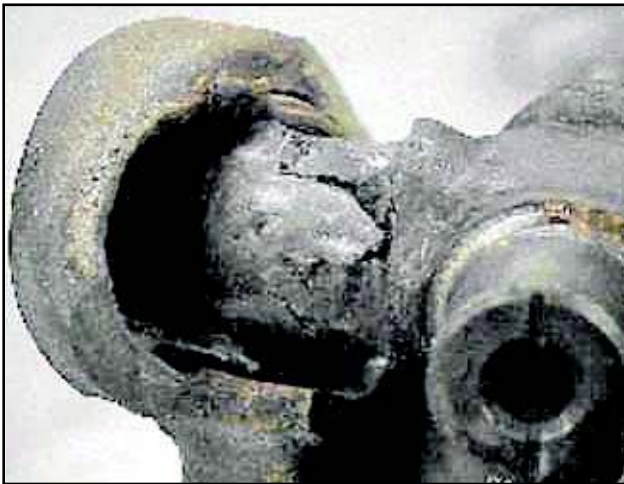
TRUNION & YOKE EAR

These pictures show examples of damage caused by a lack of grease in the cross and bearing kit.
