## PRODUCT UPDATE BULLETIN

15-0004

## PREVENT DAMAGE WHEN INSTALLING TRANSIT BULKHEADS

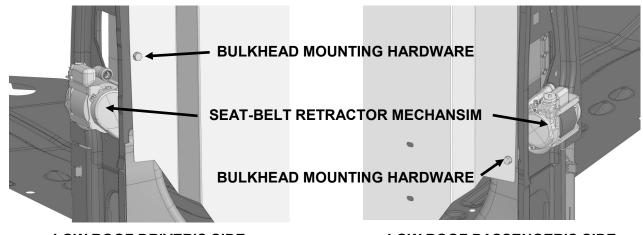
LOW ROOF PASSENGER'S SIDE

Weather Guard Transit implemented a change in January 2015 to Low-roof Bulkhead models 96301-3-01 and 96302-3-01 relocating the lowest mounting holes on the side panels to increase the clearance between seat belt retractor and the blind fasteners as shown in the figures below. The lowest mounting hole on the driver side mounting panel needs to be at least 4.0 inches above the bottom corner of the bulkhead panel. The lowest mounting hole on the passenger side mounting panel needs to be no more than 1.5 inches above the bottom corner of the bulkhead panel. Using these hole locations the mounting hardware and blind fasteners are above or below the retractor mechanism.

Check the hole location of low-roof Transit bulkheads. If they are not the same as current production, drill new lower mounting holes as shown on page 2 of this bulletin.
