## ***GENERAL BELLHOUSING ALIGNMENT INSTRUCTIONS***

## EARLY FORDS USING THE PART NUMBERS:

## FORD FLYWHEELS

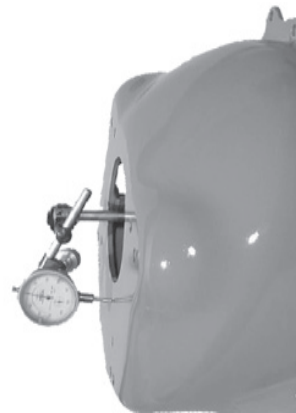
NEXT, THE BELLHOUSING FACE SHOULD BE CHECKED FOR PARALLELISM TO THE BACK OF THE BLOCK. INSTALL THE INDICATOR (AS SHOWN ABOVE). ROTATE THE CRANKSHAFT AND MARK DOWN THE READINGS (BE SURE TO PUSH THE CRANKSHAFT AGAINST THRUST BEARING FOR ACCURATE MEASUREMENT). THE MAXIMUM OUT OF PARALLELISM IS .002"

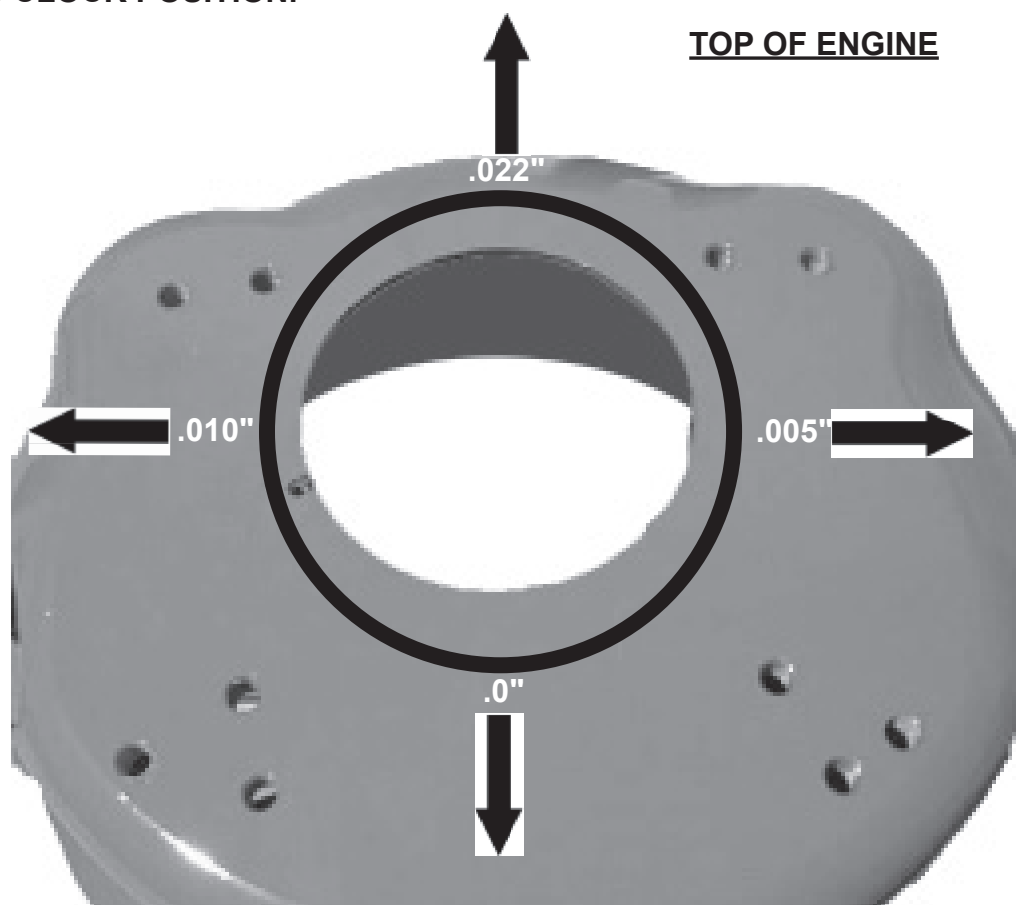
## EXAMPLE

THE BELLHOUSING WAS OFFSET TOWARD TOP OF ENGINE AND SLIGHTLY TO THE LEFT (AS VIEWED FROM BEHIND). TO ALIGN THE BELLHOUSING, INSTALL TWO .014" OFFSET DOWEL PINS WITH THE MAXIMUM OFFSET POSITIONED ROUGHLY AT THE 5 O'CLOCK POSITION.

TO CORRECT OFF-CENTER CONDITION, SELECT THE OFFSET DOWEL PIN PAIR THAT IS CLOSEST TO ONE-HALF OF THE INDICATOR READING (I.E., IF READING IS .016", 1/2R=.008" USE .007" DOWELS. IF READING IS .024", 1/2R=.012" USE .014 DOWELS).

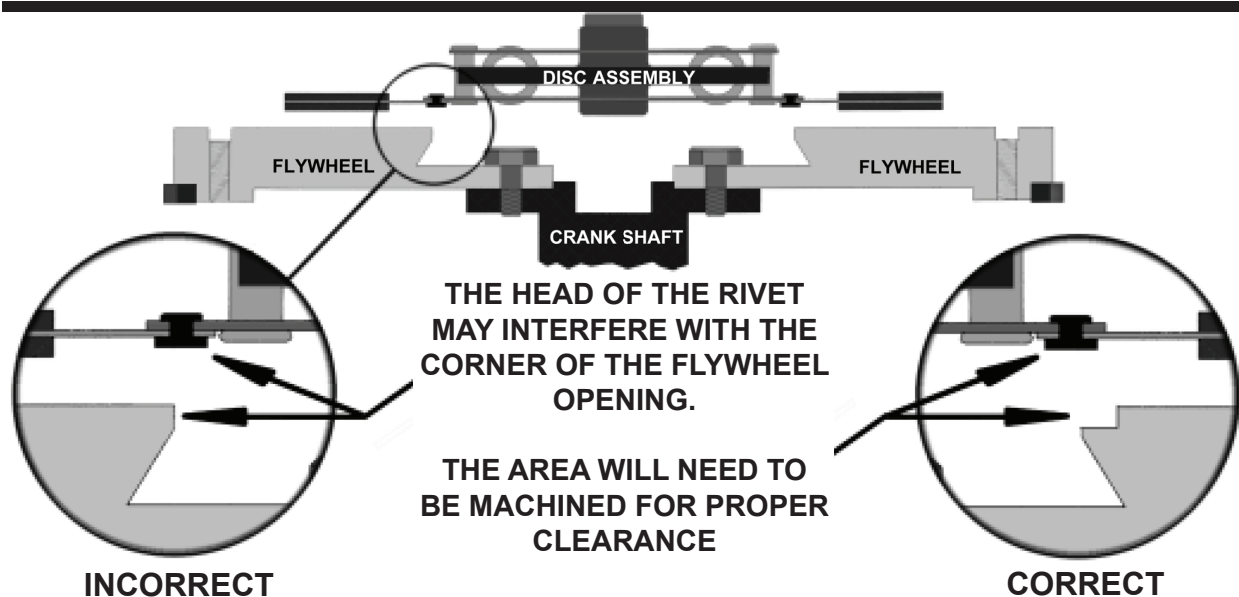
POSSIBLE INTERFERENCE MAY OCCUR BETWEEN THE CLUTCH DISC HUB TO MARCEL RIVETS DUE TO THE CENTER OPENING OF THE FLYWHEEL BEING INADEQUATE. THE RIVETS MAY RUB ON THE FACE OF THE FLYWHEEL. CAUSING THE ASSEMBLY TO RELEASE IMPROPERLY, MAKE NOISE DURING ENGAGEMENT, POSSIBLE FLYWHEEL AND DISC DAMAGE, AND/OR PREMATURE CLUTCH DISC FAILURE.

TO CORRECT THIS INTERFERENCE PROBLEM, A RELIEF MUST BE MACHINED INTO THE FLYWHEEL BY A QUALIFIED MACHINE SHOP. THE RELIEF SHOULD BE APPROXIMATELY .100" DEEP WITH SUFFICIENT DIAMETER TO CLEAR THE RIVET HEADS.
