ECOTEC 1.4L INTAKE MANIFOLD IMPROVED DESIGN ELIMINATES EXCESSIVE OIL CONSUMPTION

615-380 Chevrolet Cruze 2016-11, Chevrolet Sonic 2019-12, Chevrolet Trax 2019-13, Buick Encore 2019-13

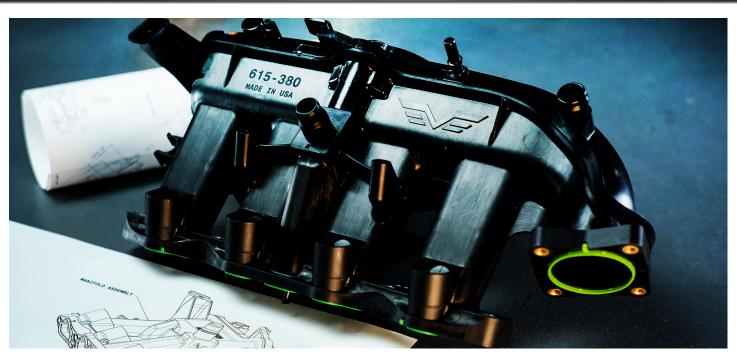
General Motors' 1.4L Ecotec engine has an inherent issue that can lead to excessive oil consumption. The umbrella-style PCV valve built into its intake manifold routinely becomes dislodged with age, and when it does, oil vapor flows freely.

PROBLEM: The original intake manifold on this GM Ecotec engine uses excessive oil when the internal PCV valve becomes dislodged

Dorman redesigned the intake manifold to include an internal retaining piece that holds the valve in place without affecting its functionality, solving the original issue permanently.

Our replacement has been improved by adding a retaining pin to keep the valve in place and prevent future failure.

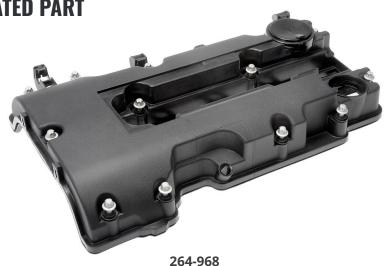
Excess vacuum created by a missing intake manifold PVC valve can damage the fragile diaphragm integrated into the valve cover's PCV cap. The proper fix is to replace both the intake manifold and the valve cover at the same time.

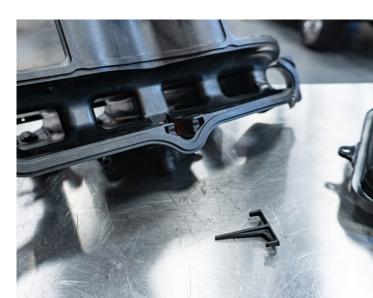
miles on it. This valve, little more than a simple rubber flap with a retainer tab on one side, drops out of its mount with nothing to secure it in place. Once this valve is gone (it's typically sucked through the intake system and combusted), vaporized oil is free to pass through the engine, resulting in the higher oil consumption.

ideation team looked at the source of the problem, they developed a smart solution to keep the valve located, even if its retainer should wear out. By incorporating a restraining pin into the intake manifold, the valve in this improved design is now captive, eliminating the chance it will ever become dislodged.
