**Therefore, some febi suspension arms provide of a rubber bearing where the installation position is identified by a marking:**

**e.g. with the febi suspension arm for the Audi A 4 front axle**

*febi no. 11350*

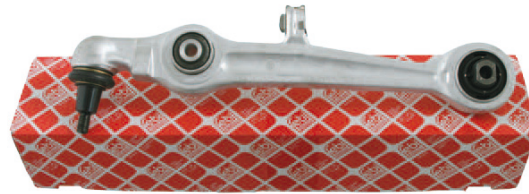
Make sure to tighten the fastening screws of the exchanged suspension arm in the deflected state in any case to avoid complaints. The tightening of the screws in the rebound state is a serious assembly error that results in an overload of the rubber bearings. This may lead to cracks that result in the premature failure of the rubber bearing. The axle geometry changes and causes additional costs (increased tyre wear!).

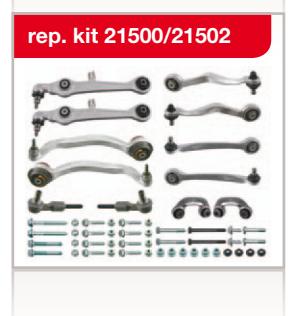
The marking of the suspension arm and the countermarking on the drive assembly carrier must match. Then, your customer is on the safe side!
