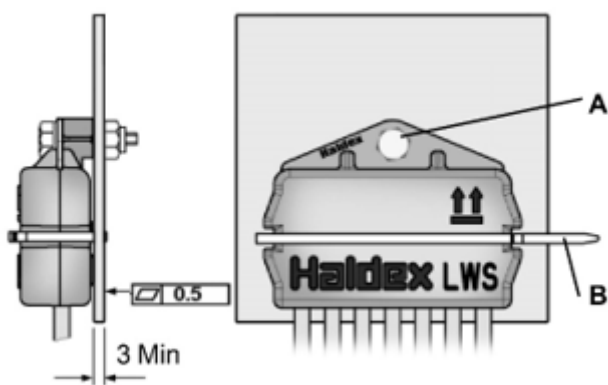
Haldex Lining Wear Sensing (LWS) integrates several wear indicators at a joint analogue input on the EB+. Haldex provides a detailed guide for workshop installation or original trailer manufacturer fitting. During installation, mounting points A and B as shown in the diagram (M6 screw and cable tie) must be used, i.e. not A or B.

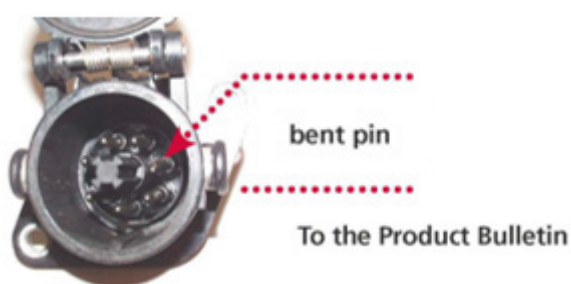
ISO 7638 - Connection problems

When it comes to problems with the trailer ABS/EBS, the cause is often faulty couplings between tractor and trailer: Pins in the trailer socket could be bent and/or the connector on the spiral flex cable could be damaged. Haldex therefore recommends to always carefully check the tractor connector and trailer socket before joining them. Haldex has created a Product Bulletin about checking and aligning pins and how to proceed in the event of a problem.
