THE PROBLEM SOLVER®

Corrosion freezes the camber bolt in place

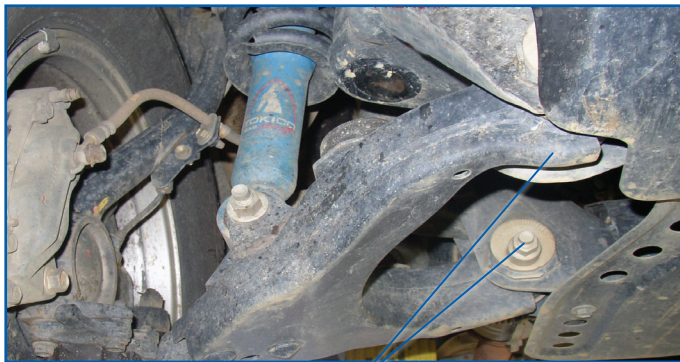
The camber adjustment bolt on lower control arms of certain Toyota trucks is subject to excessive corrosion (especially in the North, where salt is prevalent). The corrosion seizes the bolt and/or sleeve in the bushing, preventing rotation. The seized parts prevent the vehicle from being aligned properly. The process of removing the seized bolt can be difficult and may damage the bushing.

SEIZING OCCURS IN THESE AREAS, CAUSING ISSUES AND PREVENTING ALIGNMENT.

The MOOG® Problem Solver® camber adjustment bolt features a fully greaseable design that prevents corrosion. A grease fitting on one end of the bolt allows grease flow inside. An engineered grease channel in the bolt lets grease flow out and along the interior and exterior of the sleeve to keep the bolt and sleeve lubricated. With these features enabling regular maintenance, the MOOG camber adjustment bolt will remain adjustable even after many miles of service in harsh conditions.
