REMANUFACTURED AIR STRUT SERVICE BULLETIN

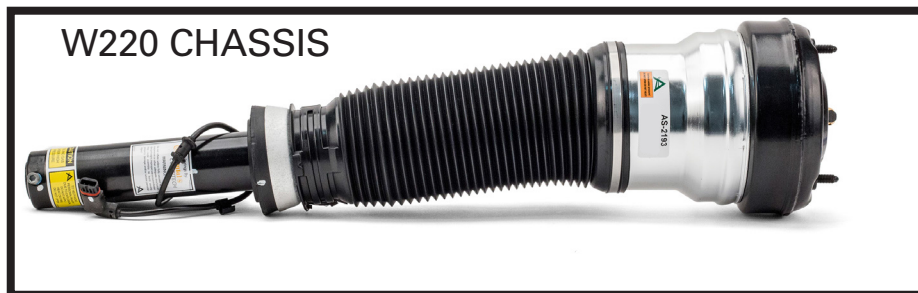
THIS IS NORMAL
(AS-2193)

UPON VISUAL INSPECTION OF YOUR AIR STRUT, IT MAY APPEAR THAT THE AIR STRUT IS BENT. THIS IS COMPLETELY NORMAL AND THE AIR STRUT WILL STRAIGHTEN OUT WHEN PROPERLY INSTALLED ON THE VEHICLE.

DO NOT RETURN AIR STRUT DUE TO THE VISUAL APPEARANCE OF IT BEING BENT.

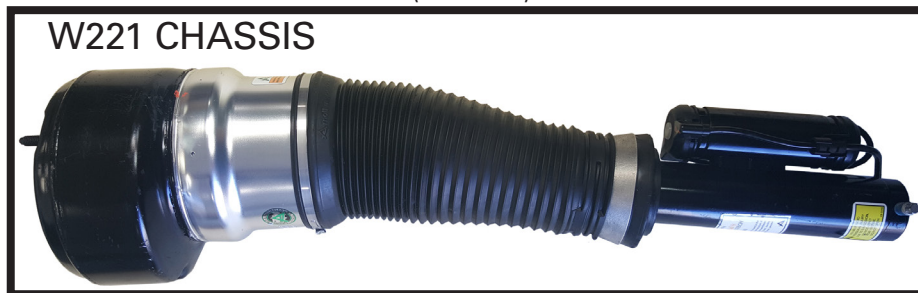
THIS IS NORMAL
(AS-2540, AS-2547, AS-2548, AS-2603, AS-2604)

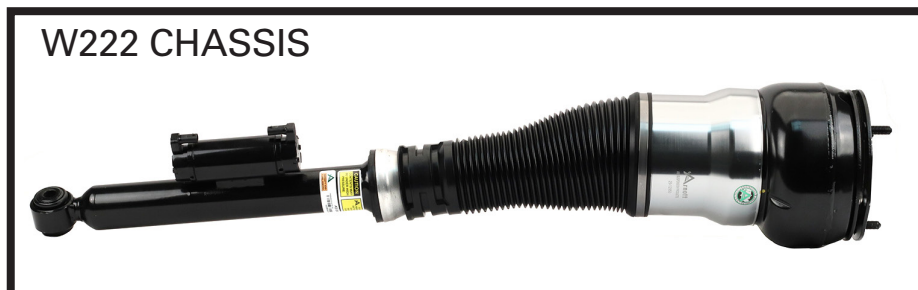
THIS IS NORMAL
(AS-3360, AS-3361, AS-3366, AS-3367, AS-3358, AS-3359)
