## **ATS or BD.....you decide.**

The products that I'll be discussing are two competing sets of compound turbos, both installed on 2006 Dodge Ram's with Cummins Turbo Diesel engines. One set was from ATS, which included the Aurora 3000 and Aurora 5000 turbos and the other was from BD Power, which included the SuperB and R700 turbos. Both are advertised as towing / race setups.

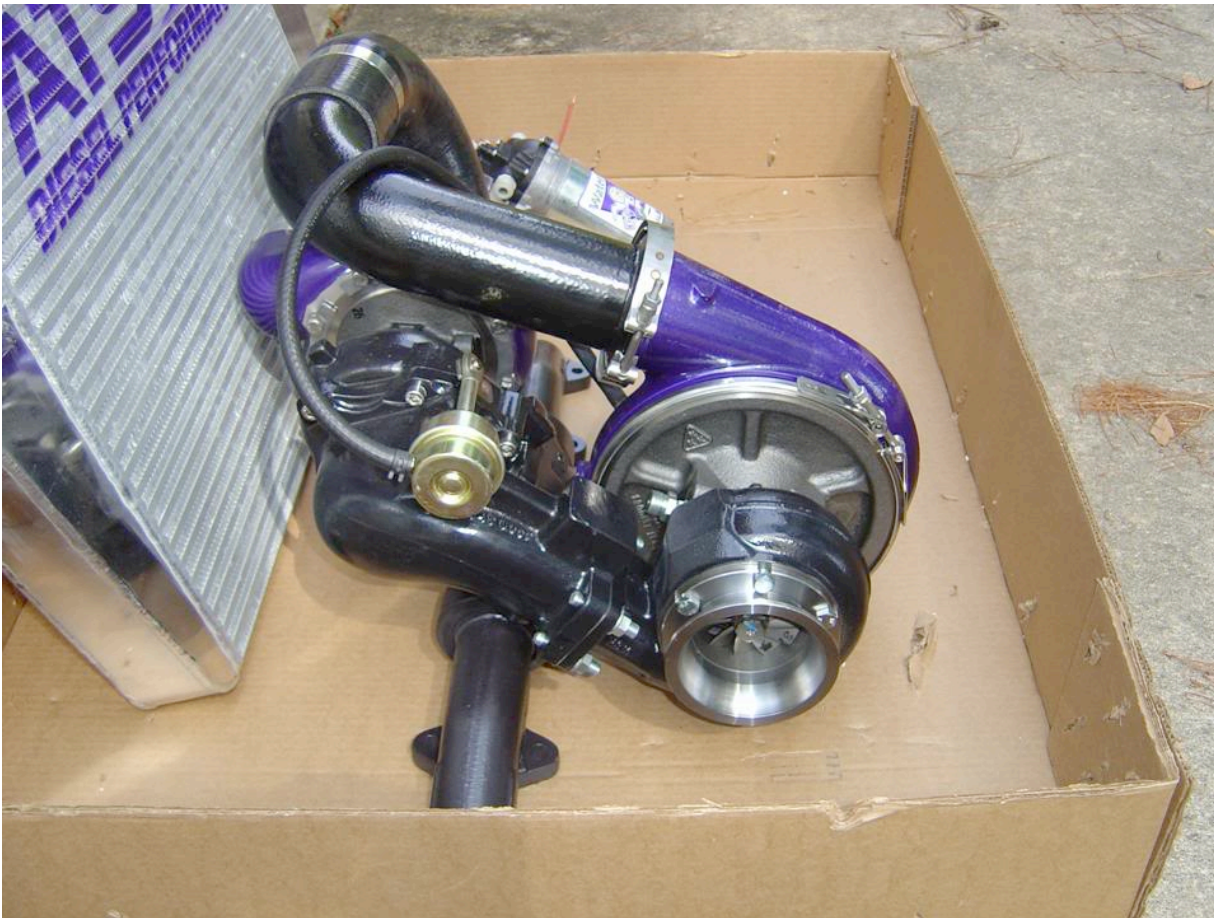
When the parts arrived, they were in very different conditions from each other. The ATS kit came completely assembled and made for a very easy install. You had the finished product to look at prior to installation.

The parts arrived complete, free of rust and corrosion and clocked correctly for the application.

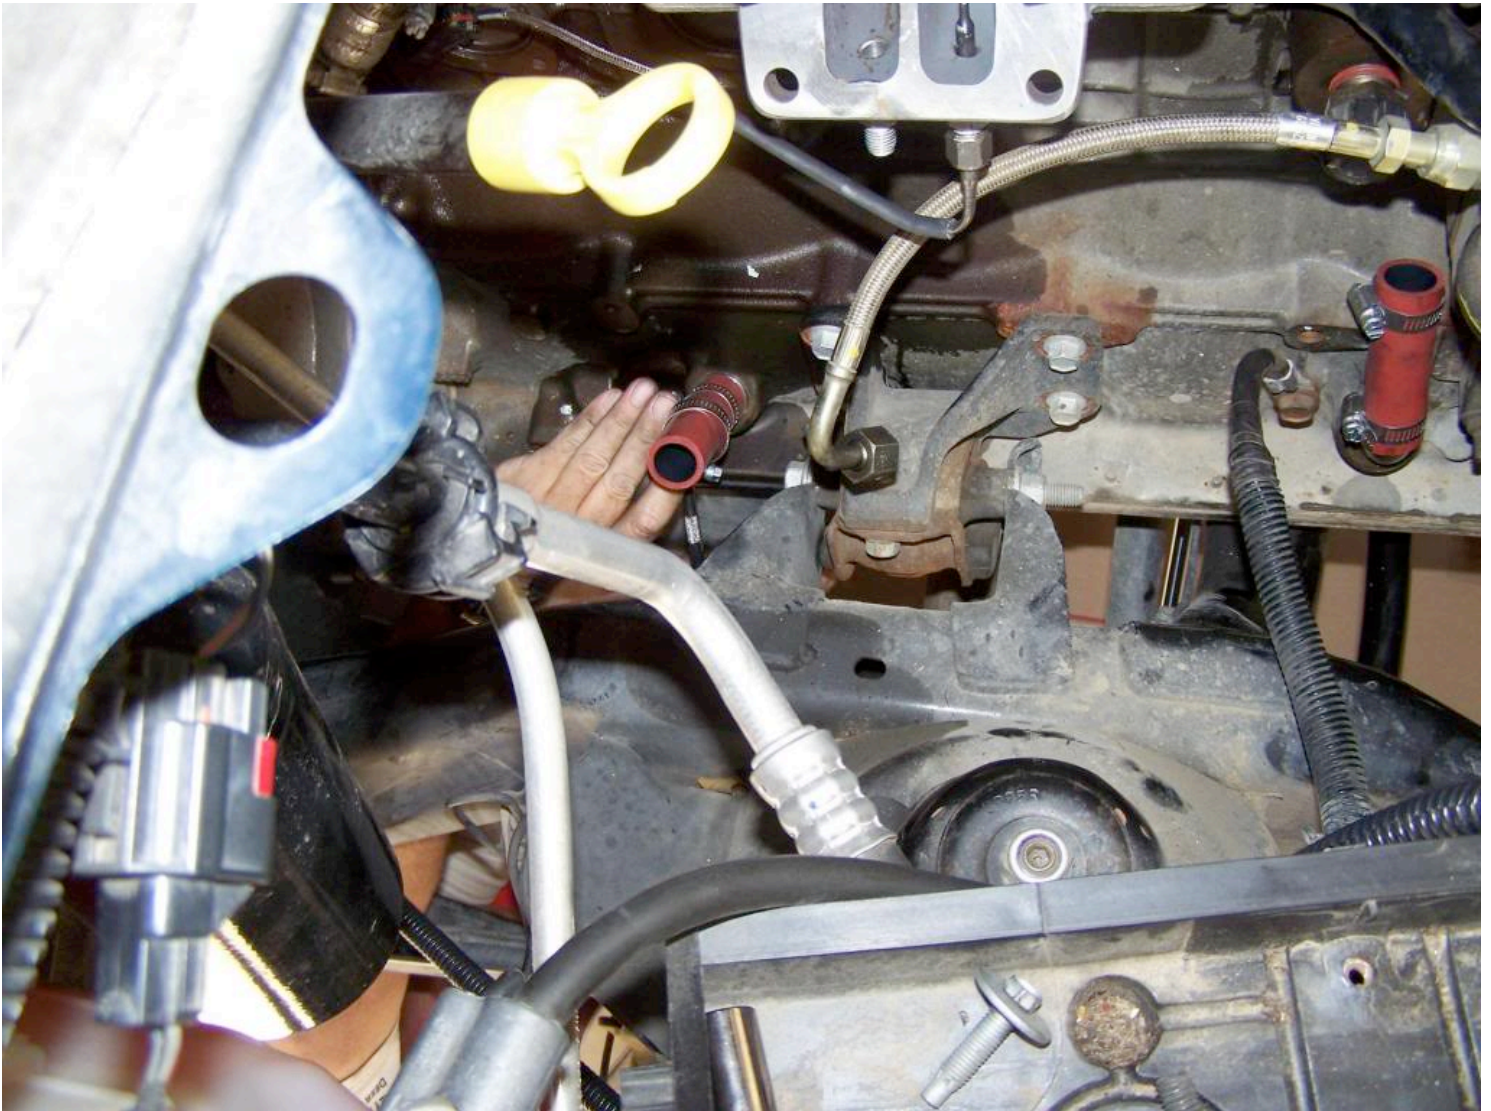
The picture below shows where the OEM return is (rear of engine) and the new secondary drain is located (front of engine)

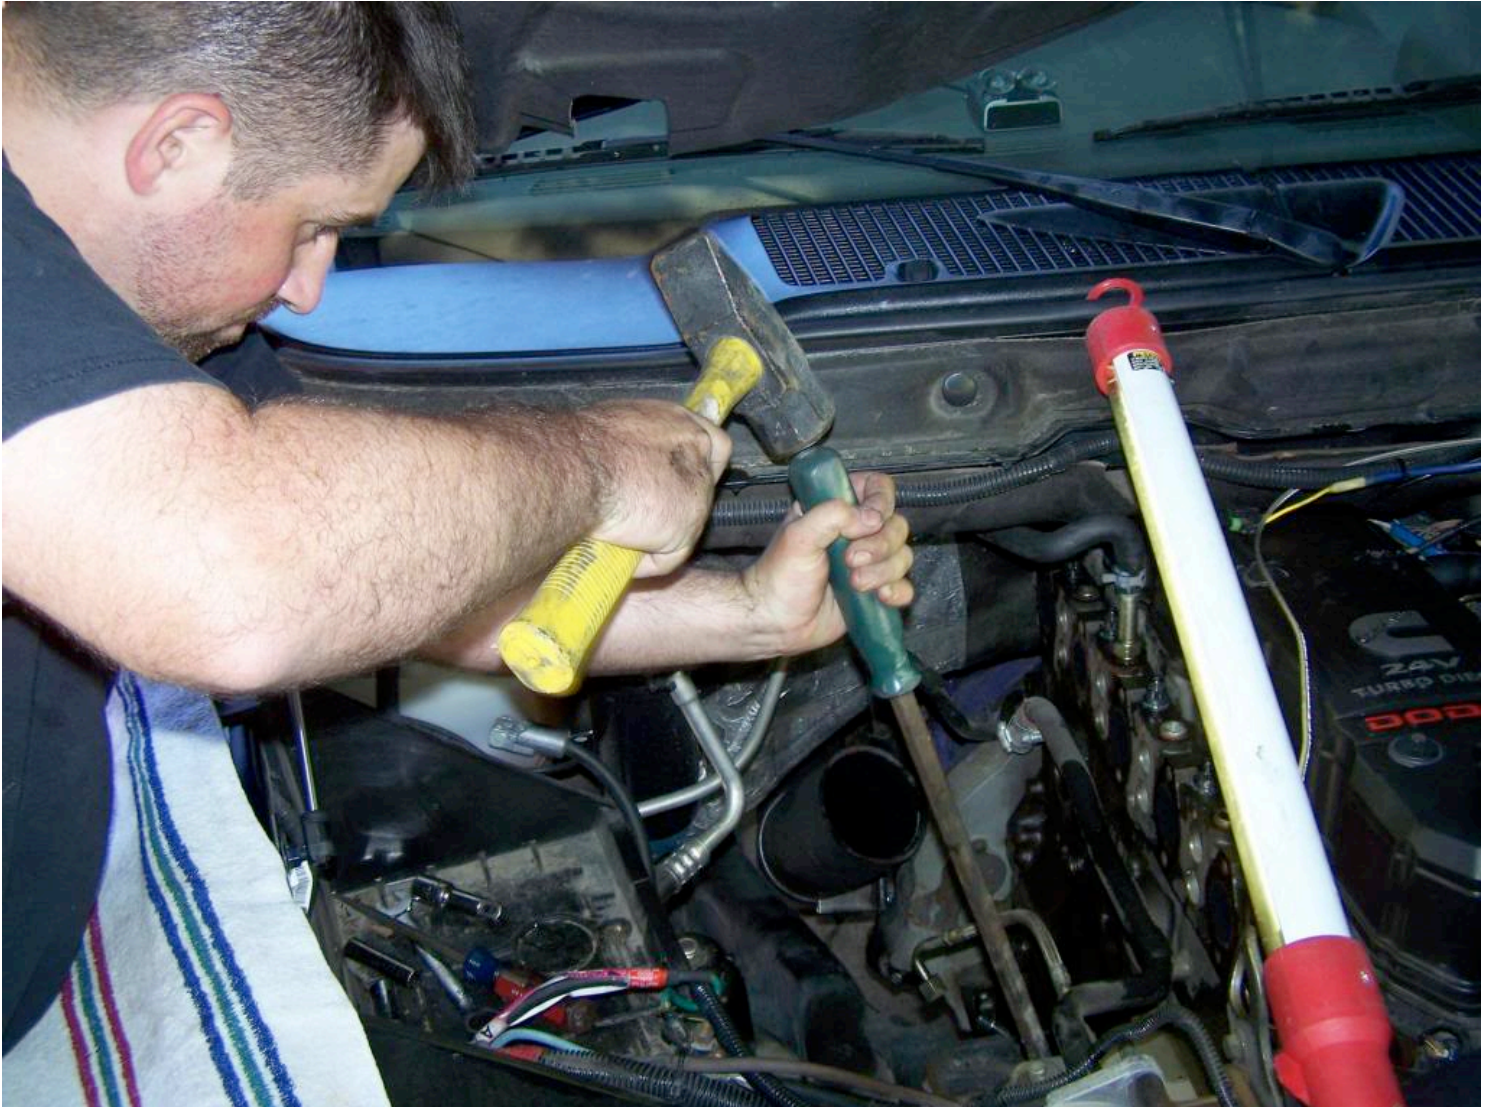
The secondary turbo also required a steel adapter to go in the frost plug hole. This adapter did not fit. The instructions said that you may have to use a punch to get it to fit....this was a mild understatement.

I tried brass and steel punches, using a reasonable amount of force and it would not even seat. I ended up need to use a pry bar and a mallet to mark the adapter where it was oversized so it could be re-sized with a die grinder.

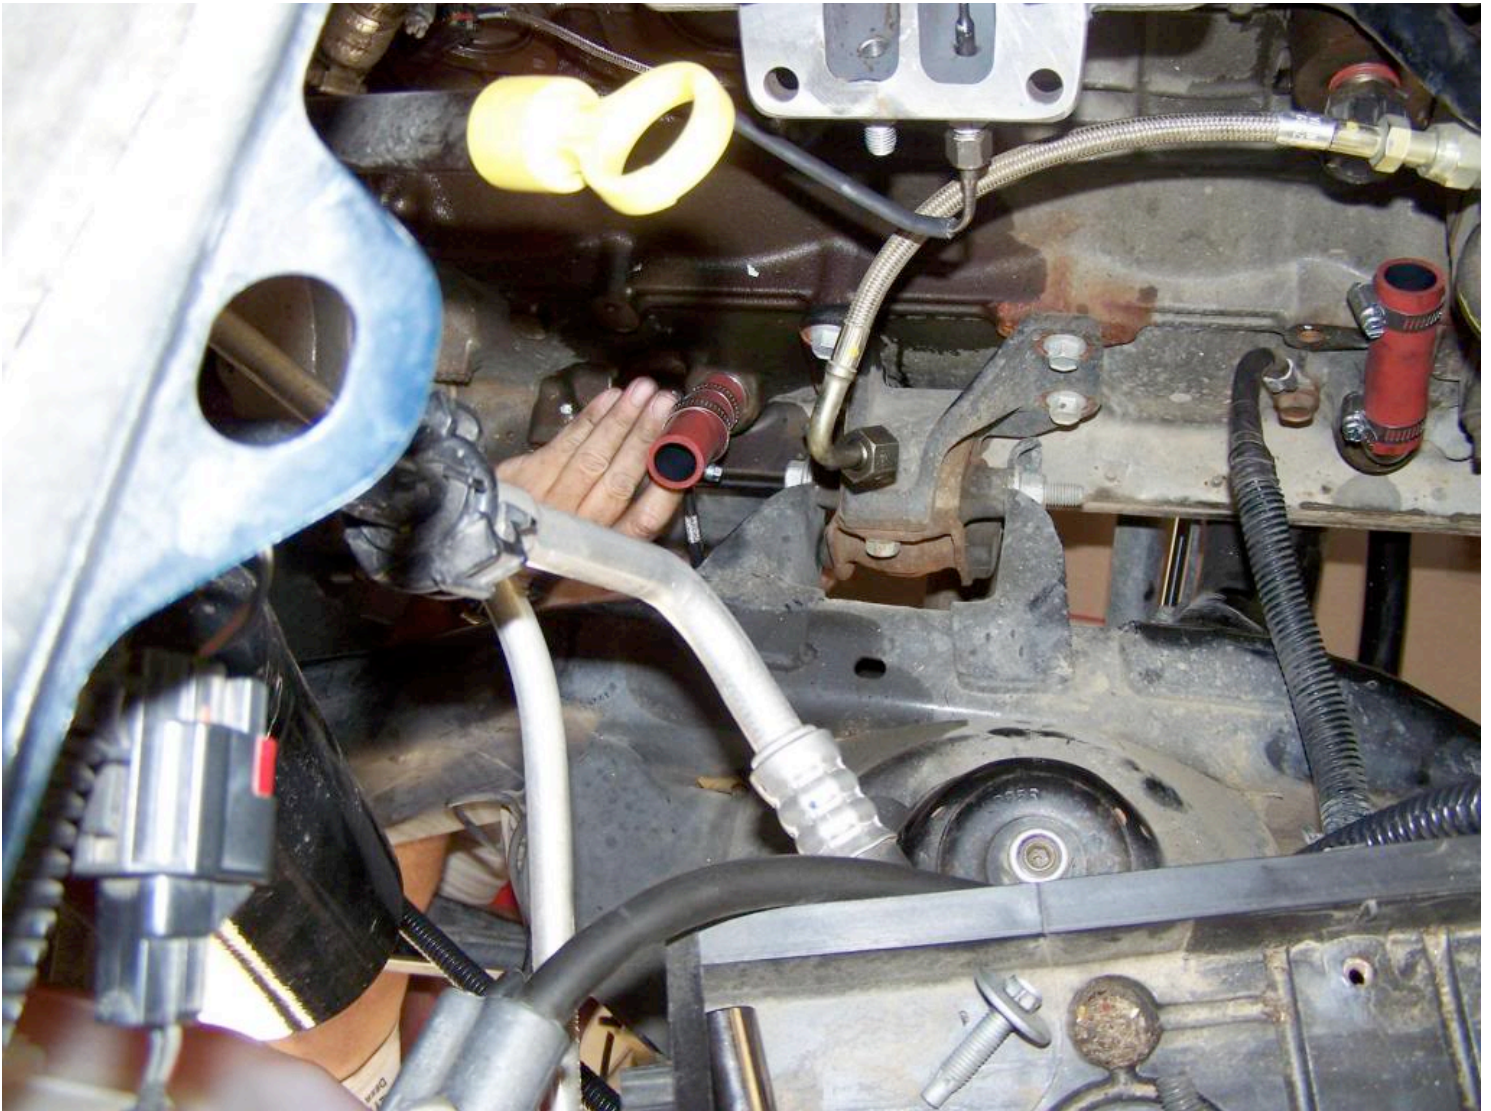
Once it was chamfered and resized, the secondary adapter was installed. The picture below is of those two components and their associated hoses and clamps installed.

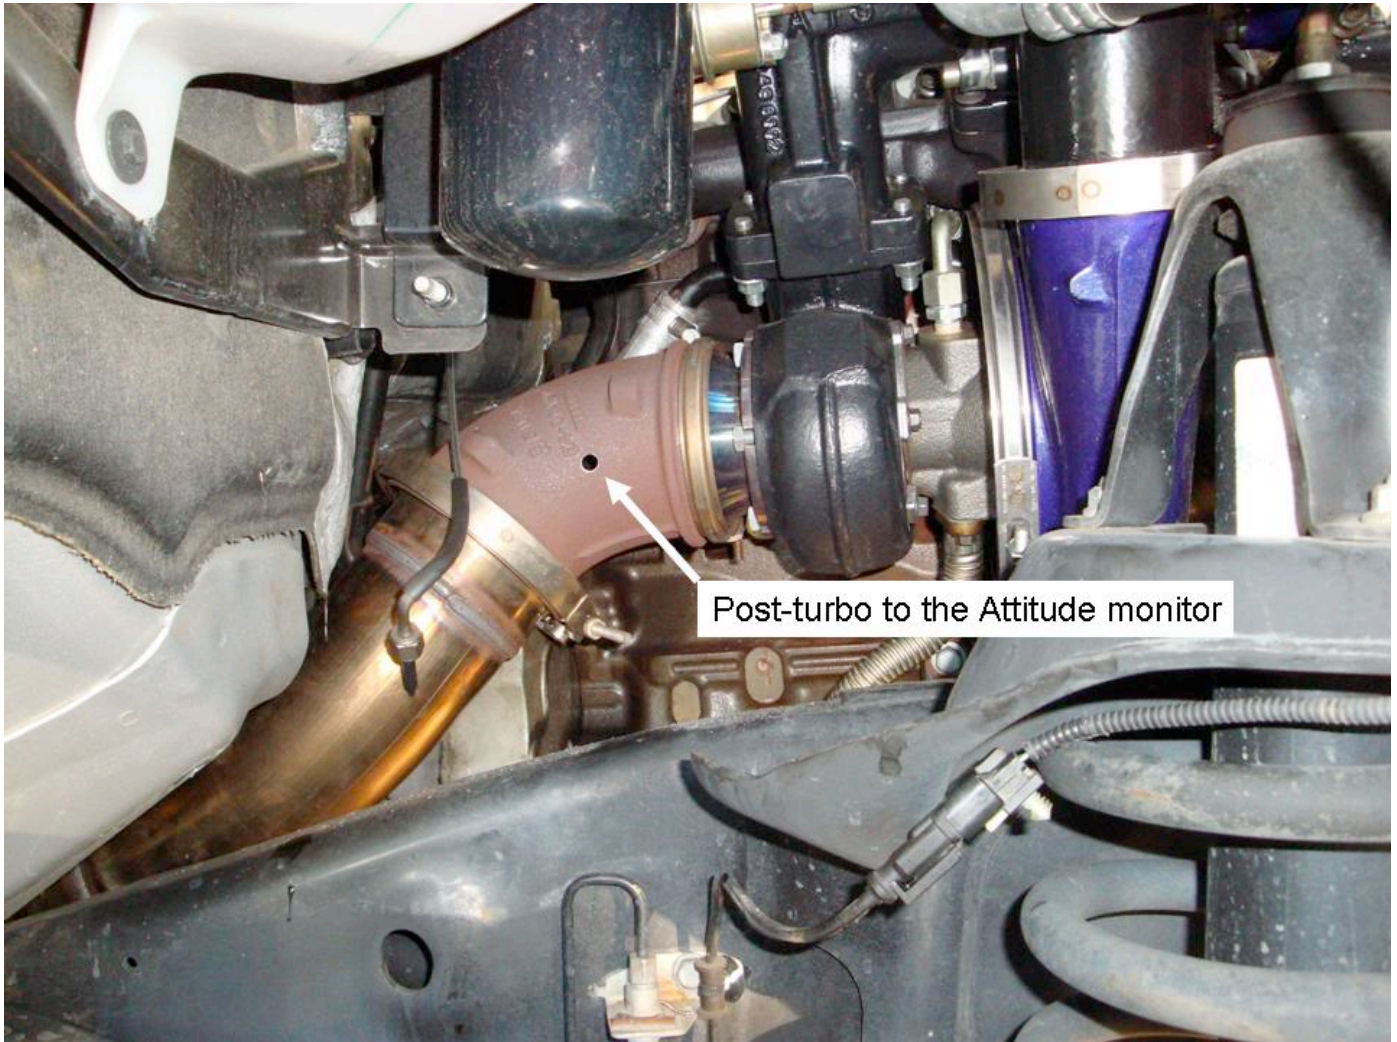
Now, from here, the ATS primary was attached the OEM exhaust elbow by removing the locator roll pins in the elbow and loosely attaching it to the existing down pipe for alignment and attachment to the secondary.

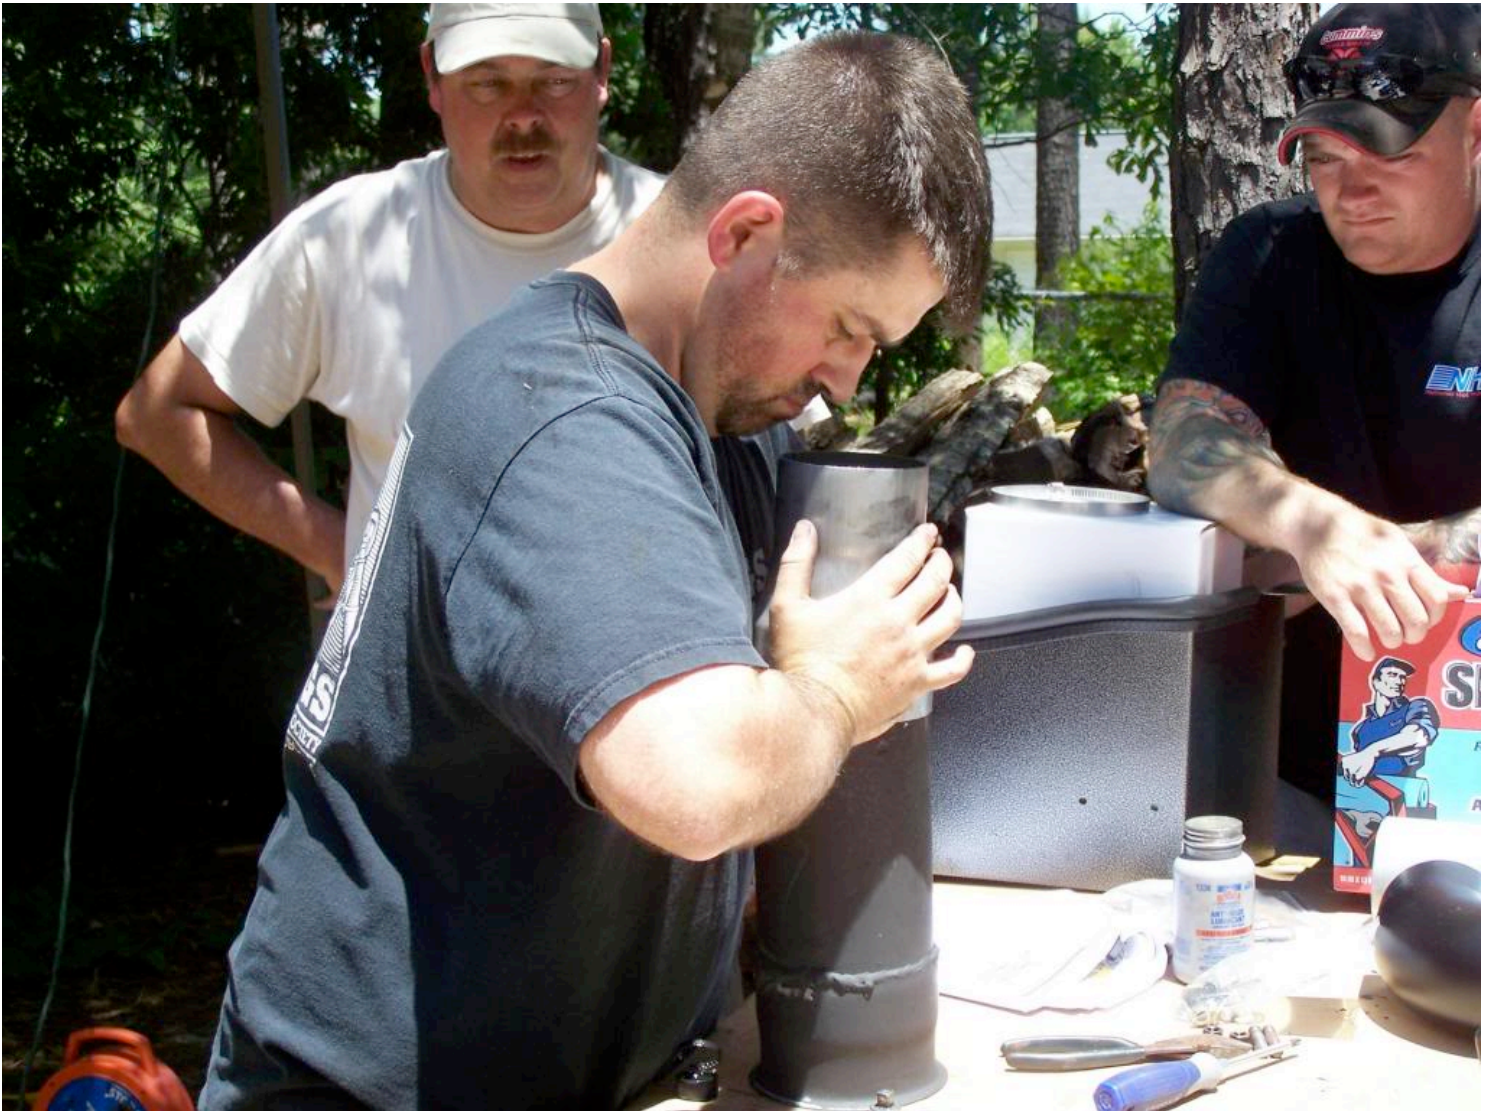
The BD kit does not sit in the OEM location and cannot reuse the existing elbow or down pipe. This presented a problem as both trucks had 5" exhausts and the BD downpipe that comes with the kit is 4", which required getting an adapter to mate the two. This also eliminated the possibility of using the existing exhaust elbow and the post-turbo pyrometer used to monitor the exhaust brake.

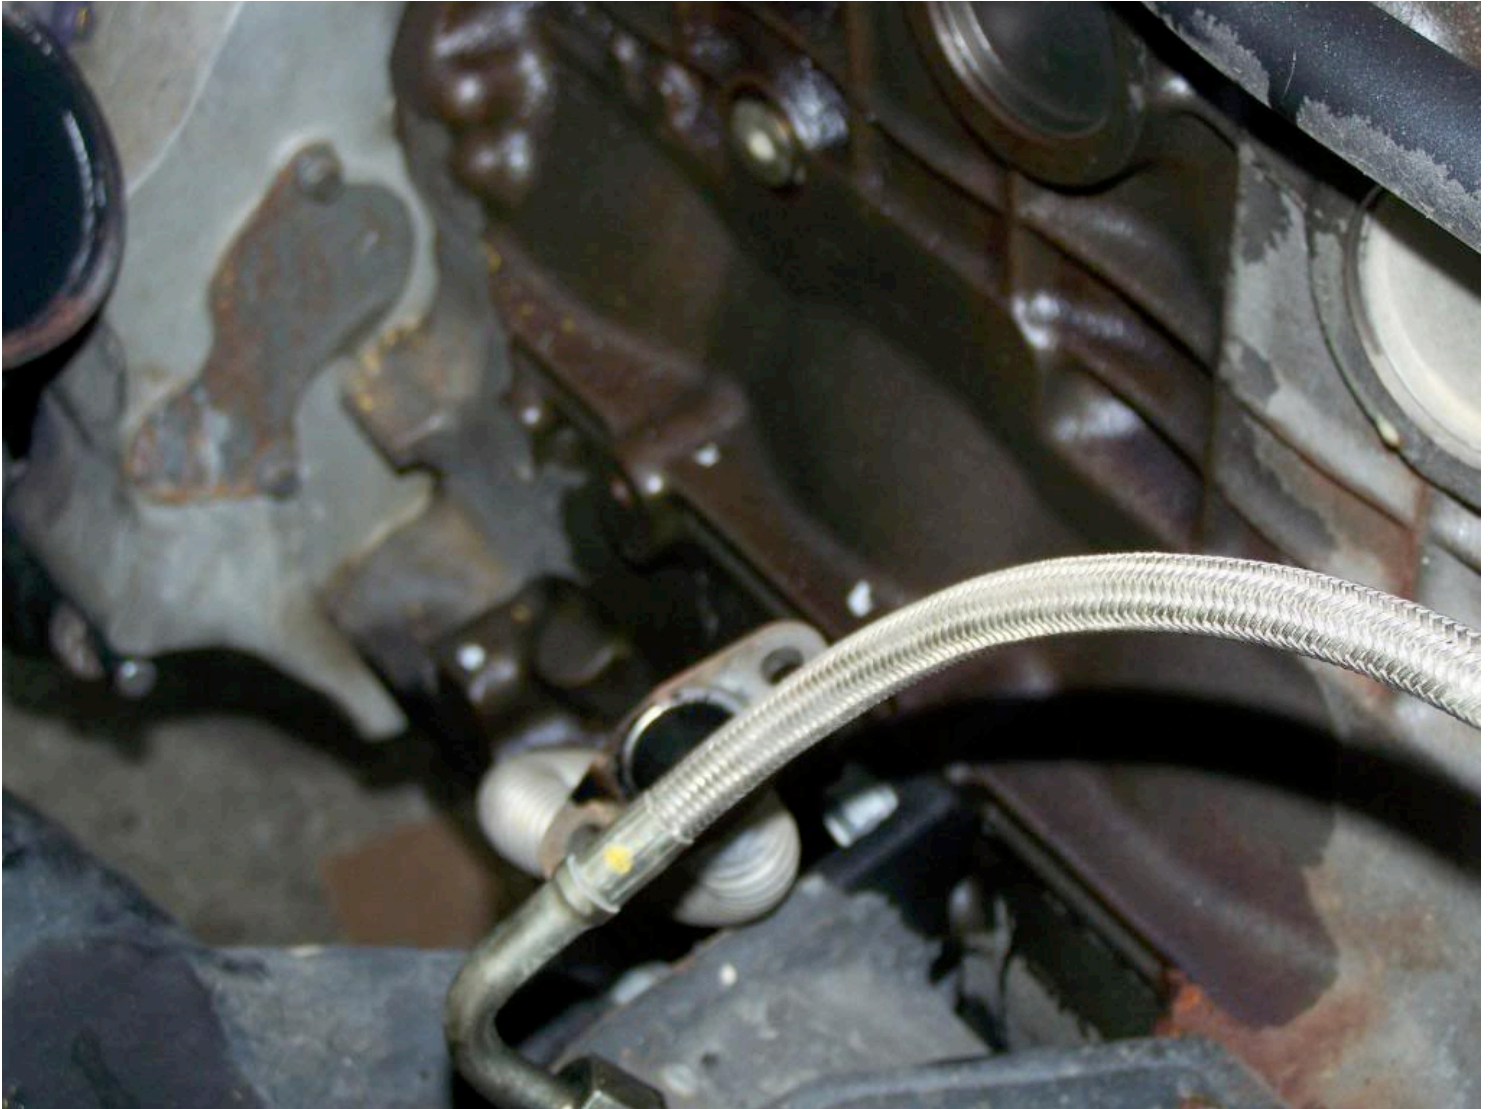
Once this modification was made, the BD kit required draining approx 3 gals of coolant from the system. This was necessary because you had to cut the tube on the steel coolant line that runs near the bottom of the engine block. This was to install an adapter that bolted to existing bungs in the block. The kit came with a 90\* adapter for this cut, but it was larger than the existing pipe and would not clear the bracket. We ended up fabricating a soft coolant line from the bottom of the engine to the heater core supply fitting. This still presented a problem as the edges of the supplied bracket are very sharp and would have cut the hose quickly. We omitted using the bracket at this point.

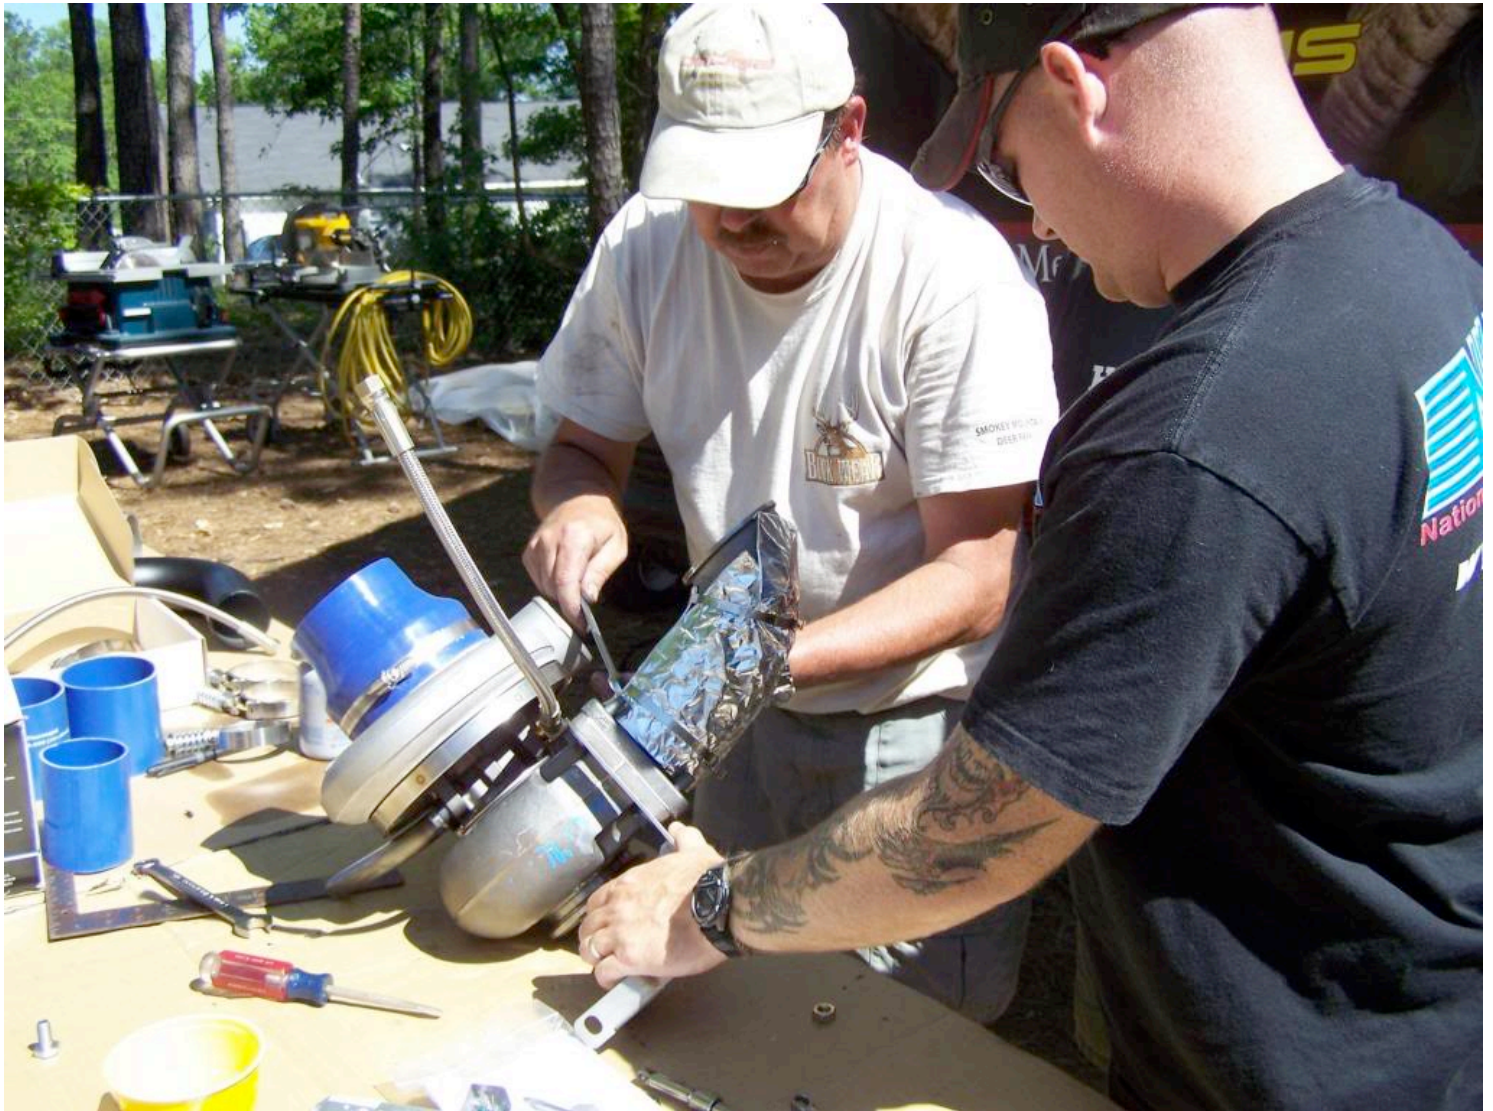
From here, you must fit the exhaust adapter from the secondary to the primary on the BD compound. This again presented a problem. The studs supplied with the kit were incorrect in thread pitch, count and coarseness. We had to run to the hardware store to get fasteners of the correct type to bolt the adapter to the primary.

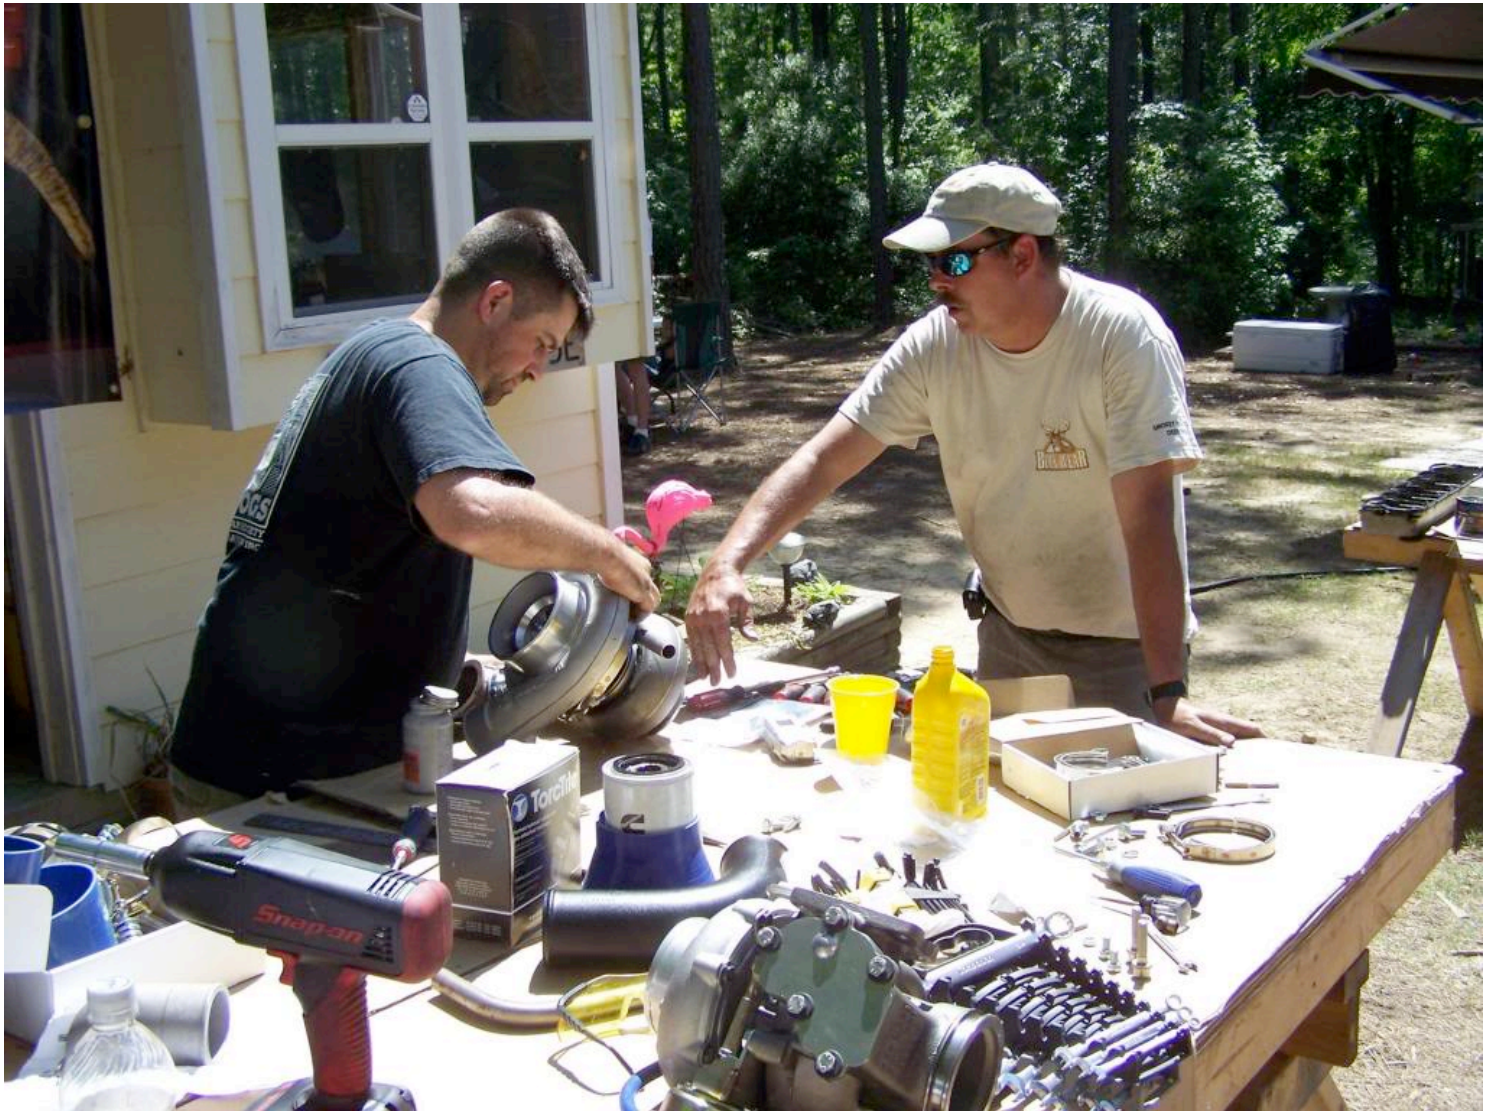
Once the primaries were positioned, we found the clocking that was called for in the BD directions was incorrect, so this was adjusted.

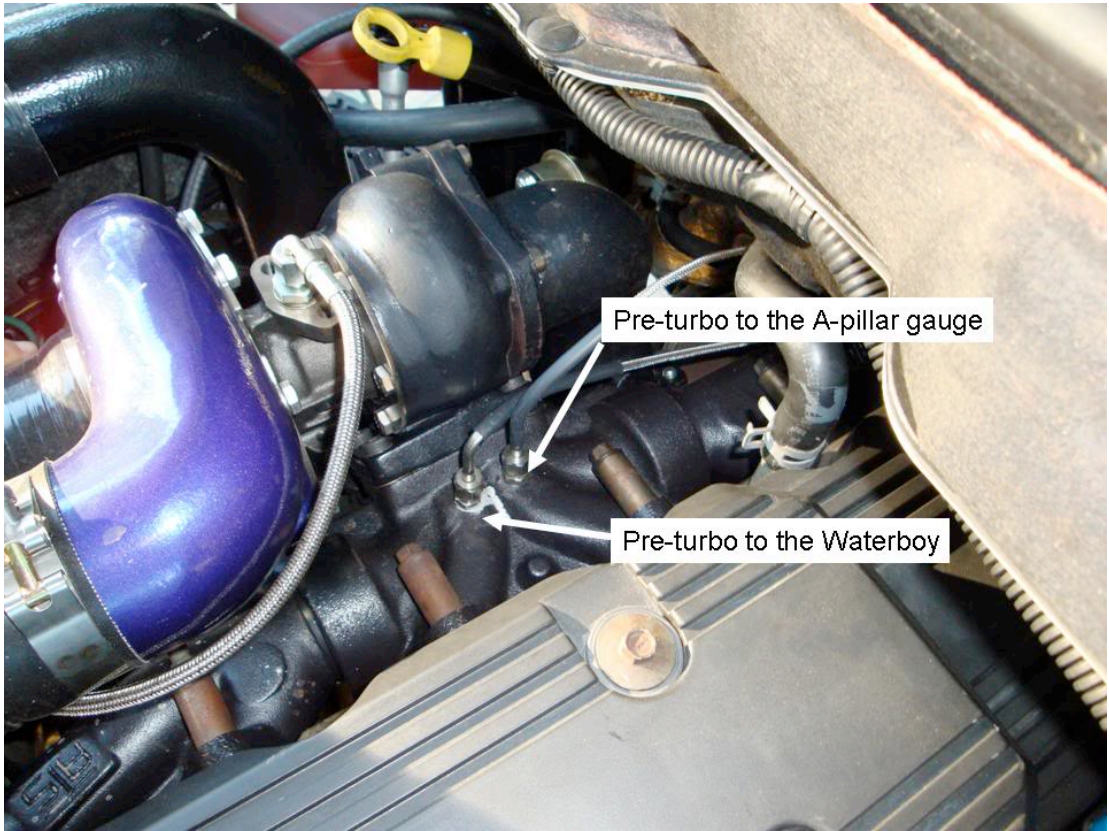
The ATS manifold came pre-drilled and tapped with four 1/8 NPT ports. Two on top and two on the bottom. These ports were in the correct locations for the application and were correctly tapped.

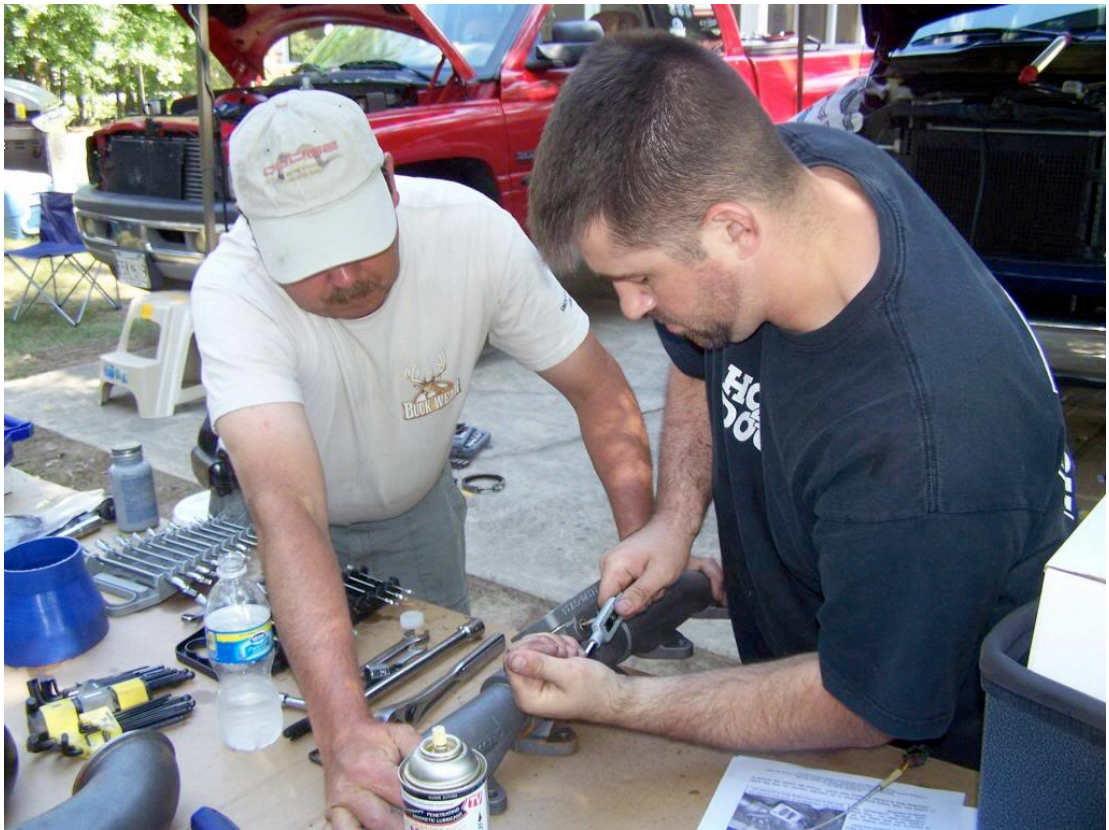
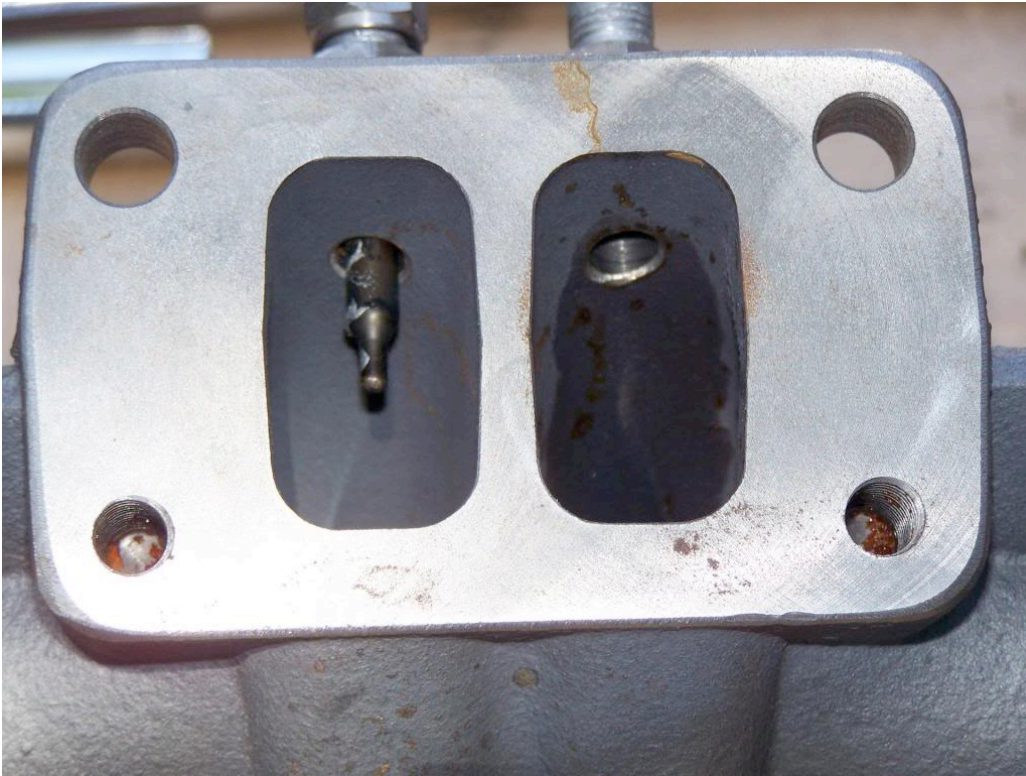
The BD kit came with two pre-drilled and tapped ports. The ports, as the manifold was to be installed, were located on the bottom of the manifold. They were also not tapped deep enough to properly seat a 1/8 NPT fitting. We could only get 2 threads of the probe fitting in before it stopped. This required tapping the manifold further to allow proper EGT probe function.

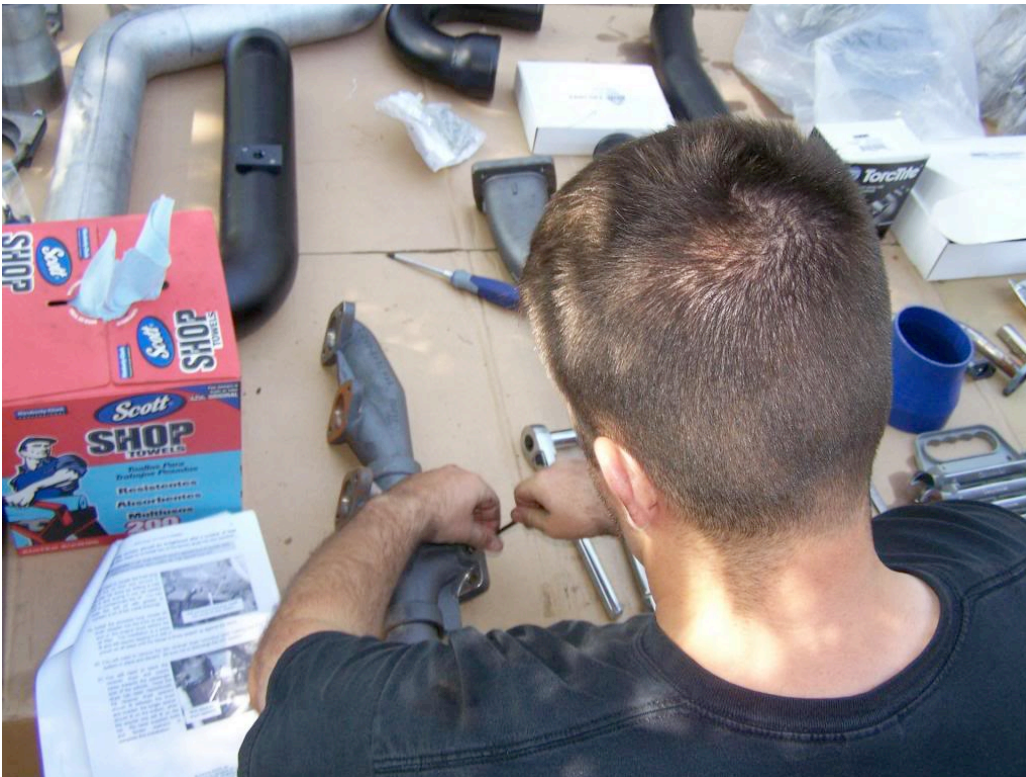
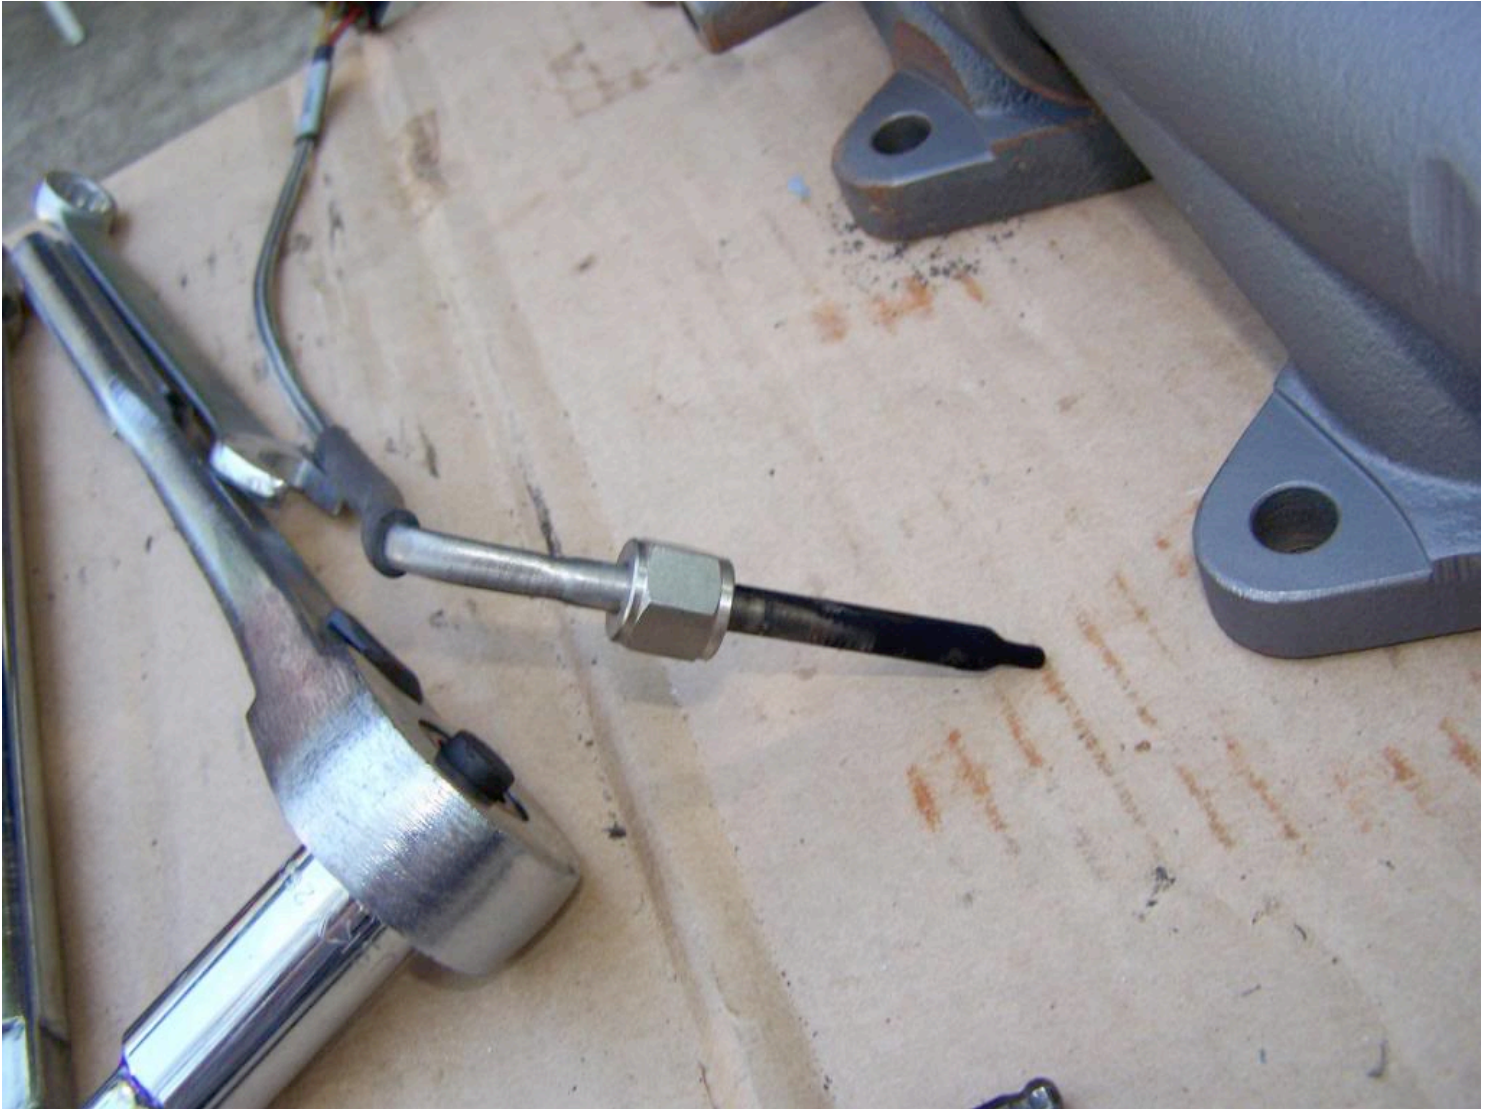
Once this was done, we installed the EGT probes and found another problem. The location of the ports on the bottom of the BD manifold did not allow enough clearance for straight type EGT probes. The probes ran directly into the side of the SuperB compressor housing. We ended up taking two 90° probes off of another truck to make them fit.

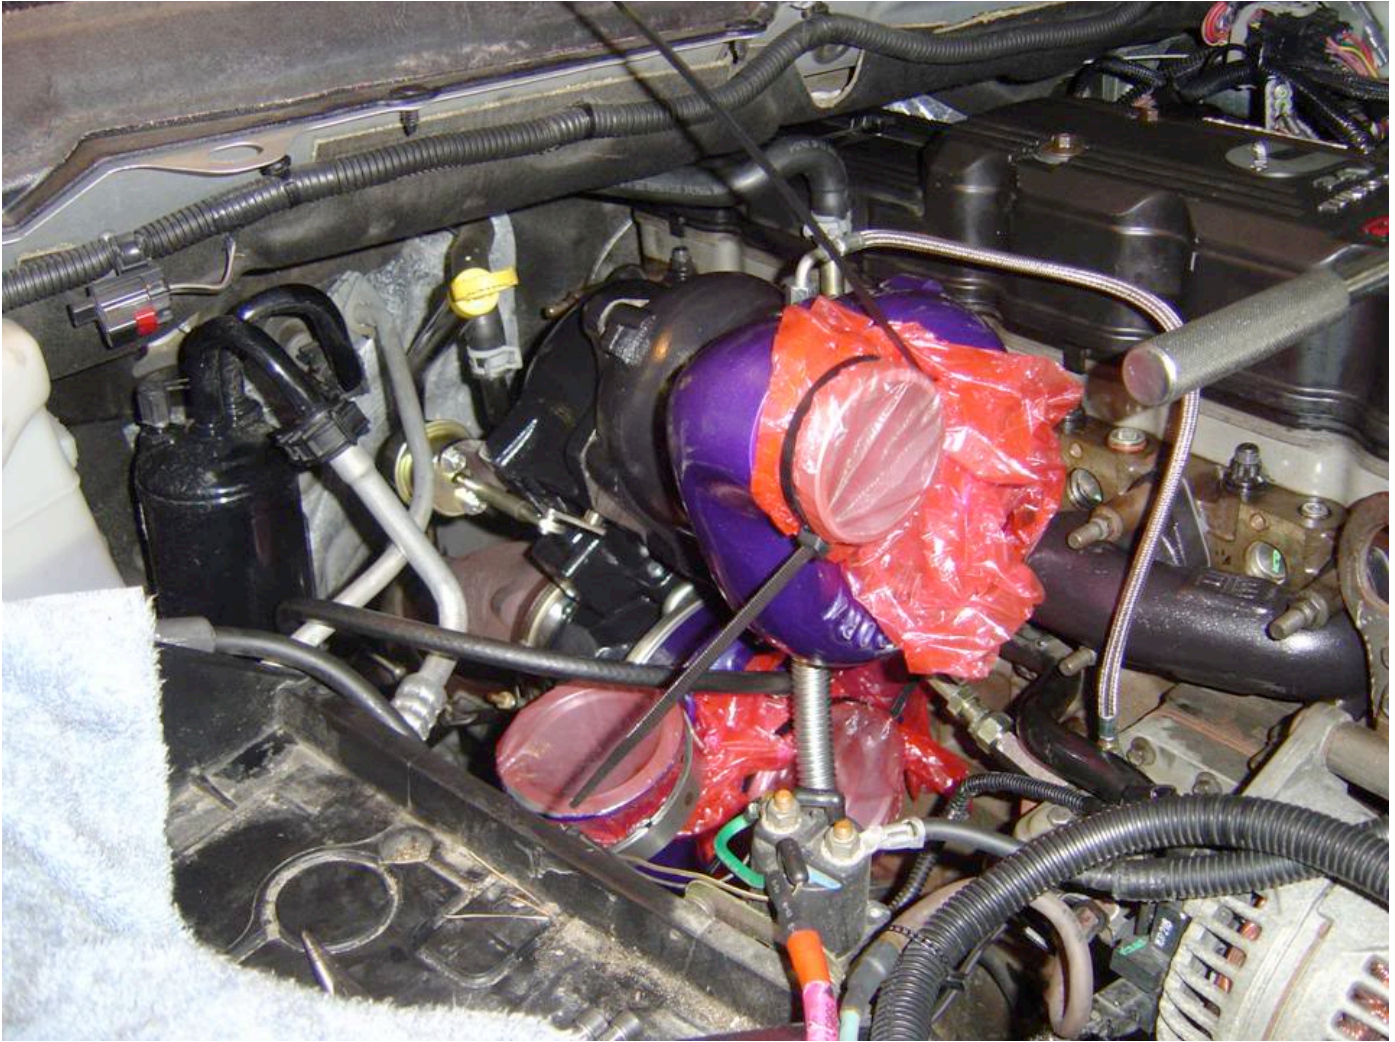
Once this was done, we were able to attach the secondary to the exhaust manifold. From here we saw another problem. The alignment of the compressor, cartridge and turbine housing's on the BD kit were incorrect as called for in the directions. This was changed to get the proper alignment of the oil supply and return lines.

This led to another problem. The flanges on the nuts for attaching the secondary to the exhaust manifold were too large and made contact with the secondary oil drain. These had to be removed, filed down and re-installed.

The ATS kit already had the secondary attached to the manifold, so all I had to do was check for proper torque specs on the fasteners.
