## **ATS or BD.....you decide.**

The products that I'll be discussing are two competing sets of compound turbos, both installed on 2006 Dodge Ram's with Cummins Turbo Diesel engines. One set was from ATS, which included the Aurora 3000 and Aurora 5000 turbos and the other was from BD Power, which included the SuperB and R700 turbos. Both are advertised as towing / race setups.

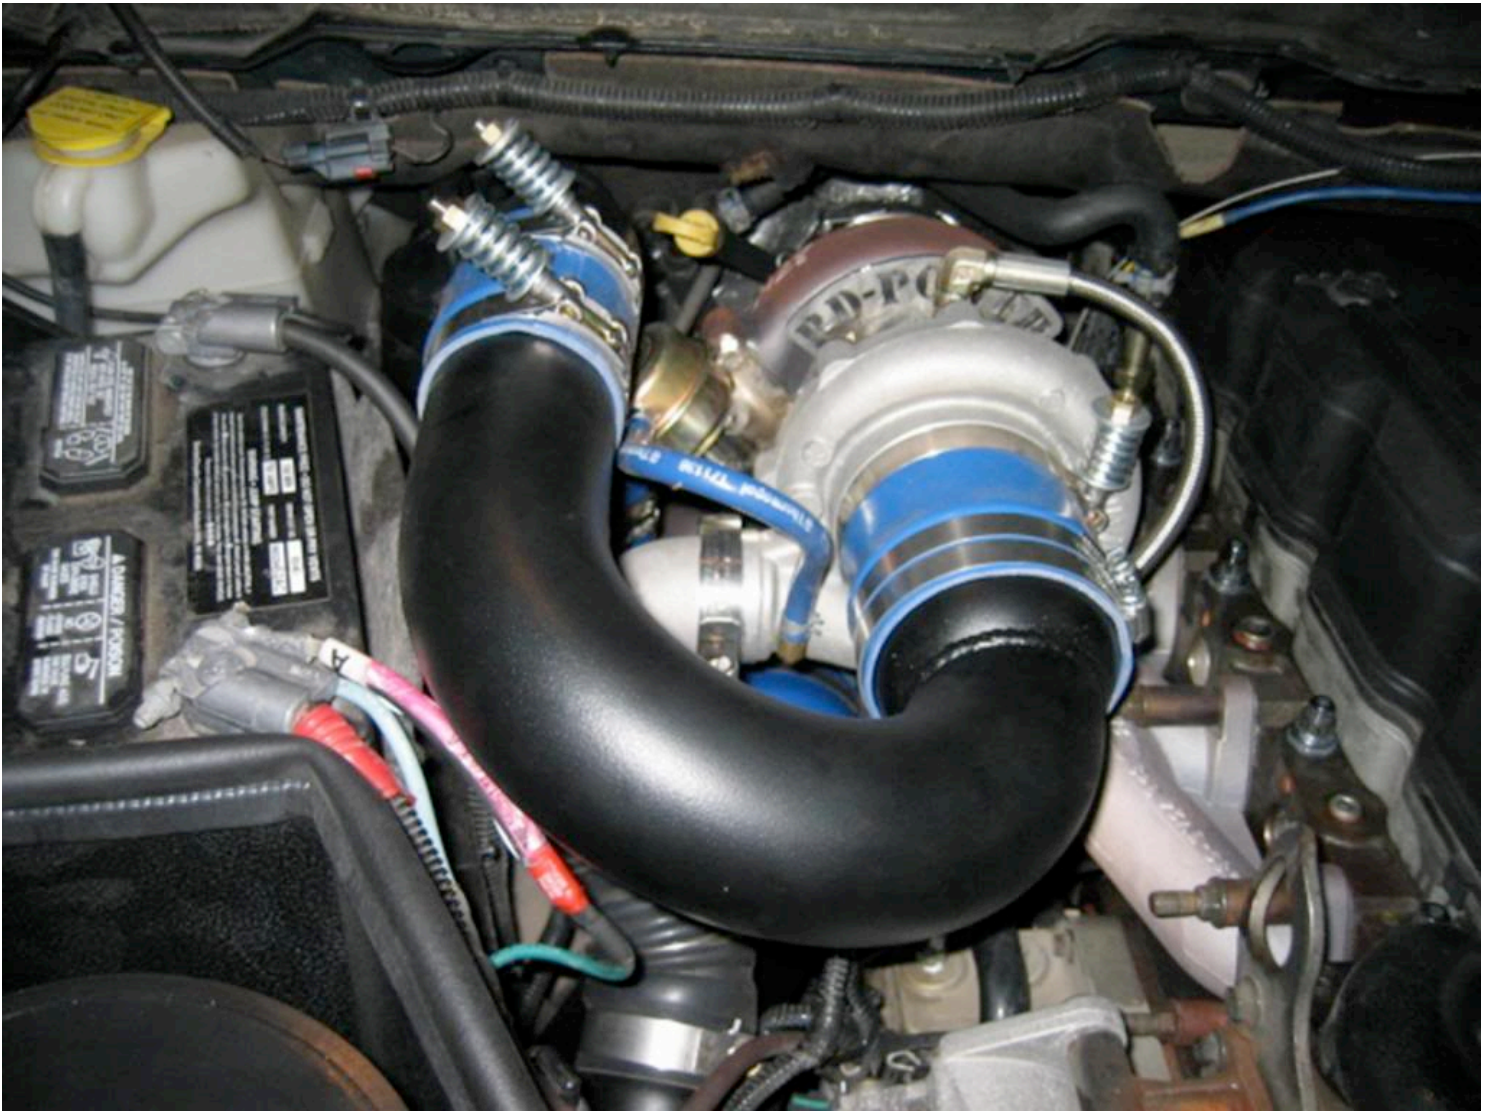
The ATS kit called for re-using the stock exhaust manifold studs, with the exception of two cap head bolts that were used where the turbo/manifold flange was. These were used due to the clearance issue that would have been presented by the OEM studs.

The BD kit called for new cap head bolts all the way around. These were supposed to be included in the kit, but were not, so the OEM studs were re-used. This caused another trip to the hardware store for cap head bolts to fit behind the manifold.

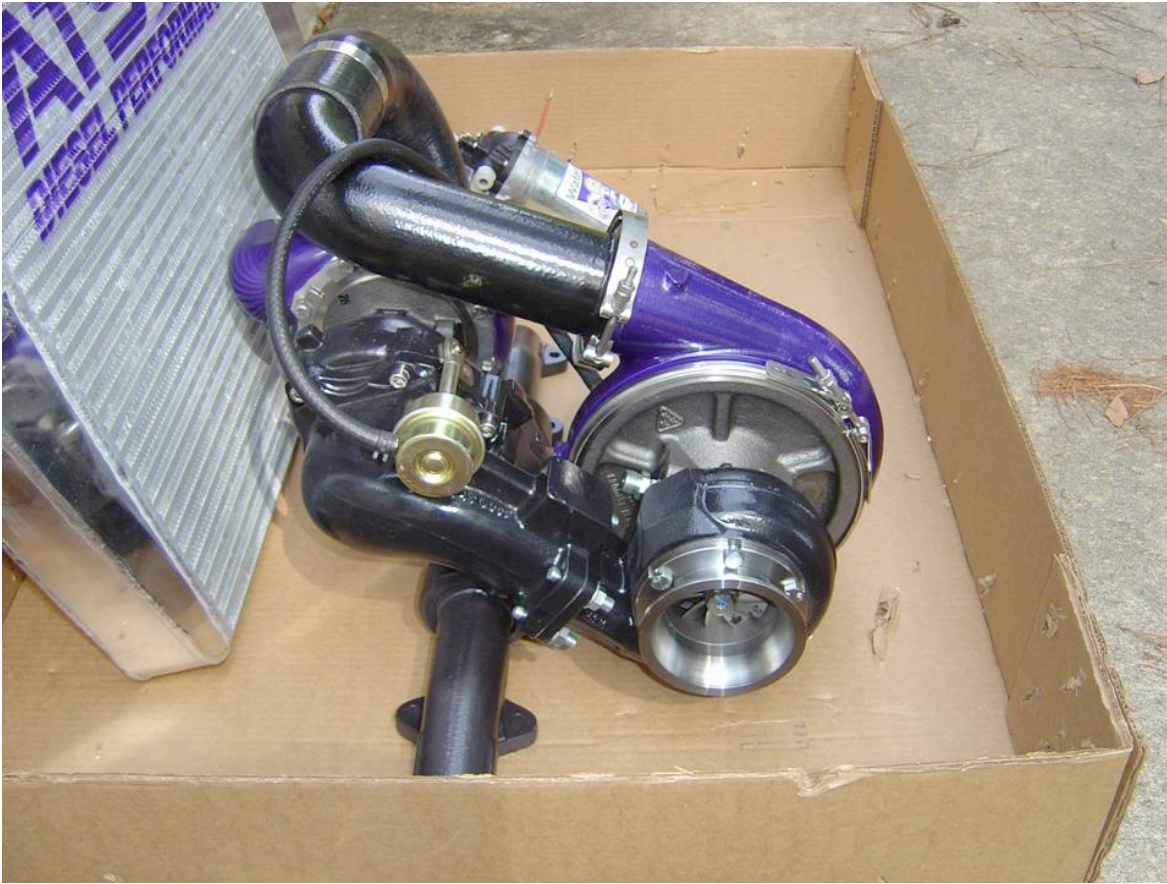
From here, the ATS kit requires attaching the exhaust adapter to the turbine housing of the secondary. This was simply a matter of lining up the holes and attaching the bolts. Using a ratchet wrench is essential here, otherwise you'll be making minute turns on two of the hard to reach bolts. The picture below shows the ATS exhaust adapter and where it fits to the secondary.

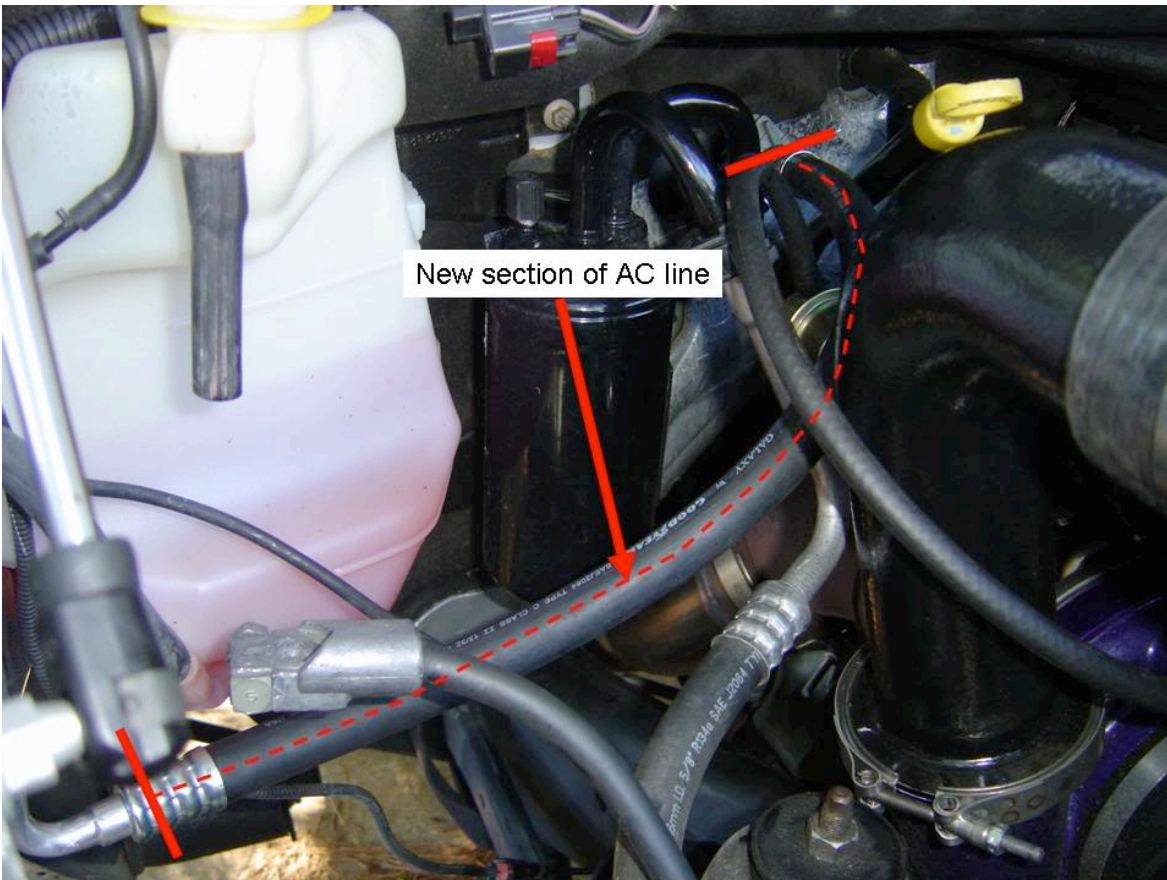
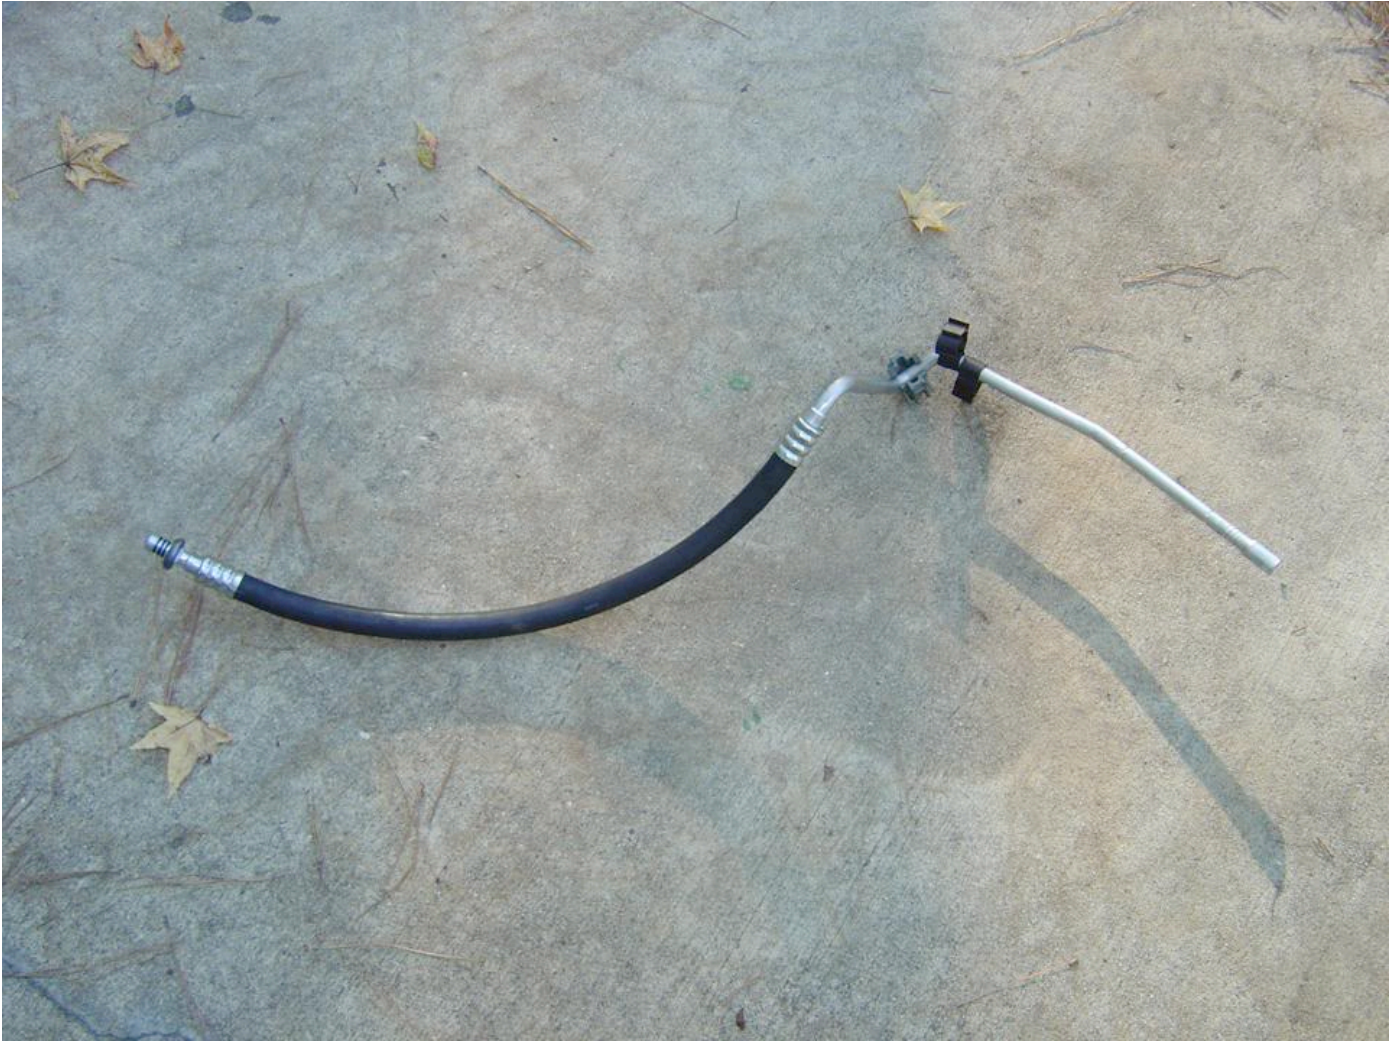
Now this is where we ran into a problem with the ATS setup. The location of the wastegate head was trying to occupy the same space as one of the AC lines. The required evacuating the AC system and removing the AC line until I could get a custom one made at a local shop. Here is the line I had to remove and the one I had had made to clear the wastegate head.

I contacted ATS regarding this, sent them the pictures and was reimbursed the \$45 that it cost me to have a new AC line made.

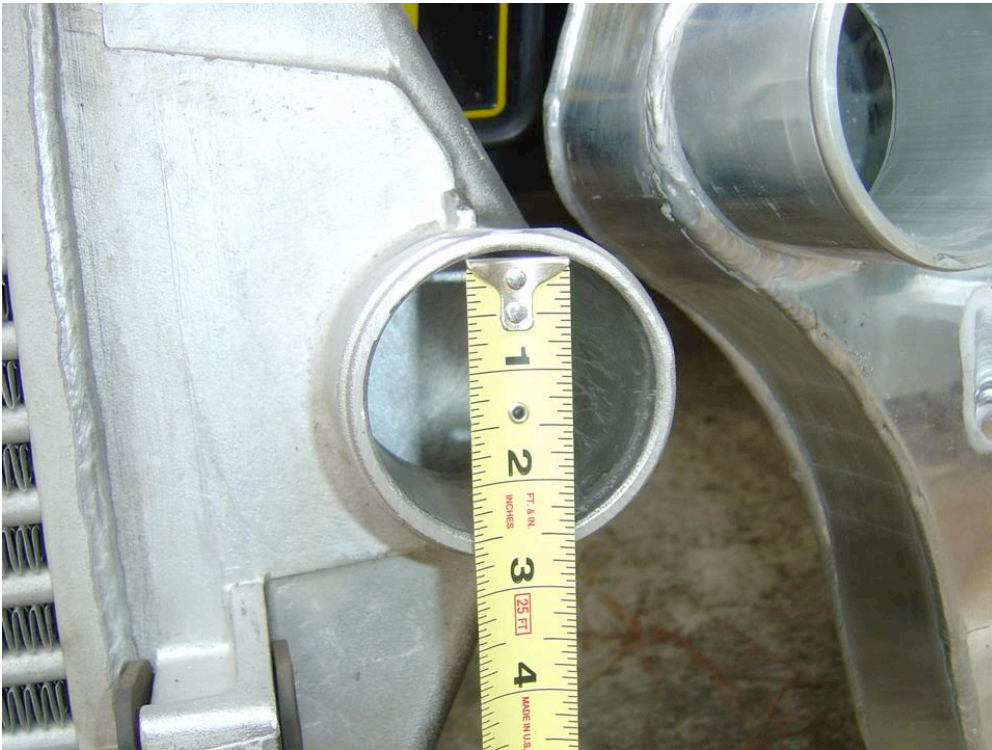
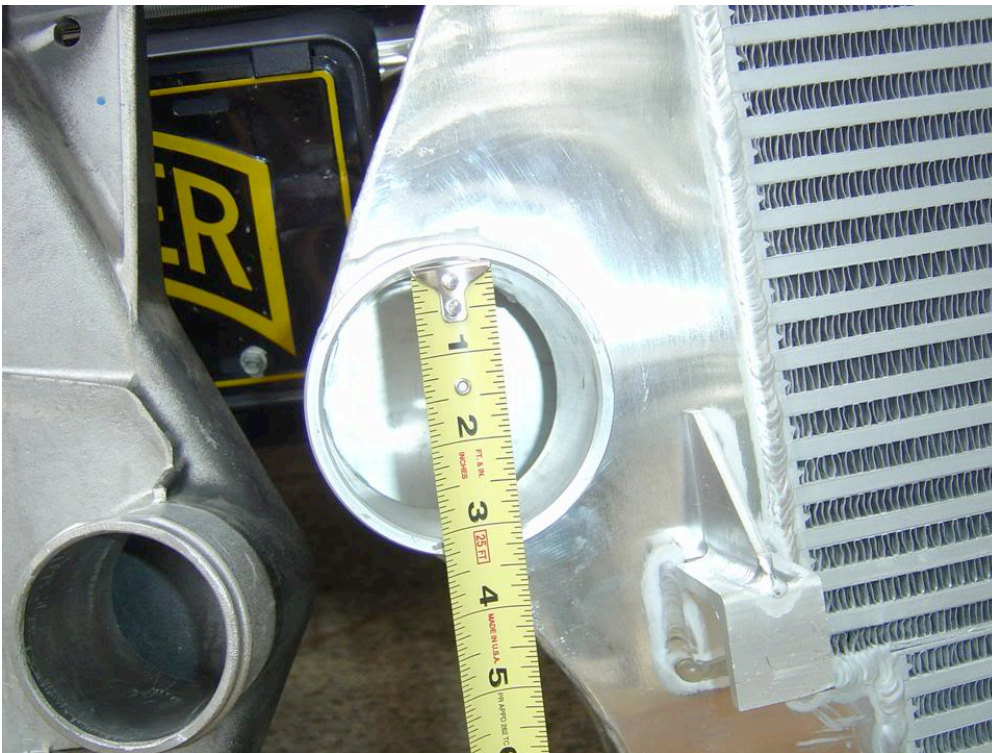
The ATS kit presented me with one final problem here. The kit comes with a 90\* boost boot to go from the secondary boost tube to the intercooler opening. This boot is sized for a stock intercooler and I had the ATS intercooler that had a larger opening.

This required removing the ATS intercooler and re-installing the stock intercooler until the new one from ATS showed up, which was sent overnight.

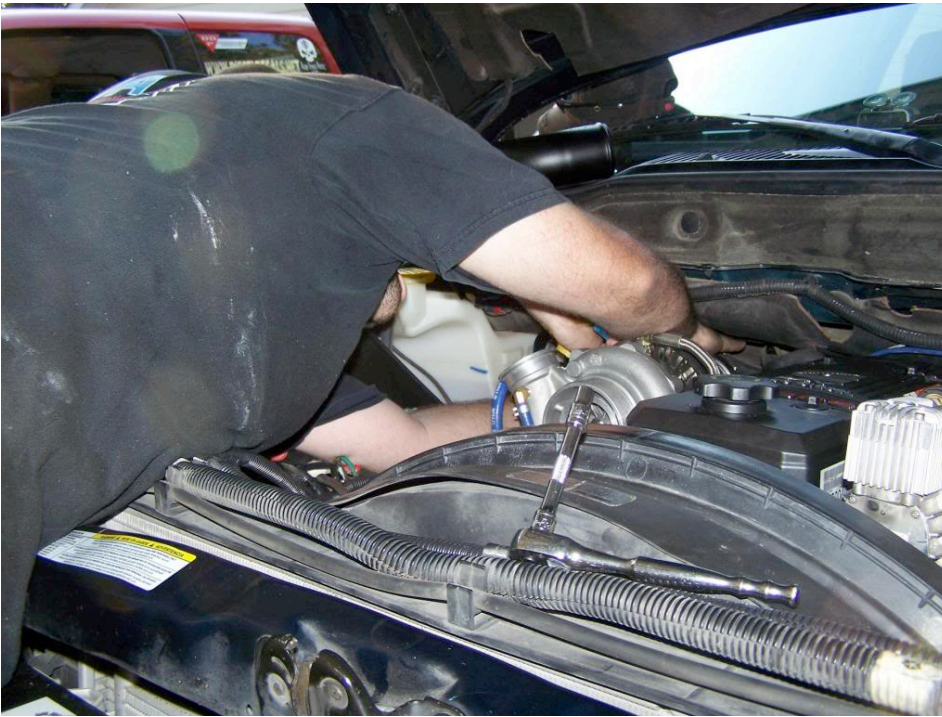
As we began routing the piping, we found that the compressor outlets still needed some tweaking to line up. Other than it being a pain to reach all the hold down bolts at this point, we found that the location of the wastegate head made it impossible to turn the compressor outlet to the correct position. You could go toward the engine, as it would hit the manifold and you couldn't go toward the battery as you hit the wastegate head. So, we had to remove the wastegate head, clock the compressor housing and then re-install the head. Now, the location to the wastegate head and it's 3 bolts make this a task for a contortionist. This took us a little while an increased our vulgarities count significantly.
