**41321 / 41322 / 41323**  
**2001-02 GMC Sierra HD, Denali, Sierra C3# PU – Bolt Over Logo Covered**

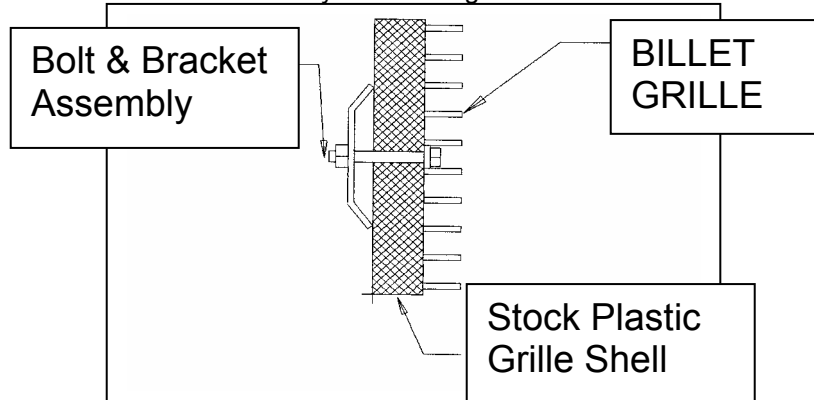
Step 1: Center [billet grille](#) in opening. Use bolts, nuts and brackets supplied and attach per illustration below.

Step 2: Check to make sure the grille is properly in place and tighten the bolts just enough to hold the grille in place. **DO NOT OVER TIGHTEN** as this may cause the grille shell to crack.
