## **Installation instructions**

For set # 4.3168 98-11 FORD RANGER 2WD WITH COIL SPRINGS

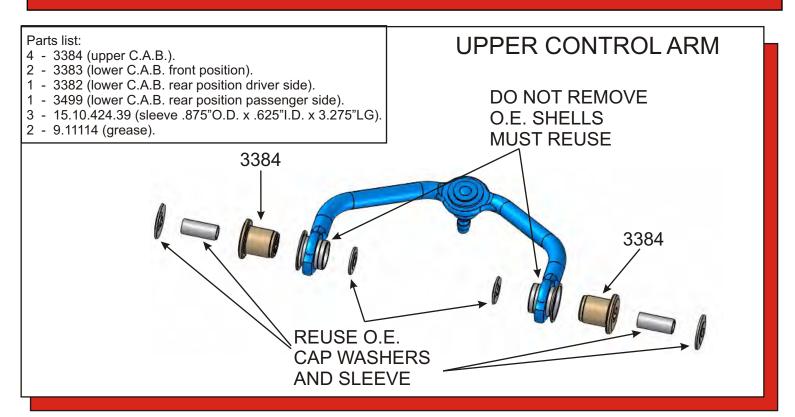
It is recommended that if you are unfamiliar with this type of work that you refer to a qualified service center specializing in this type of work. It is also recommended that if you choose to do this work yourself that a factory service manual be obtained for the proper procedures pertaining to removal, replacement and proper torque specifications for your vehicle. This instruction set is intended as a guideline for the safe installation of Energy Suspension's polyurethane bushings, once you have removed the factory components from your vehicle. Wheel alignment is almost always disturbed when suspension components are removed or replaced. It is recommended that you have the alignment checked on your vehicle at a qualified alignment shop. Energy Suspension recommends that you read over all the installation instructions and check all P/N's and quantities in the parts list before you start.

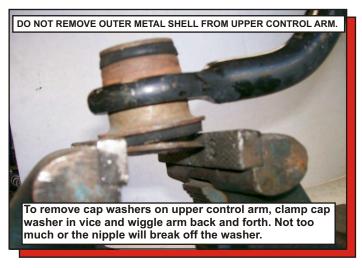
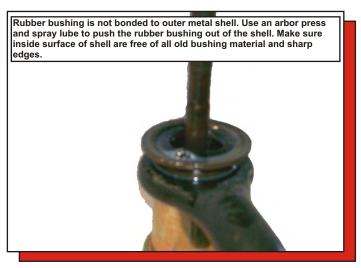
Inner sleeve is bonded with the old rubber bushing. To remove the old rubber bushing from the sleeve, clamp the sleeve in a vice and using a utility knife, slice the bushing longways away from yourself. Clamp the bushing with vicegrips pulling the rubber back and slice as close to the sleeve as possible. Rotate the sleeve in the vice until you get all the way around. Clean as much rubber off the sleeve until smooth.

Coat urethane bushing, sleeve and shell I.D. with supplied grease. (all surfaces of bushings that contact metal). Inner sleeve and cap washer must be reused. Press the polyurethane, sleeve and big cap washer into the shell, then press on the small cap washer. The lower control arm bushings will be similar to the upper with the removal of the old rubber bushings and installation of the new polyurethane bushings.

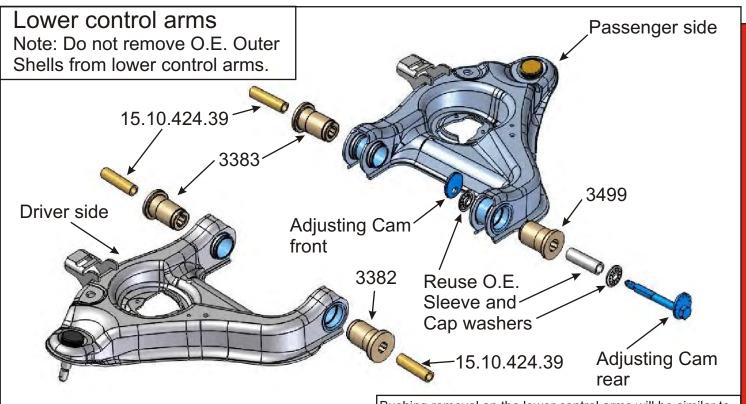
Be sure to place matchmarks on the front and rear of the adjusting cam before you start. You will need to use these matchmarks to reinstall the passenger side lower control arm back in the same position after the new polyurethane bushings are installed. Then have the vehicle's alignment checked by a certified technician . The alignment must be within factory specifications.

Bushing removal on the lower control arms will be similar to the upper control arms. Remove cap washers from the passenger rear position. Inner sleeve is not bonded to the rubber. With an arbor press and spray lube, press out the inner sleeve first to relieve the load from the rubber bushing. Use a lot of lube to help press out rubber bushing from shell. Install the new polyurethane bushings the same way as the upper control arm.
