# Installation instructions

For set # 8.3128

07-08 Toyota FJ Cruiser

03-08 Toyota 4Runner

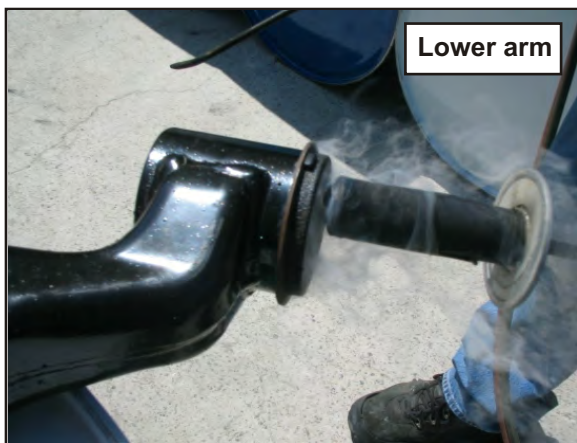
Do not remove the factory metal shells from the lower control arms, they must be reused. The inner metal sleeves and washers on the lower control arm must be reused. To remove the old rubber from the factory shells and inner sleeves, apply light heat evenly around the outside of the control arm outer metal shell, just enough to brake the bond with the rubber. Do the same on the inside of the sleeves on the lower control arms. When you see light smoke coming from the sides of the bushing the bond should be broken. At no time should there be any flames coming from the rubber, if there are any flames, you need to back off with the heat. Just push the old rubber and inner metal sleeve out. Let the outer metal shells and sleeves cool off before cleaning. Use a wire brush to remove any remaining old rubber. File off any sharp edges that will contact the new polyurethane bushings.

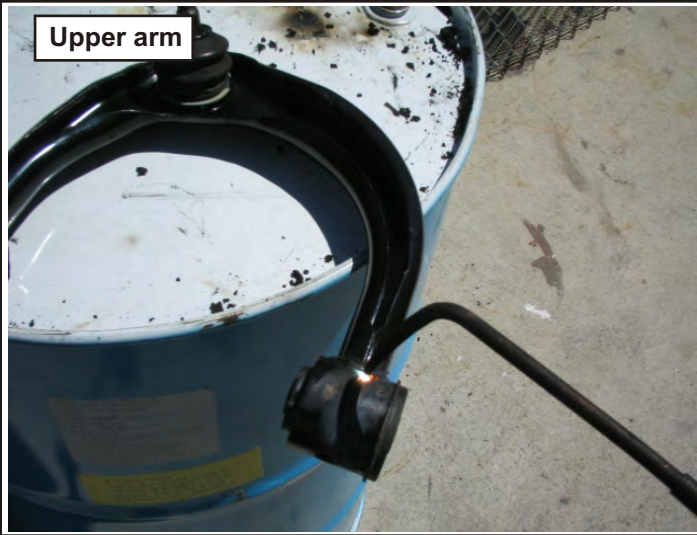
Do not remove the factory metal shells from the upper control arms, they must be reused. New inner metal sleeves are supplied for the upper control arms. To remove the old rubber from the factory shells and inner sleeves, apply light heat evenly around the outside of the control arm, just enough to brake the bond with the rubber. When you see light smoke coming from the sides of the bushing the bond should be broken. At no time should there be any flames coming from the rubber, if there are any flames, you need to back off with the heat. Just push the old rubber and inner metal sleeve out. Let the outer metal shells and sleeves cool off before cleaning.
