febi 48876

Various Alfa Romeo, BMW, Chevrolet, Citroen, Fiat, Ford, Lancia, Opel, Peugeot, Saab, Suzuki & Vauxhall models

Oil Drain Plug with O-Ring

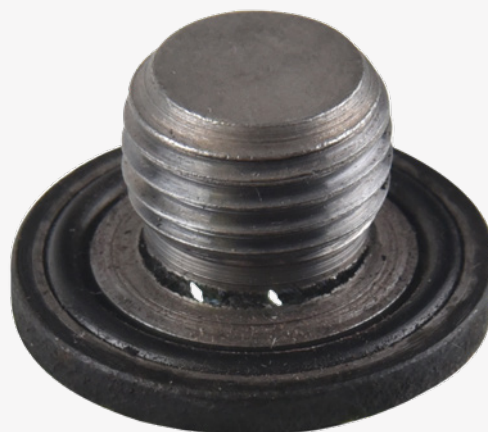
Original Part Figure 1

The original oil drain plug fractures between the thread and the head of the plug (Fig 1) which poses a high risk of coming loose from the oil pan. This causes oil to drain from the engine, which can lead to engine failure as well as excess oil being spilled onto the road surface – a hazard to other road users.

The repeated loosening and tightening of the same oil drain plug, during routine maintenance, leads to the weakening of the drain plug material. This can be accelerated if the drain plug is overly tightened.

To avoid failure, febi recommends that this drain plug is replaced during every oil change and tightened to the vehicle manufacturer's recommended torque settings.
