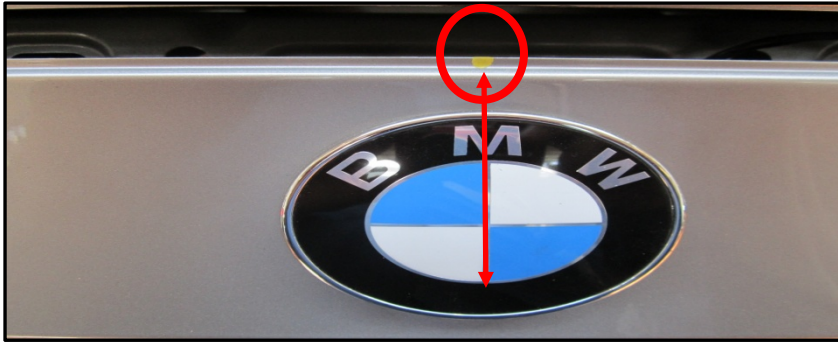
3. The new brake lamp may have a guide as indicated in the picture. If the lamp has a guide, proceed to the next step. If the lamp does not have a guide, finish the replacement.
