2009–2014 Ford F–150 Pickup

Tech Tip

#65

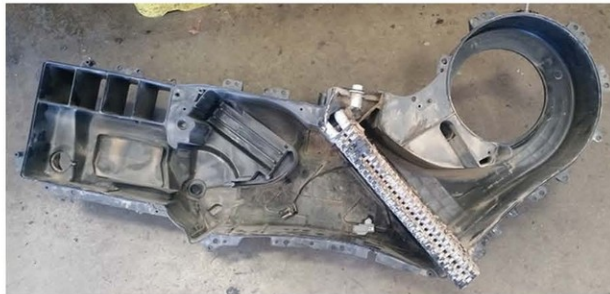
gpd has noticed an issue with 2009–2014 Ford F–150 pickups pertaining to their evaporator. Ford sells the unit as a total assembly but it has been designed to be split and put back together with screws. **The replacement evaporator is gpd #4712009.**

Expansion valve

For replacement, be sure to keep the retaining clip on the expansion valve to be reused. **The replacement expansion valve is gpd #3411482.**

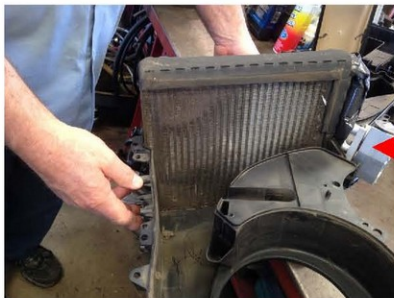
Because the vehicle does not come equipped with a cabin air filter, debris becomes caught in the air flow and is deposited into the evaporator. (as seen to the left)

The deposited debris acts as an insulator to the thermistor probe; giving an incorrect reading.

Debris

Thermistor

This is a zoned evaporator. If you move the thermistor to a different location, the system will not work correctly.
