2009–2014 Ford F–150 Pickup

gpd has noticed an issue with 2009–2014 Ford F–150 pickups pertaining to their evaporator. Ford sells the unit as a total assembly but it has been designed to be split and put back together with screws. **The replacement evaporator is gpd #4712009.**

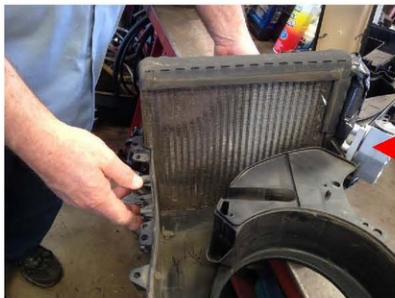
Because the vehicle does not come equipped with a cabin air filter, debris becomes caught in the air flow and is deposited into the evaporator. (as seen to the left)

The deposited debris acts as an insulator to the thermistor probe; giving an incorrect reading.

Debris

Thermistor

This is a zoned evaporator. If you move the thermistor to a different location, the system will not work correctly.

Expansion valve

For replacement, be sure to keep the retaining clip on the expansion valve to be reused. **The replacement expansion valve is gpd #3411482.**
