Saturn Compressor

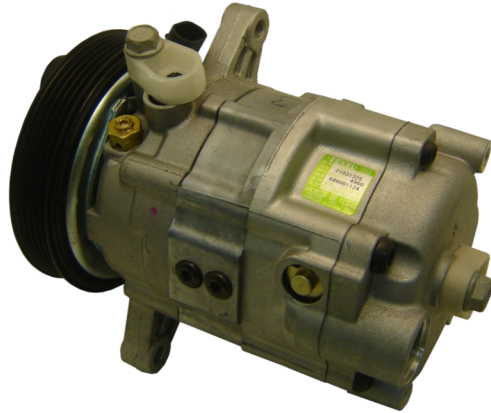
gpd #7512025

This Saturn compressor has an internal thermostatic control valve.

When charging the system thru the low side, the thermostatic control valve **will** freeze open and will not allow the compressor to pump, which leads the installer to believe that the compressor has failed.

* To charge the system properly, the Freon must be pumped in on the HIGH side using a charging machine with the engine off.
