History

Inspection & Diagnosis

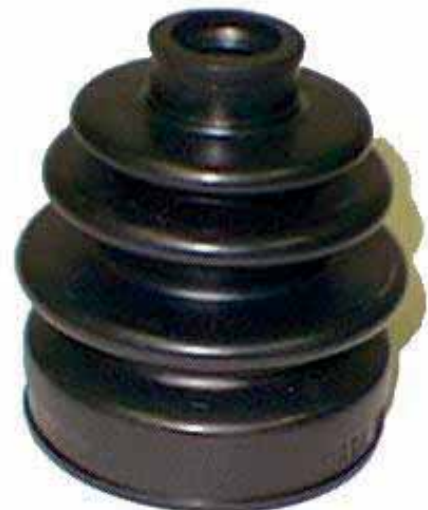
The Rzeppa CV joint was patented by Alfred H. Rzeppa in 1928. These early designs had six tracks in the housing and race, and a cage with six balls just like the modern version. These early designs worked well but they lacked lubrication. The grease in these early joints did not hold up and the boots were made of leather and did not seal properly. This type of joint did not work practically until the advent of the neoprene boot.

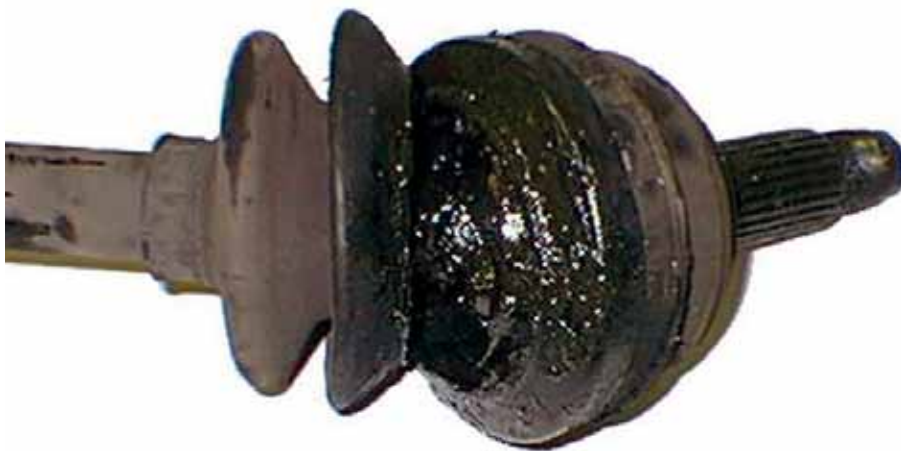
Communication with your customer is very important. Ask specific questions and listen very carefully to the answers. If necessary take your customer with you on a test drive. Vibrations or wobbles are usually caused by indentation or looseness in the inner joint. The clicking noise commonly associated with a bad CV joint is usually caused by indentation or wear in the outer joint. To diagnose which side of the vehicle the clicking noise is coming from turn the steering wheel all the way to one lock. Drive the car in reverse. If the clicking noise is louder while turning to the right then the left [axle](#) is the cause of the problem. If the clicking noise is louder while turning to the left then the right axle is the cause of the problem. Look for torn or dry rotted boots during a visual inspection.

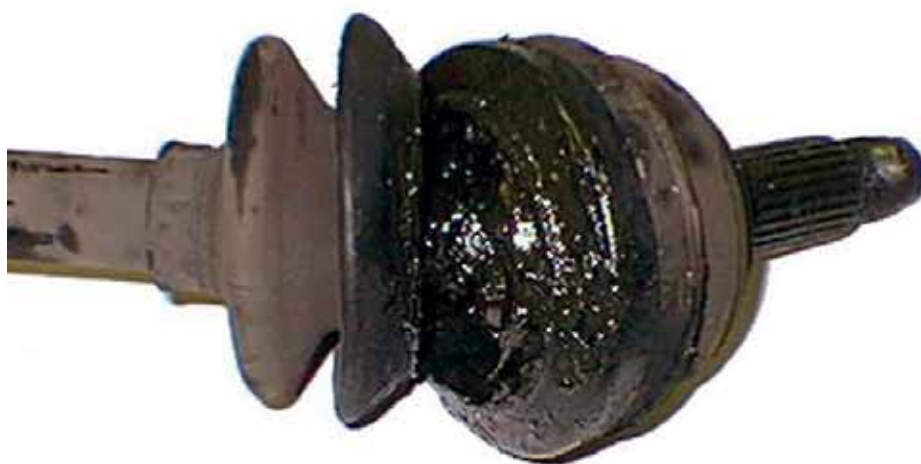
When inspecting the CV shafts be sure to check the condition of the boots. To determine if your customer needs a couple of boots or a complete axle, answer these questions. Are the joints clicking or making noise? Is the boot completely torn open or does it have a small hole? Has all of the grease been completely thrown out of the joint or is it still in good condition? What is the vehicle mileage? How long has the boot been torn open? Many times the cost of replacing both boots vs. replacing the complete axle is not much different. The warranty your customer gets with a complete axle is usually much better than with a boot replacement. With a complete axle your customer not only gets new boots but they get a remanufactured inner and outer joint and the shaft too.

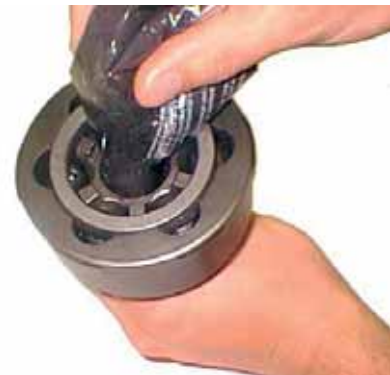
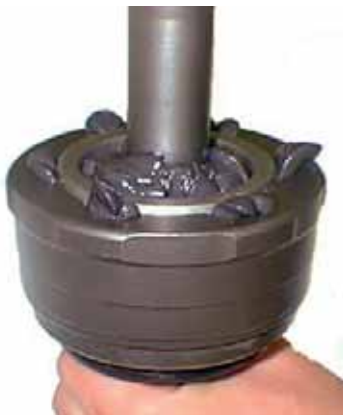
1. Remove the CV axle from the vehicle, the joint from the center shaft, and the old boot from the center shaft. Using a rag clean as much of the old grease from the joint as possible.
2. Apply a small amount of grease to the inside lip on both the small end and the large end of the boot. This will help the boot slide onto the center shaft and over the outer joint. Install the small end of the new boot on the center shaft. Be careful not to damage the boot on the splines of the center shaft.
3. Cut a corner off the grease package and squeeze as much of the grease into the hole in the center of the race. Squeeze the remaining grease into the boot.

4. Install the center shaft into the race of the outer joint. The pressure will force the grease out through the balls. The grease that squeezes out through the balls should be cleaned off with a rag.

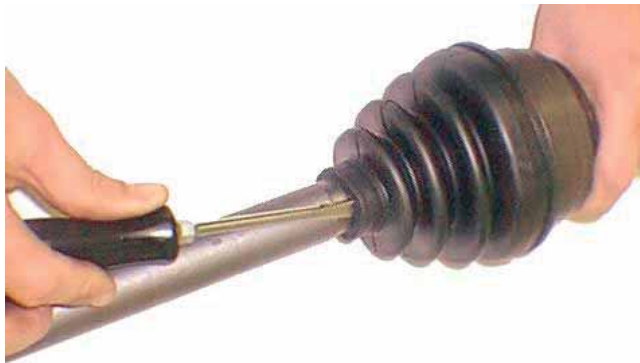
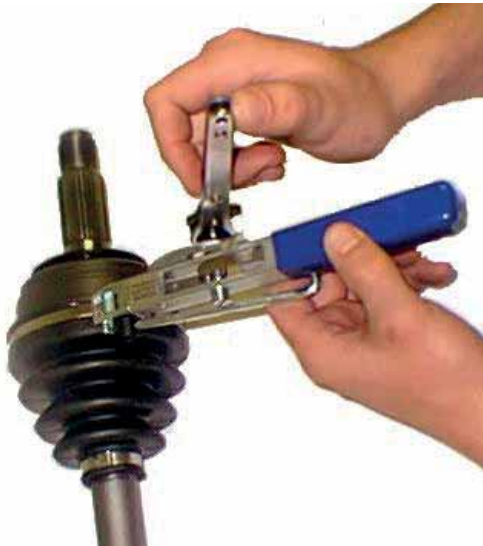
5. Install the large end of the boot onto the CV Joint.
6. Before installing the clamps, you must vent any excess air that is trapped in the boot. Excess air will cause the boot to distort and shorten the life of the boot. To purge air from the boot, insert a small screwdriver between the small end of the boot and the center shaft. Any trapped air will escape and the boot will stabilize.

7. The clamps supplied with this kit are universal-type. Wrap the clamp around the boot and insert the end of the clamp into the clamp tool. Ratchet the clamp tool till the clamp is tight. Be careful not to over tighten the clamp so it cuts the boot. Cut the band with the clamp tool and fold the end back between the tabs. Fold the tabs over to lock the end in place.

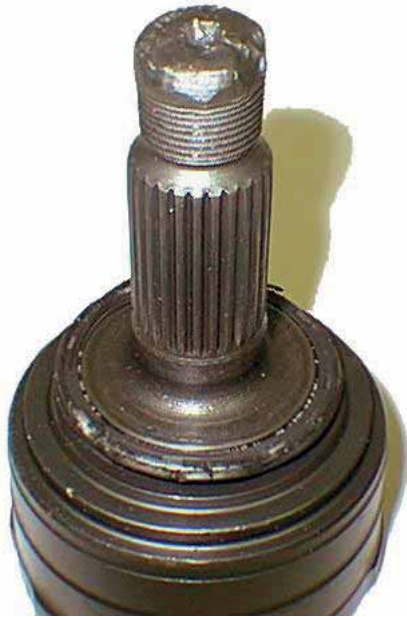
3. Remove outer joint from hub.

4. Do not use a hammer to drive the C.V. Joint out of the hub. This will damage the joint and the core will have no value.

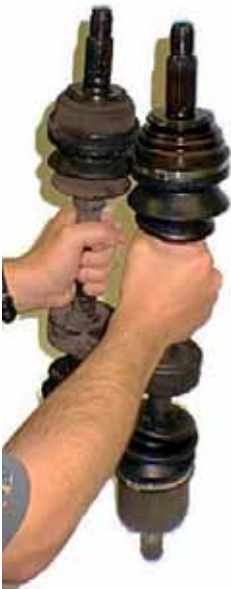
1. Before installing the new axle match it to the old unit. Check the over all compressed length by bottoming both inboard joints on something hard like a cement floor.

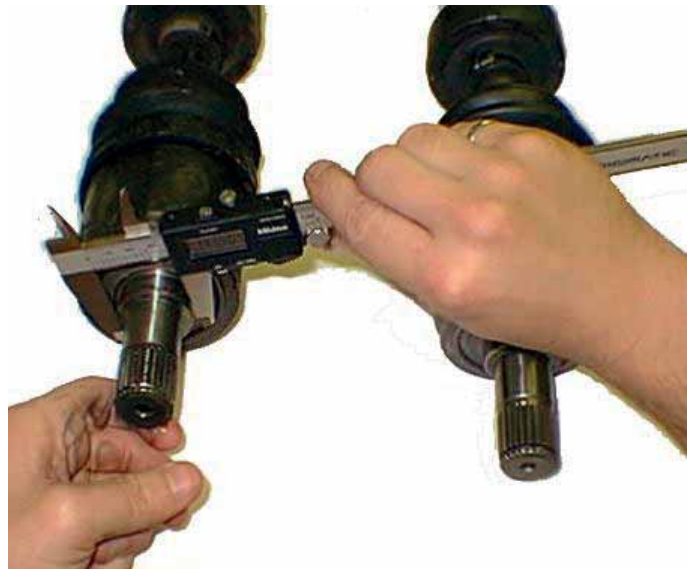
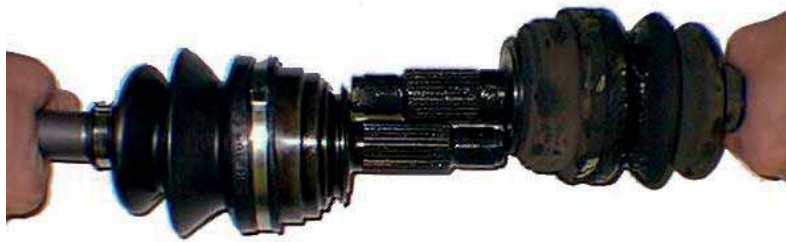
2. Measure and compare the inner and outer seal surfaces.

3. Compare the outer stub lengths.

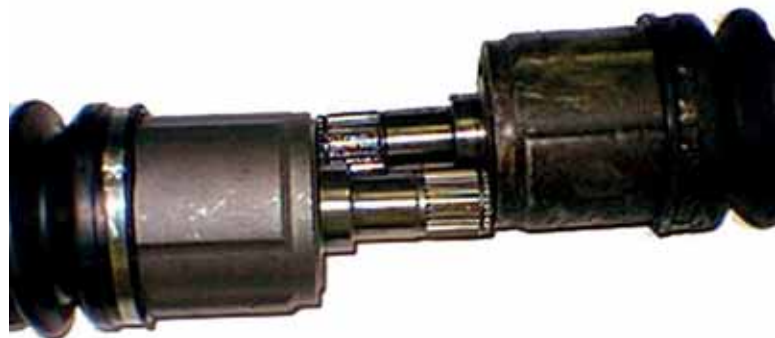
4. Compare the inner stub lengths.

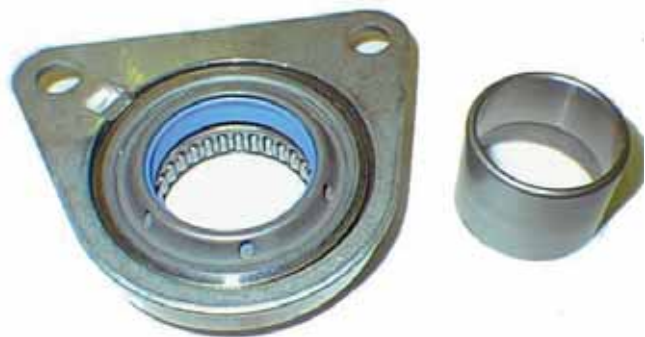
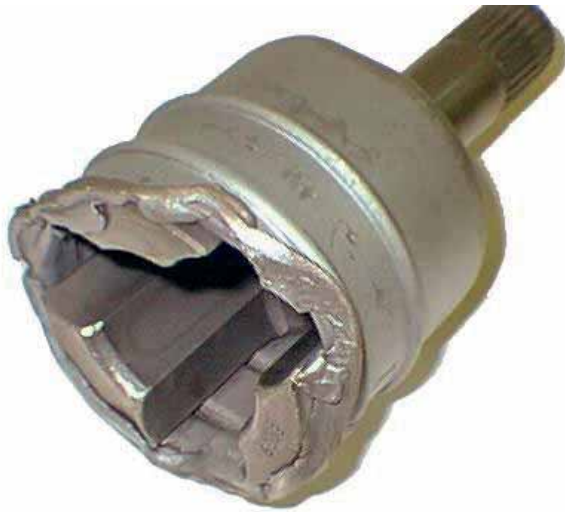
6. General Motors vehicles from 1982-91 with the TH125 transmission may have a carrier support bearing on the passenger side of the vehicle. This bearing and sleeve is an aftermarket fix for a worn side bushing. If the vehicle has this carrier bearing assembly on it you will need to order the axle that includes the sleeve.

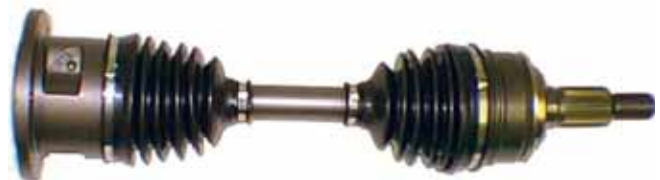
8. G.M. Trucks with I.F.S. have a problem that is similar to the Chrysler pull apart. The inner joint housing can break or crack due to an axle being stretched longer than it is designed for. This is usually caused by increasing the operating angle of the axle.

9. On some Escort & Lynx models you will need to remove the right hand CV shaft before removing the left hand shaft. The Ford differential rotator tool can be used to remove the left hand shaft. If both shafts are removed leave the rotator tool in the differential so the side gears will stay aligned.

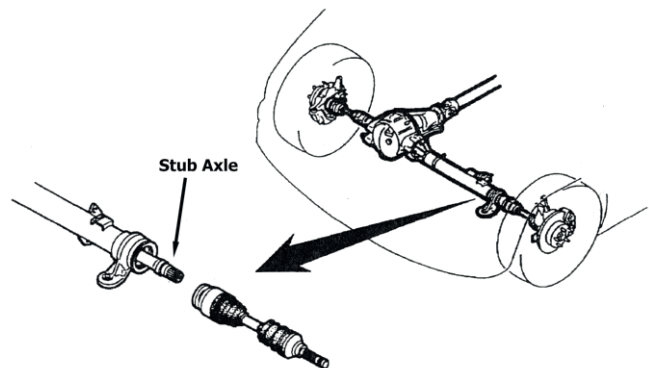
12. The front stub axle on a Mazda MPV 4X4 requires a small amount of grease on the splines. Without lubrication the splines on the stub axle and the inner joint housing will wear and create a vibration.
