GM8428

2015-16 DURAMAX 6.6L DOWN PIPE 3-BOLT FLANGE

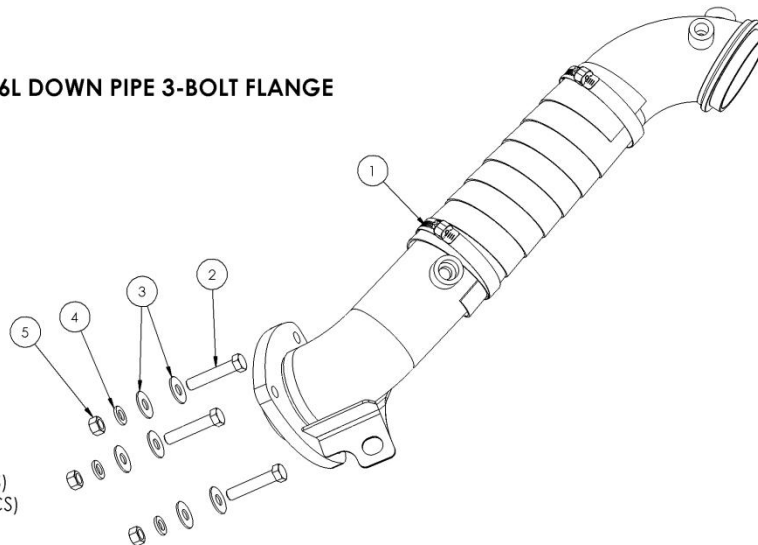
- 1. DOWN PIPE
- 2. 2" X 3/8" BOLT (3 PCS)
- 3. 3/8" FLAT WASHER (6 PCS)
- 4. 3/8" LOCK WASHER (3 PCS)
- 5. 3/8" NUT (3 PCS)

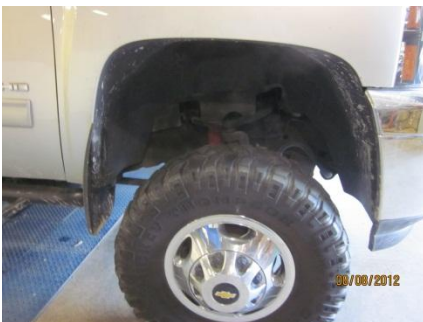
Figure 1

1. Remove the passenger-side inner fender.
See Figure 1.
Note: we also removed the Grille Assembly to prevent damage to it during the removal or installation of the down pipe.
2. The front pipe needs to be temporarily removed. Carefully disconnect all sensors and loosen the four flange nuts on the rearward part of the front pipe. The transmission cross-member will need to be temporarily dropped to remove the front pipe. Remember to support the transmission with a block or jack stand while doing the transmission cross-member removal.
See Figure 2.
3. Remove the hex bolt securing the down pipe to the exhaust manifold. Remove the sensor located just above the hex bolt. The 3 nuts connecting the front pipe to the down pipe can also be removed. Save the hex bolt, nuts and sensor for the installation.
See Figure 3.

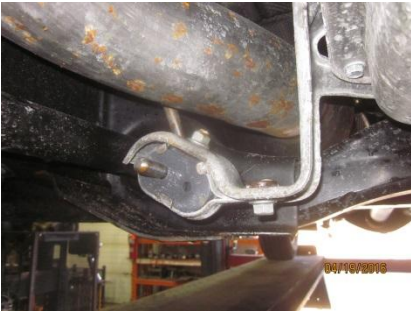
Figure 4

4. The front pipe has a hanger mounted to the transmission that will also have to be removed. Remove the bracket from the transmission.
See Figure 4.
5. Remove the combination stud/bolt from the transmission bellhousing just above the locating dowel. It has already been removed in **Figure 5**. This is to allow the clearance necessary to remove the down pipe.

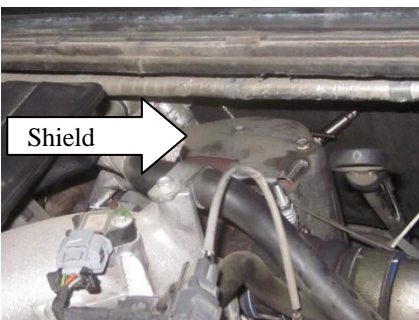
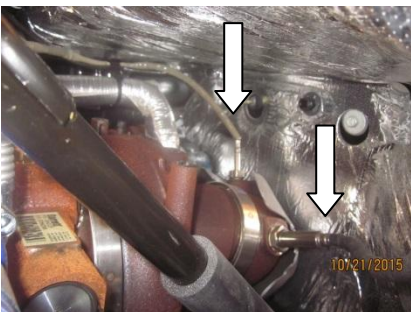
6. The heat shield on top of the turbo will need to be removed. The 2 stock sensors on the top of the down pipe need to be carefully removed. Set the sensors aside and save for the installation. The stock V-Band clamp can be removed, and saved for the installation.
See Figures 6 & 7.

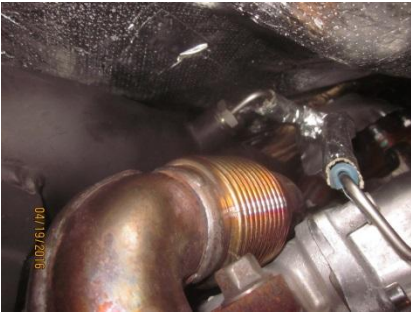
Figure 8

4. Install the stock sensors into the **Down Pipe**. One is located along the lower section of the **Down Pipe** (Refer to **Figure 8**.) The other two sensors are located closer to the turbo.

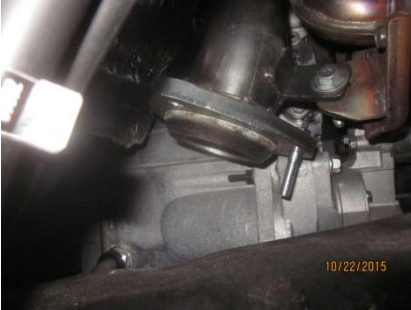
Figure 9

5. The front pipe can then be reinstalled using the supplied **3/8" Bolts, Flat Washers, Lock Washers and Nuts**; as well as the factory hardware for the 4-bolt flange.
See Figure 9.

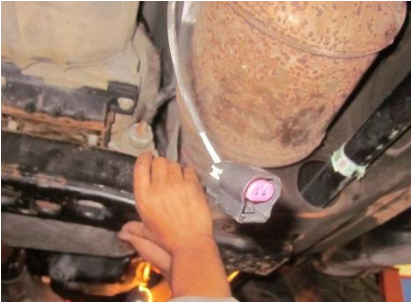
Figure 10

6. Reinstall the transmission cross-member. Reinstall the exhaust hanger to the transmission. Reconnect all the sensors to the front pipe.
See Figure 10.
