GMCA427

2011-2015 CHEVROLET/GMC, SILVERADO/ SIERRA,
HD2500-3500, DURAMAX, DOWN PIPE
CARB EO# D-763

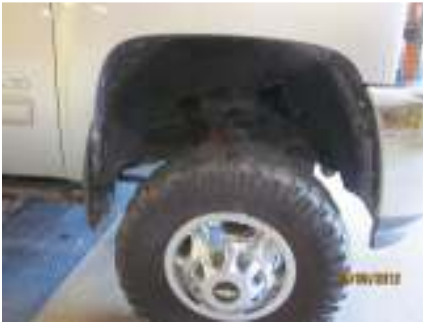
Figure 1

1. Remove the passenger side inner fender. See Figure 1.
Note: we also removed the Grille Assembly to prevent damage to it during the removal or installation of the down pipe.
2. Remove the hex bolt securing the down pipe to the exhaust manifold. Remove the sensor located just above the hex bolt. The V-Band clamp connecting the front pipe to the down pipe can also be removed. Save the hex bolt, sensor and V-band clamp for the installation. See Figure 2.
3. The front pipe needs to be temporarily removed. Carefully disconnect all sensors and loosen the four flange nuts on the rearward part of the front pipe. The transmission cross-member will need to be temporarily dropped to remove the front pipe. Remember to support the transmission with a block or jack stand while doing the transmission cross member is removal. See Figure 3.

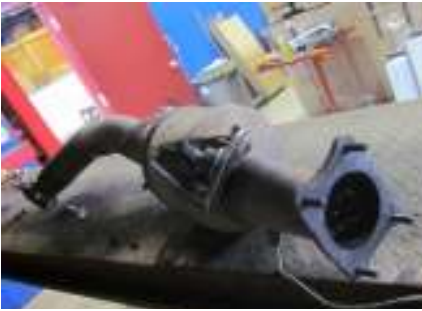
Figure 4

4. The front pipe also has a hanger mounted to the transmission that will also have to be removed. **Figure 4** shows the front pipe assembly removed.
5. The heat shield on top of the turbo will need to be removed. There is also a shield on the back of the down pipe. It runs along the firewall that needs to be removed. The 2 stock sensors on the top of the down pipe need to be carefully removed. Set the sensors aside and save for the installation. The stock V-Band clamp can be removed save for the installation. From the underside of the vehicle carefully slide the stock down pipe out between the frame and transmission.

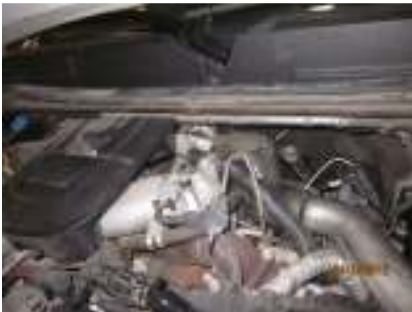
Figure 10

5. Reinstall the exhaust hanger to the transmission cross member. Reinstall the transmission cross member. Reconnect all the sensors to the front pipe.
6. Reinstall the passenger side inner fender.
7. Reinstall the turbo heat shield. **Refer to Figure 10.** Check along the exhaust to make sure all connections are tightened. Check along the whole length of the exhaust system to ensure that there is adequate clearance around the spare tire, fuel and brake lines or any wiring. If any interference is detected relocate or adjust.
