MOOG®
STUD MATERIAL

THE PROBLEM SOLVER®

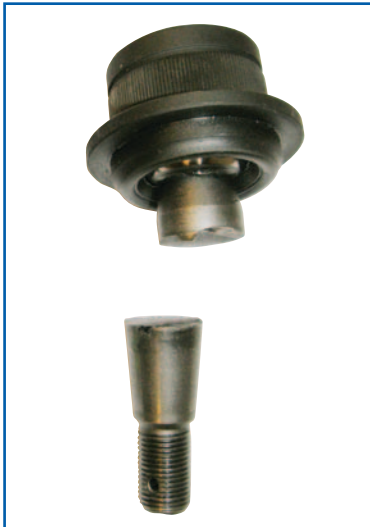
STUD WITH NO INDUCTION HARDENING IS 50% LOWER IN FATIGUE STRENGTH.

- Improper or lack heat-treating can result in cracked/broken studs and steering loss.
- Some suppliers' studs are not induction-hardened, causing them to have 50% or more reduction in fatigue strength.
- Machining the stud end can leave crack-prone stress risers that may lead to stud fracture.

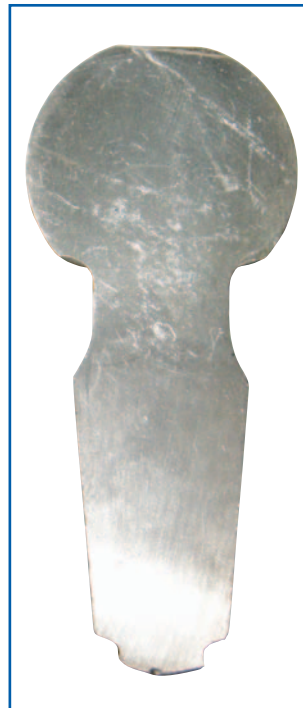
ALTERNATE SUPPLIER'S STUD, CRACKED DUE TO IMPROPER HEAT-TREATING

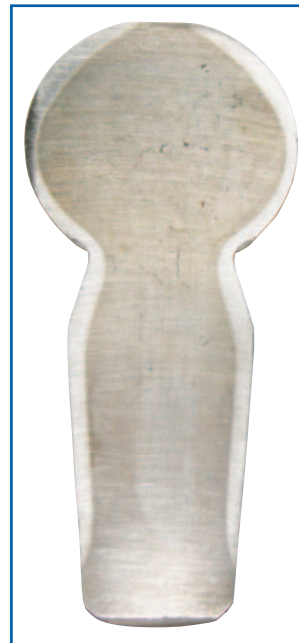
HEAT-TREAT INDUCTION HARDENING CREATES A WEAR RESISTANT SURFACE ON THE BALL AND INCREASES THE FATIGUE STRENGTH OF THE STUD.

MOOG studs are engineered with a hardened exterior and a soft core, which allows them to bend instead of break during a severe impact. This prevents the complete loss of steering that would occur if the stud actually broke. In addition, through complete understanding of the OEM material and heat-treat, MOOG designs a stud to meet or exceed the OEM stud's strength.

- Consistent-dimension forged alloy steel construction that eliminates taper-end machining.
- MOOG-specified steel composition that produces stronger consistency than commonly used larger-grain composition.
- MOOG ball construction that offers excellent core ductility with a hard, heat-treated outer shell.

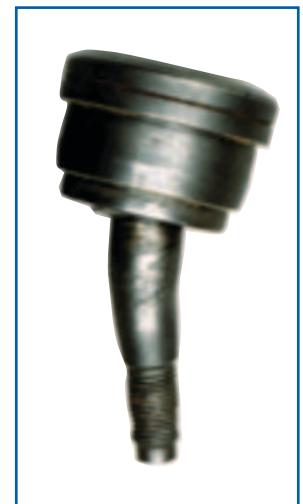
MOOG STUDS ARE DESIGNED TO BEND, NOT BREAK, IN CASE OF SEVERE IMPACT.
