OFFICIAL STEERING & SUSPENSION OF NASCAR®

THE PROBLEM SOLVER®

Lower Ball Joint Failure

MOOG® Problem Solver® K7467 Lower Ball Joint

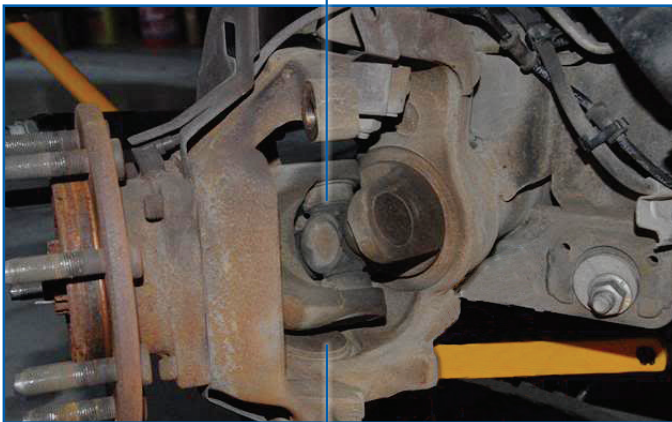
OE and other suppliers' designs can lead to early failure in vehicles that are subject to adverse road conditions or severe duty use.

- Plastic bearing is subject to excessive wear.
- No provision for preload can lead to excessive deflection and degradation of socket torque as the bearing wears.
- OE ball joint is non-greaseable, and the tight installation clearance makes servicing other suppliers' ball joints difficult.

OUTER U-JOINT

NOTE LIMITED CLEARANCE

Note:
In order to remove and install the lower ball joint, the knuckle must be removed. We recommend that you replace the outer universal joints at this time, as they are easily accessible during this procedure.

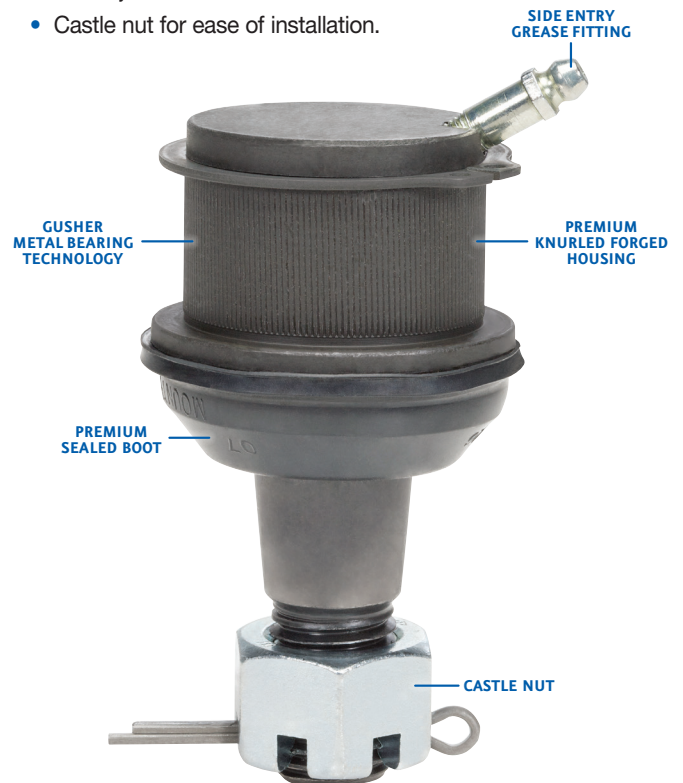
The MOOG® Problem Solver® K7467 ball joint features many improvements over the OE and other suppliers' ball joints.

- Exclusive powdered-metal "gusher" bearing improves wear resistance and durability.
- Belleville washer ensures proper preload and consistent socket torque for the life of the part.
- Premium knurled housing ensures strength and a secure installation.
- Premium black polychloroprene boot lasts longer than blue neoprene boots.
- Side-entry style grease fitting allows easy service of ball joint while on vehicle.
- Castle nut for ease of installation.
