STEERING & SUSPENSION

**THE PROBLEM SOLVER®**
**LEAKING/WORN STRUTS**

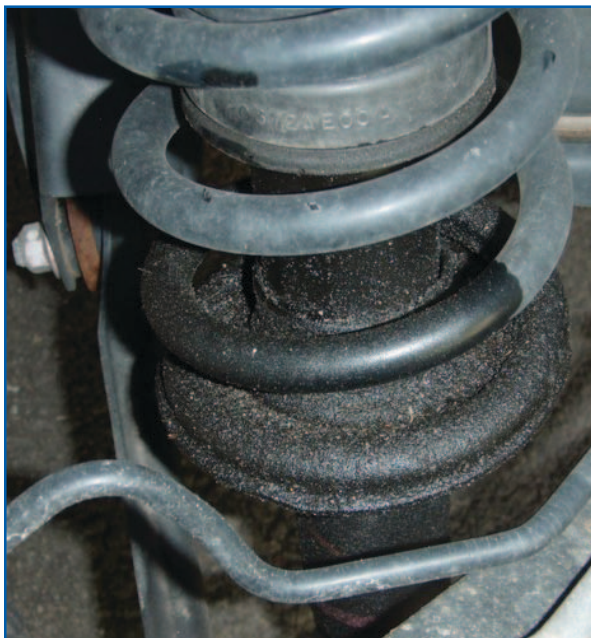
Debris can enter the seal cavity and lead to premature wear of both the main seal and the piston rod. This causes the strut to leak hydraulic fluid. Fluid loss will lead to further problems, including product failure.

Pressure spikes are a rapid rise in the static pressure of the strut's hydraulic fluid. These spikes are caused by shock loads – from rough roads or a single forceful road impact, such as hitting a pothole. Pressure spikes can force fluid past the main seal, resulting in fluid leakage. Pressure spikes can also permanently damage the main seal, which will eventually lead to product failure.

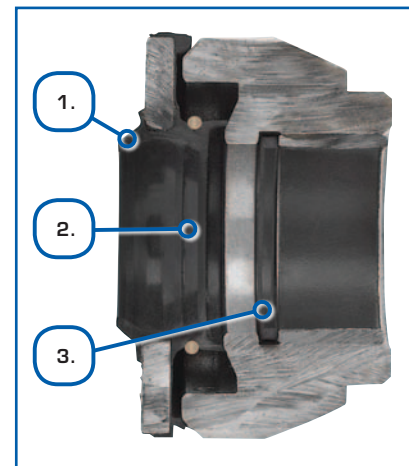
**SOLUTION:**
**MOOG® Triple Piston Rod Seal**

The problem-solving MOOG® Triple Piston Seal offers dual protection to an enhanced main seal, resulting in longer life. **(1) Outer wiper seal** cleans the piston rod, preventing contaminants from entering the strut and damaging the main seal. **(2) The MOOG main seal** is a one-piece molded design featuring twin seal lips, optimizing sealing performance and durability. **(3) An exclusive inner PTFE buffer seal** absorbs high-pressure fluid spikes caused by rough road impact, improving the efficiency of the main seal, for longer seal life.
