I-SHEET PART NUMBER: INST-00272

PART NUMBER: **T16BR-TX**PRODUCT: **SPORT BAR**

APPLICATION: 16-21 TACOMA

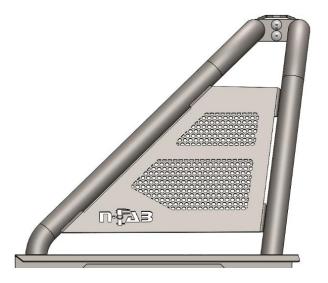
PARTS INCLUDED	QTY
CENTER LIGHT MOUNT ASSEMBLY	1
DRIVER SIDE ASSEMBLY	1
PASSENGER SIDE ASSEMBLY	1

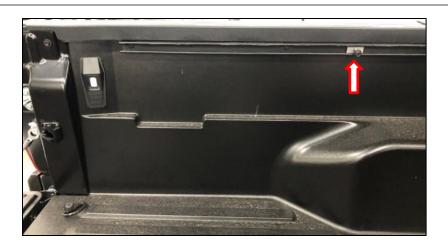
**Step 3.** Install one bolt and nut assembly in each bed rail by sliding through the channel opening until it makes contact with the end cap on the opposite end.

**Step 4.** Next, slide the two remaining bolt and nut assemblies half way through the channel.

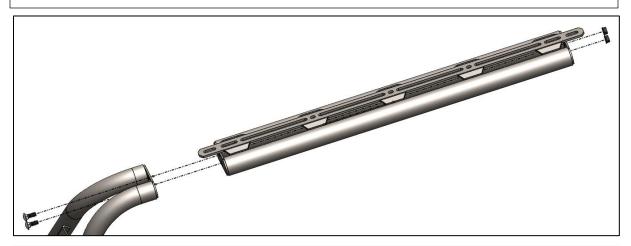
<u>Step 5</u>. Attach the Center section to the driver and passenger side assemblies using the supplied 3/8" x 1" carriage bolt (x4) and 3/8" fanged nut (x4) and leave finger tight for now. \*NOTE: Begin with the upper bolt and nut first to have easier access to the lower fasteners. \*
