PROCEDURE FOR 2008 F-250/F-550 6.4L DIESEL RADIATOR REPLACEMENT VENTURI TEE INSTALLATION KIT

8C3Z-8B379-B VENTURI TEE KIT IS REQUIRED TO INSTALL THIS RADIATOR

SK 8C34-8A468-AB

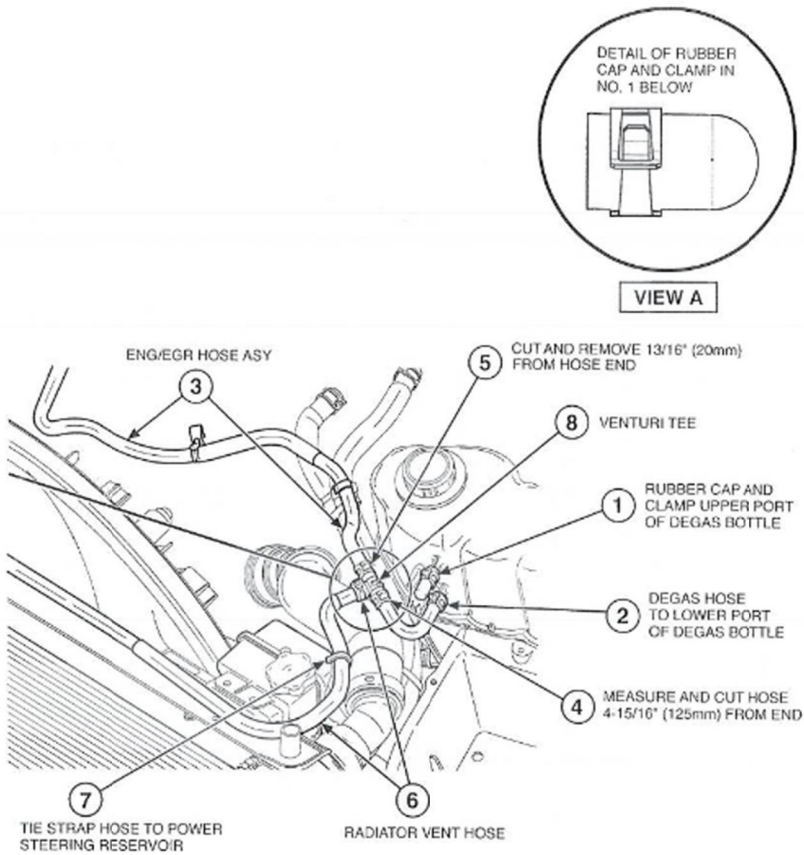
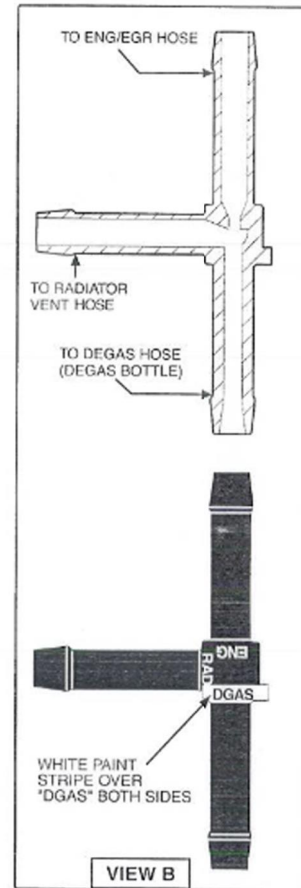
FIGURE 1

Some 2008 F-250/F-550 Super-Duty vehicles equipped with a 6.4L Diesel engine may exhibit a Radiator coolant leak.

NOTE: Installed orientation of Venturi Tee is critical (refer to Figure 1).

1. Remove two (2) vent hoses at Degas Bottle (refer to Figure 1, item 1 and 2).
2. Locate the Exhaust Gas Recirculation (EGA) vent hose (refer to Figure 1, item 3).
3. First cut: Measure and cut hose 125mm from end that attaches to Degas Bottle hose. Include hose bend in measurement (refer to Figure 1, item 4).
4. Second cut: Measure and cut 20mm off opposite end of (EGR) vent hose (refer to Figure 1, item 5).
5. Install two (2) #16 Constant Tension Clamps (CTC) included in service kit on hose ends. Slide new clamps far enough up hoses so they won't interfere with Venturi Tee installation.

6. Insert end of Venturi Tee labeled "ENG" (view B) into Exhaust Gas Recirculation (EGR) vent hose (refer to Figure 1, item 3 and 8).
7. Insert end of Venturi Tee labeled "DGAS" (White Stripe) (view B) into end of Degas hose (refer to Figure 1, item 8).

8. Insert end of Venturi Tee labeled "RAD" (view B) into end of Radiator Vent Hose (refer to Figure 1, item 6 and 8).
9. Install Venturi Tee in a slight upward position to prevent contact with Upper Radiator hose (refer to Figure 1, item 6).

10. Install completed Venturi Tee assembly hose onto lower Degas bottle port (refer to Figure 1, item 2).
11. Verify hoses are not kinked or bent to ensure maximum coolant flow.

12. Tie-strap radiator vent hose to hole in edge of power steering reservoir (refer to Figure 1, item 7).
13. Install rubber cap and clamp assembly (view A) on upper Degas bottle port (refer to Figure 1, item 1).

14. Ensure that all hoses are fully seated on Venturi Tee ports and all clamps are set / installed into position at hose joint connections.
15. Replace the radiator assembly.
