WHEEL

WHEEL BEARING KIT
BRAKE DISC HUB KIT

WHEEL BEARING
RANGE

DIAGNOSTIC EXPERT

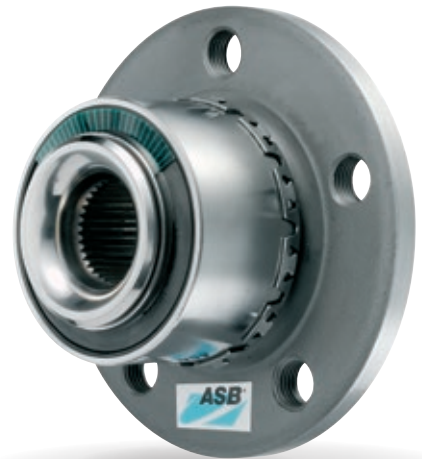
CHEAP COPIED BEARINGS

ORIGINAL NTN-SNR BEARING

Cheap copied bearings have appeared on the market over the past few years, these bearings can put the life of drivers and their passengers at risk if they fail.

- The installed bearings do not comply with the OEM specifications, especially with regard to service life and quality. Reduced service life can lead to premature deterioration and the risk of brake disc malfunction.
- The magnetic encoders installed on the discs, which are used for ABS and ESP systems, are not of OEM quality. Some were found to have the wrong number of magnetic pick-ups giving incorrect readings.

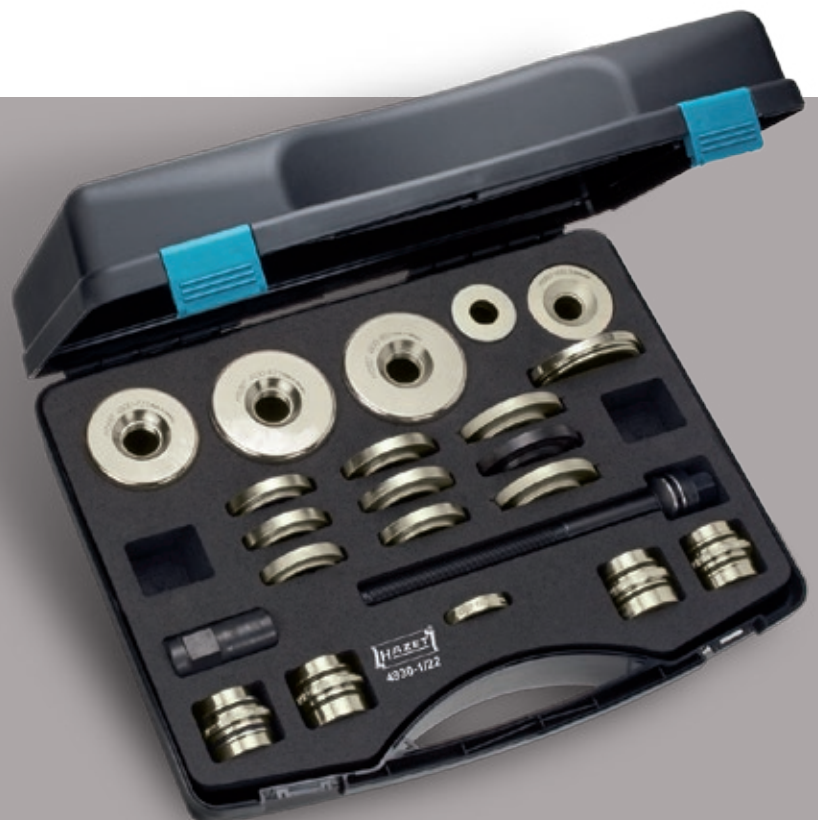
Special tools developed
for special bearings !

Follow these instructions for installation/removal of a bearing equipped with ASB® technology:

- 1st generation bearings (symbol: XGB...): Follow the bearing orientation: the markings on the bearing indicate the face with the magnetic encoder, which must always be fitted facing toward the centre of the vehicle (i.e. facing engine , gearbox or the centre of the axle)
- The bearing must be pressed-in using tools that have the required clearances in order to avoid denting or damaging the encoder (the old bearing is perfect for this task).
- Bearings must be handled and stored carefully in order to protect them from any impacts and contamination by metallic particles or moisture.
- Bearings must be kept away from any magnetic sources that may come into contact with the ASB® encoder (contact with a magnetic source such as a screw driver will damage the ASB® encoder)
- Any bearing with a magnetic encoder which is damaged and or dented, in particular due an impact, must not be used.

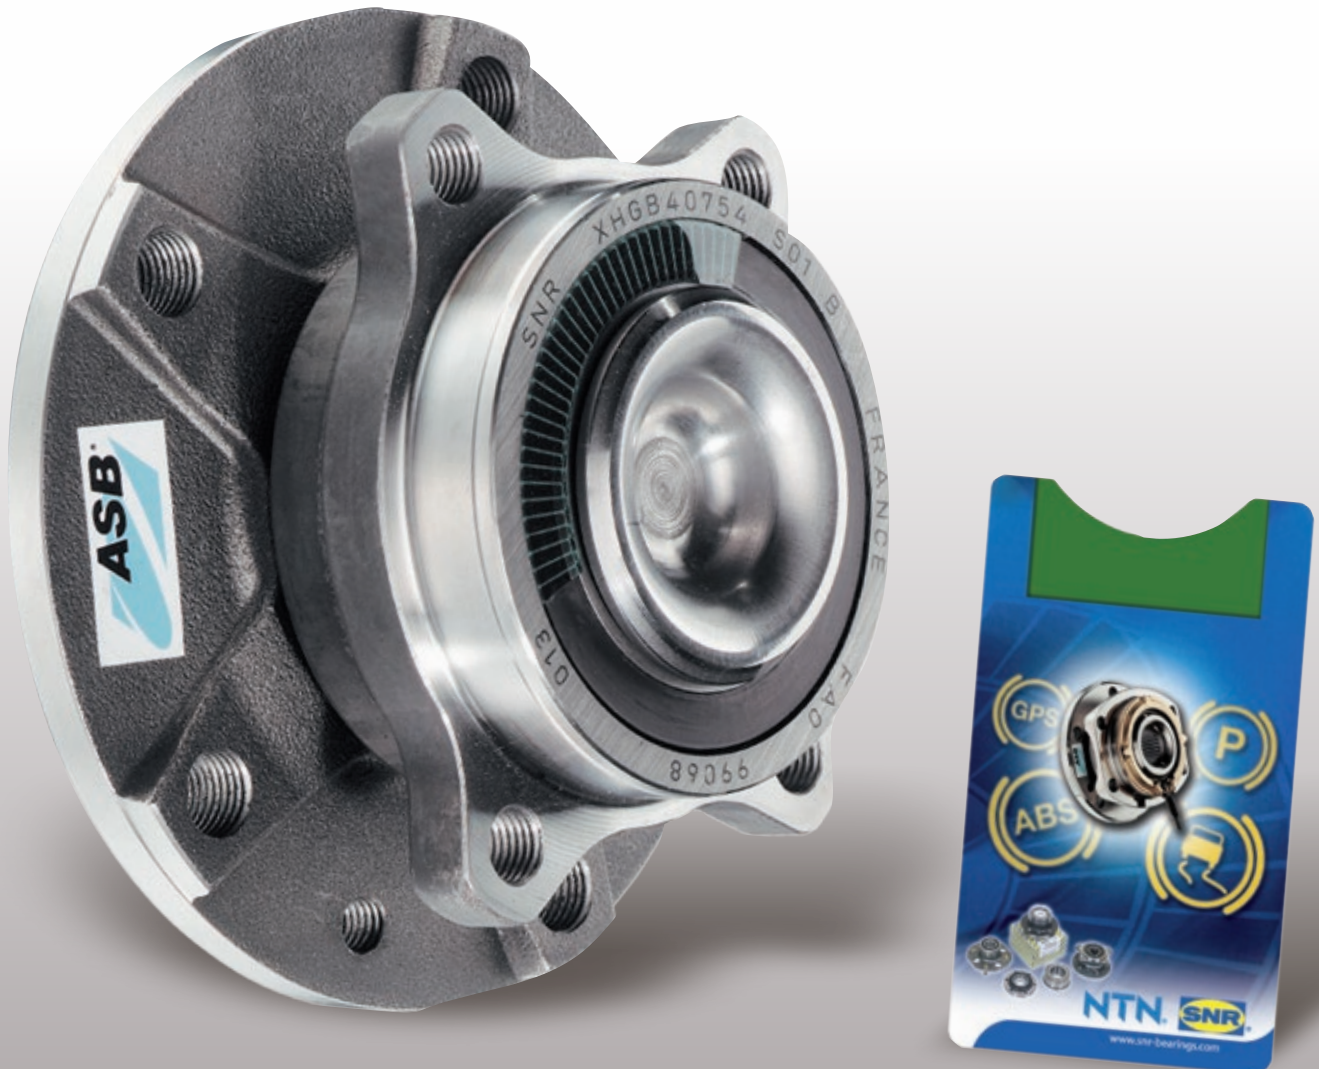
Use an ASB tester card to safely identify which side of the bearing the ASB® is fitted, the side with the bearings ID and date code is stamped also indemnifies the side the encoder is fitted.

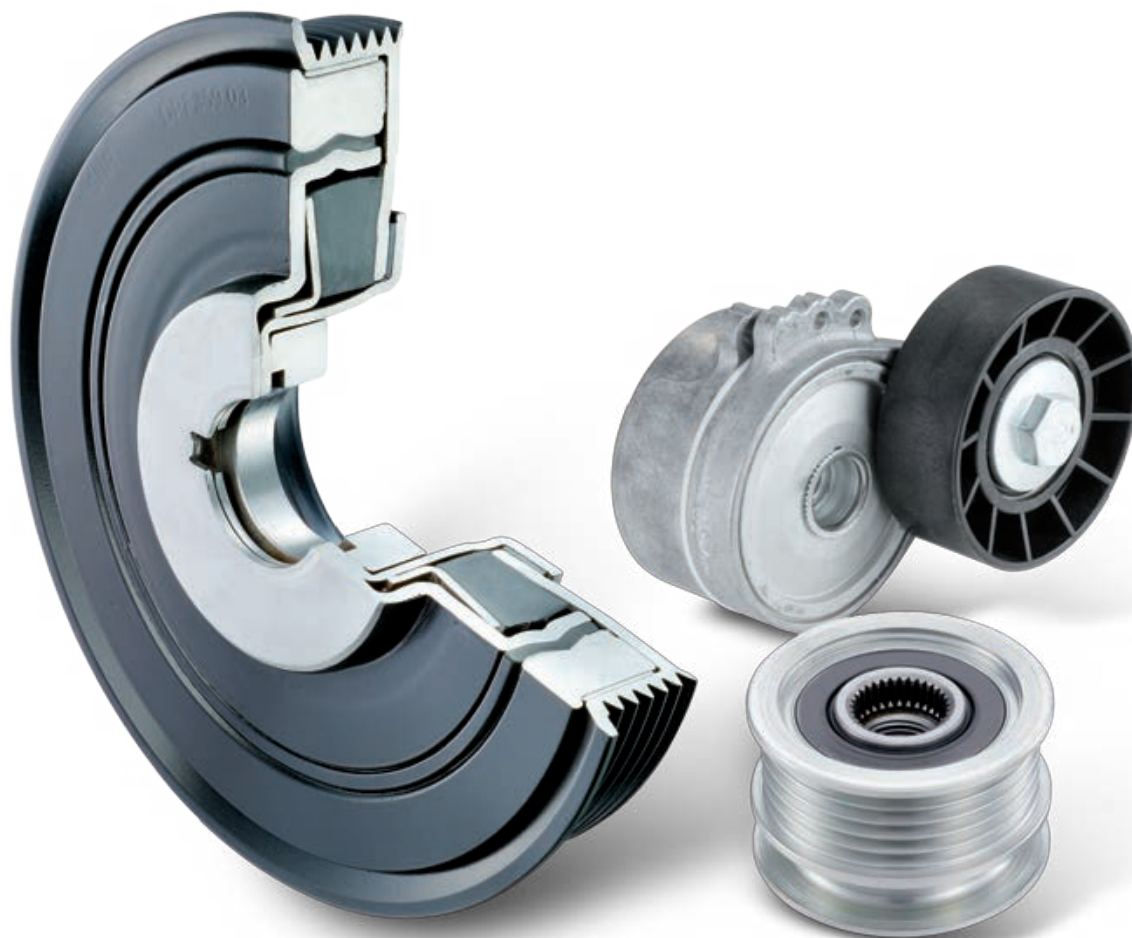
ACCESSORY DRIVE BELTS

The increase in the number of accessories and the growing sophistication of the new generation of vehicles means that a single belt can affect many different components.

If a drive belt breaks, all of those component systems stop working – from the alternator to the air conditioning, along with the power steering. It can even lead to a failure of the timing belt, in some cases resulting in severe damage to the engine itself.

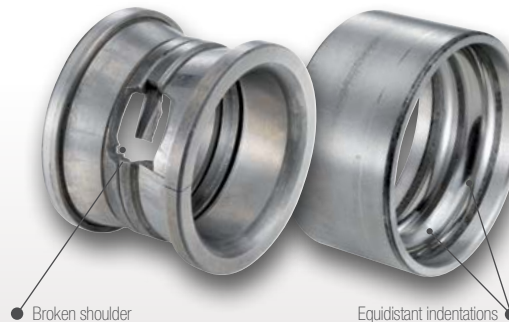
1 INDENTATIONS OR BREAKAGE OF THE SHOULDER DUE TO A FAULTY FITTING

EVIDENCE

- Presence of indentations located on the edge of the track and often seen over the complete circumference of the ring
- The indentations are in line with the position of the rolling elements
- Damaged or broken shoulder
- A slapping noise to the assembly

CAUSES

- The bearing was off-centre when fitted
- The bearing fitting was incorrect
- The bearing was dropped onto a hard surface
- The bearing tightening load was transferred through the rolling elements

NTN-SNR ADVICE

- Apply the load on the right ring, the fitting force should not go through the rolling elements
- Follow the general recommendations related to fitting

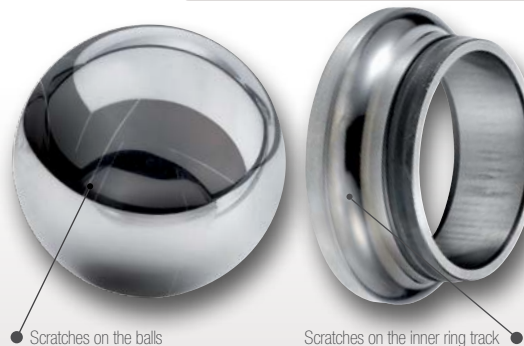
2 SCRATCHES ON SUCCESSIVE BALLS FROM AN UNTIGHTENED DRIVESHAFT

EVIDENCE

- Damage with circular grooves deforming the surface of the balls
- Grooved scratches similar to "petanque balls"
- Matching damage on the bearing tracks

CAUSES

- The vehicle was moved without the driveshaft or hub nut in place (such as when being serviced)
- Damage on the balls from contact and rolling on the inner edge of the track, due to a gap between the inner races

NTN-SNR ADVICE

- Avoid moving any vehicle when the driveshaft nut is not tight

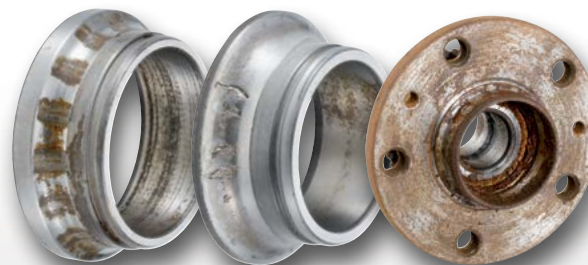
3 CONSECUTIVE FLAKING DUE TO A FAULTY SEAL

EVIDENCE

- Local or generalised oxidation of the bearing
- Reddish or black staining more or less widely distributed on the bearing
- Pitting has damaged the surface to a variable extent

CAUSES

- Insufficient or incorrect sealing for the installation
- Damage to the bearing seal during maintenance
- Lack/non replacement of the cap

NTN-SNR ADVICE

- Never dis-assemble a sealed bearing, damage is inevitable
- Avoid spraying with liquids
- Follow the general recommendations related to fitting

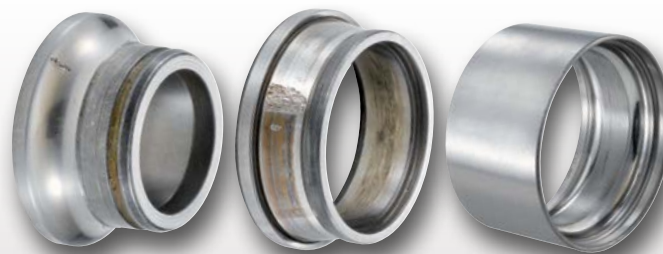
4 FATIGUE SPALLING

EVIDENCE

- Track surface damaged from flaking

CAUSES

- Faulty fitting
- Faulty (deformed) mating components

NTN-SNR ADVICE

- Follow the general recommendations related to fitting

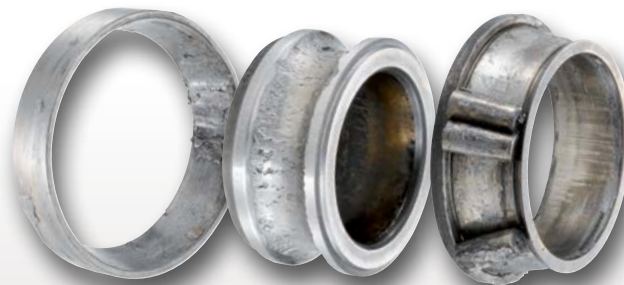
SEIZURE / OVERHEATING / FAULTY LUBRICATION

EVIDENCE

- The bearing has shallow metal surface damage on the tracks
- The bearing components are welded
- Components are coloured

CAUSES

- Lack of or incorrect bearing lubrication
- Micro-welding between bearing components
- Grease is contaminated due to pollution ingress

NTN-SNR ADVICE

- Watch out for any possible loss of grease which appears unusual
- Follow the general recommendations related to fitting

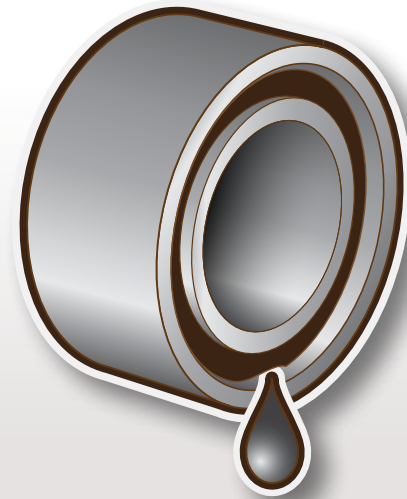
6 LOSS OF GREASE

EVIDENCE

- The mechanic notes an escape of grease from the bearing seals

CAUSES

- A large rise in bearing temperature causing deterioration of the grease
- Entry of water contaminates the grease

NTN-SNR ADVICE

- Check that there is not an overheating problem (e.g. a sticking hand brake)
- Check the bearing seal condition

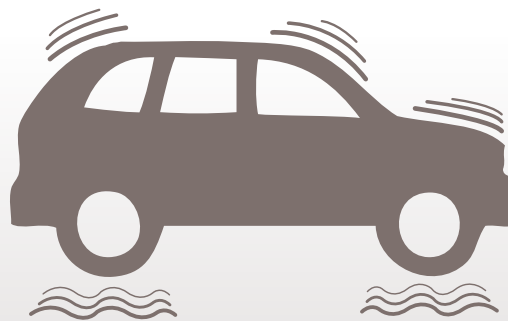
7 VIBRATION

EVIDENCE

- On the road, the driver senses vibrations in the driving compartment

CAUSES

- Bad condition of the mating parts (a balance problem)
- Incorrect tightening of the bearing

NTN-SNR ADVICE

- Check the wheel balance
- Follow the general recommendations related to fitting of the wheel bearing or torque

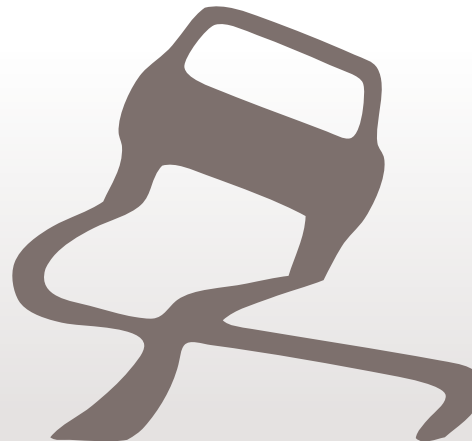
8 DIFFICULTY IN STEERING STRAIGHT

EVIDENCE

- Driven in a straight line the vehicle tends to drift to the left or to the right

CAUSES

- Incorrect adjustment of the drivetrain
- Steering system stiffness: worn ball joints
- Incorrect tightening of the bearing

NTN-SNR ADVICE

- Check the axle adjustments
- Replace the ball joints

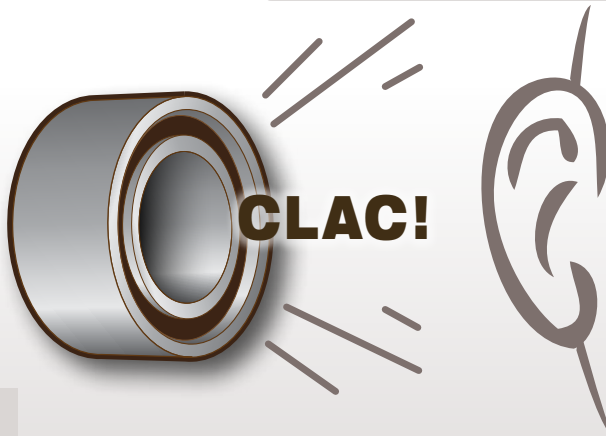
9 CLACKING / NOISE

EVIDENCE

- A loud noise from the front axle (when parking)

CAUSES

- A small movement of the bearing in the stub axle housing

NTN-SNR ADVICE

- Check the dimensions and condition of the stub axle housing

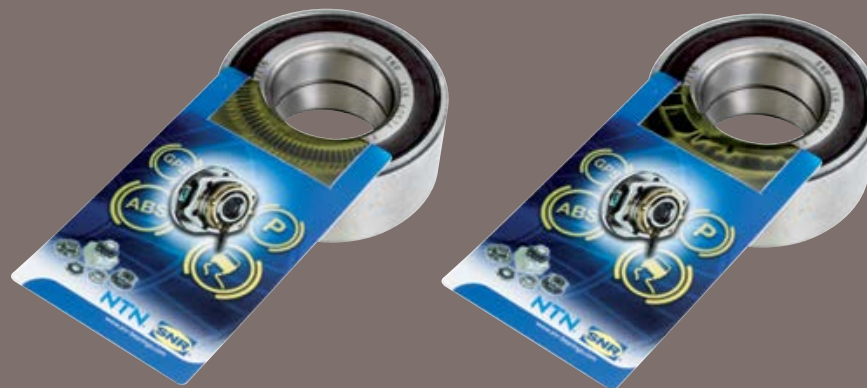
EVIDENCE

- The ABS warning panel light comes on or remains on

CAUSES

- Computer failure
- Sensor failure
- Connection problem
- Encoder deteriorated
- Bearing fitted the wrong way round

NTN-SNR ADVICE

- Check the encoder and sensor are clean
- Never bring a magnet near to the encoder
- To fit bearings of first generation in the right way, make sure to use the ASB® test card
- Use of the NTN-SNR card tester is essential
