VPW Arbitration Class 2 U1850

Symptoms: Video is not displayed on far rear screen.

Pacific Accessory Corporation MPW Arbitration Plass 2 U1850

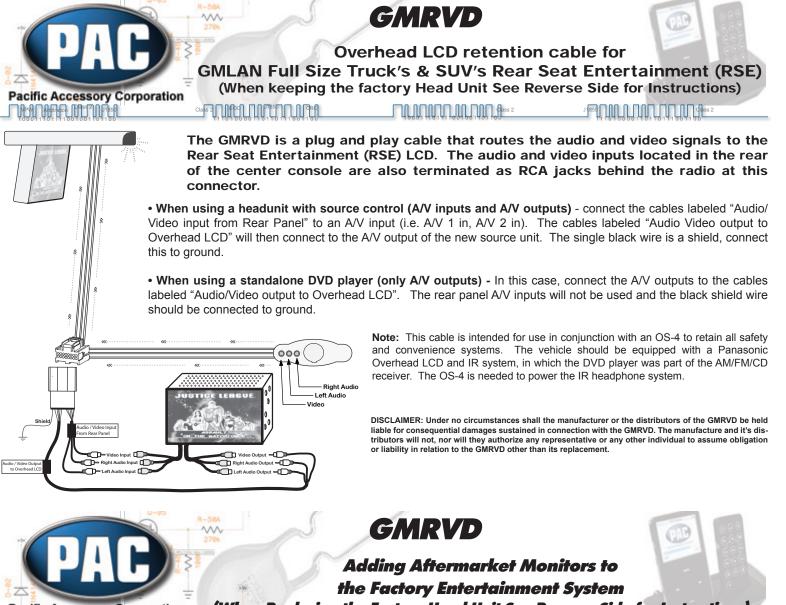
**Solution:** Below is a picture of the connector in which two wires need to be connected for video to be displayed on the far rear screen. For reference the Connector pictured below is purple in color and is located behind the radio and has the rear speaker leads in it as well. This is **NOT** the GMRVD connector.

Pin 4. - DVD Video Signal 2 (+) (Light Green) Pin 12. - DVD Video Signal 2 (-) (White)

**Reason:** We have found that there is a separate video feed for the far rear screen.

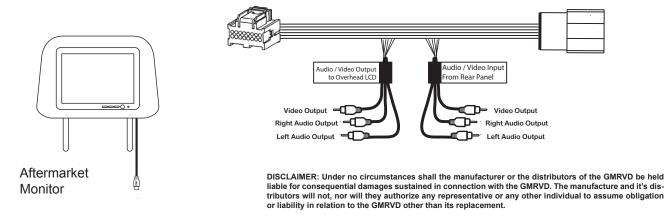
The GMRVD is a plug and play cable that allows aftermarket monitors and IR headphones to be connected to the factory entertainment system. The GMRVD is connected behind the factory head unit.

• When using an aftermarket monitor, connect the cables labeled "Audio Video output to Overhead LCD" to the aftermarket Monitor video input. If installing aftermarket IR headphones, connect the RED and WHITE RCAs to the audio input of the aftermarket IR headphones. The cables labeled "Audio Video input From Rear Panel" are not used.
