THE PROBLEM SOLVER®

DID ■ YOU ■ KNOW?

The lower control arm vertical bushing on the vehicles listed is prone to splitting and failure. Drivers will experience excessive front end noise and clunking. MOOG recommends replacement with part number K6698. This bushing is designed to work with both aluminum and stamped steel control arms. When replacing the bushing with MOOG K6698, technicians may note a difference in appearance. This is because the OE part may contain voids, or air gaps, which are prone to failure because the rubber bushing separates from the outer metal ring. The MOOG K6698 is made of solid material, increasing life.

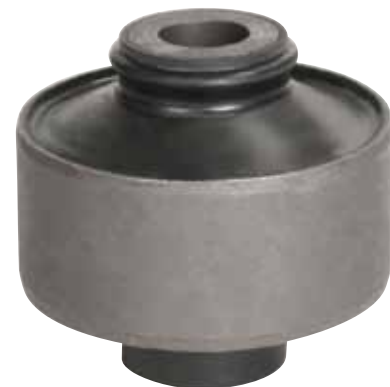
1. Place the MOOG K6698 bushing to the tapered side of control arm.

2. Using a suitable press tool, install the control arm bushing in the lower control arm.
3. Install the bushing to the same depth as noted during removal.
4. Install the lower control arm.
